Timothy P. Marshall\*  
Haag Engineering Co.  
Dallas, TX

## 1. Introduction

On 24 April 2007, a tornadic supercell crossed the Rio Grande striking the Rosita Valley community located just south of Eagle Pass, TX. The rain-wrapped tornado traveled about 6 km into the U.S. and had a damage path nearly 800 m wide (Fig. 1). More than one hundred homes, including many manufactured homes, were damaged or destroyed. Seven people lost their lives, six of them in manufactured homes. The authors conducted ground surveys after the tornado while an aerial survey was performed by the Southwest Texas Regional Advisory Council (STRAC). The National Weather Service rated the tornado EF-3 on the Enhanced Fujita scale with peak three second wind gusts around  $67 \text{ ms}^{-1}$  at 10m above the ground.

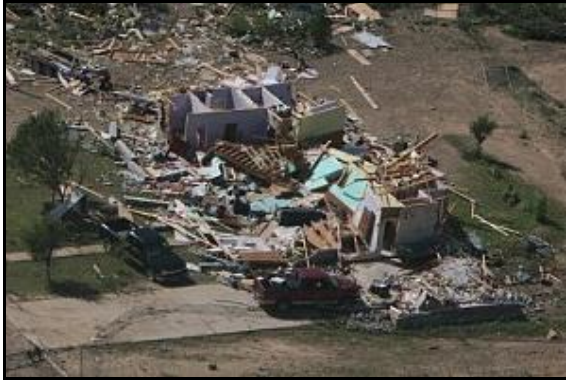
The first building damage in the U.S. was to a wood-framed residence with brick veneer exterior located on a bluff overlooking the Rio Grande (Fig. 14). The entire roof and most exterior walls were removed. Also, the attached two-car garage was destroyed. Close examination revealed wood bottom plates were bolted to the concrete slab foundation. Failure of the wall framing occurred when the studs pulled out of their straight-nailed connections to the wall bottom plates (Fig. 15). The home was assigned an EF-3 rating with a DOD of 8. Peak three second wind gusts were estimated to be around  $67 \text{ ms}^{-1}$  at 10m above the ground.

**Figure 14.** Aerial view of the first house struck by the Rosita Valley tornado looking southeast. This home was rated EF-3 (DOD=8).

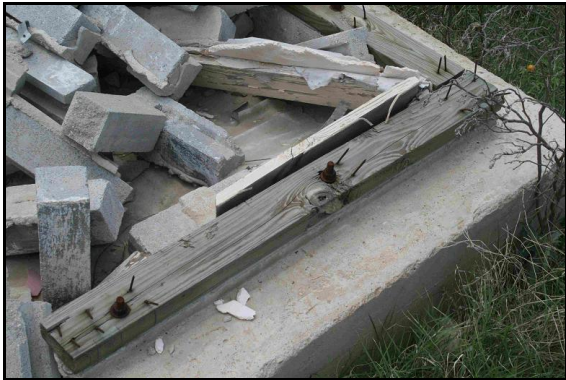
**Figure 15.** Failure of the wall framing occurred when the studs pulled out of their straight-nailed connections to the wall bottom plates. Note wall bottom plates were anchored to the concrete slab foundation.

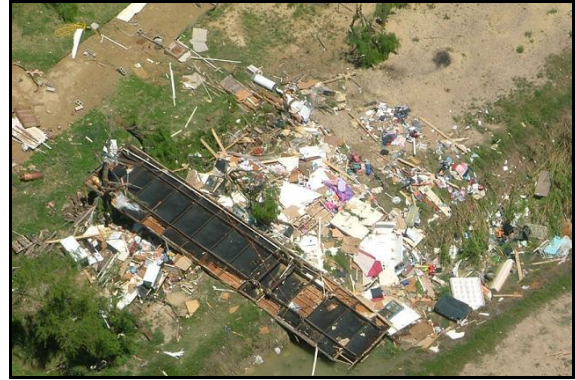
Manufactured homes consisted of wood-framed structures mounted on steel undercarriages. Some manufactured homes had their steel frames anchored to the ground whereas other manufactured homes were not anchored. Regardless, manufactured homes performed poorly in EF-2 winds (DOD=8) and offered no protection to occupants. Wall framing typically separated from the floors as the unit rolled (Fig. 16). Manufactured homes were rated EF-0 if they lost roof shingles or decking (DOD 1 and 2). An EF-1 rating was assigned to homes that shifted or rolled off their foundations or lost their roofs (DOD 3 to 5). Homes that were completely destroyed (i.e. all walls down) were rated EF-2 (DOD  $\geq 6$ ).

**Figure 16.** One of several flipped manufactured homes rated EF-2 (DOD=8). The original location of the home was in the upper left corner of the picture.

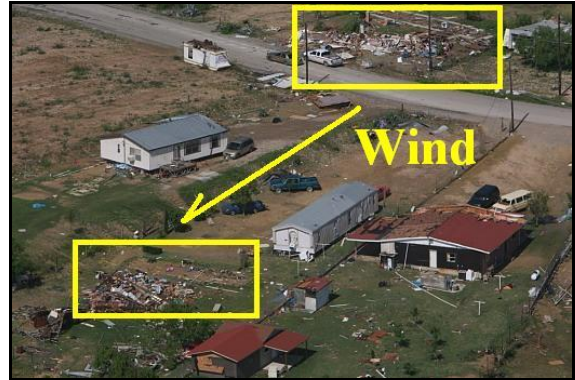
There was considerable variation in the performance of manufactured homes depending on the direction of the wind. We saw several examples where homes that were broadsided by the wind were destroyed whereas homes parallel to the wind remained on their supports (Fig. 17).

**Figure 17.** Variation in the performance of manufactured homes related to the orientation to the wind. Two manufactured homes (yellow boxes) were destroyed when broadsided by the strongest winds while other manufactured homes parallel to the wind remained.

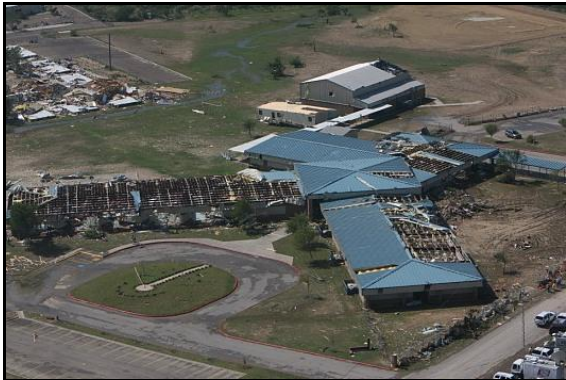
The tornado crossed Rosita Valley Road and struck the Rosita Valley Elementary School (Fig. 18). This one-story, steel-framed structure lost a significant amount of its steel-clad roof panels. Wind breached the building pushing windward walls inward and leeward walls outward. The damage was rated EF-3 with a DOD of 8. Homes east of the school also sustained EF-3 damage. Then, the tornado turned gradually to the east and crossed Wagon Wheel Road. The tornado dissipated in open ranchland lifting prior to Highway 1021.

**Figure 18.** Aerial view of the Rosita Valley Elementary School looking southeast. This steel-framed structure lost a considerable amount of its metal roof and wall cladding.
