Timothy P. Marshall*
Haag Engineering Co.
Dallas, TX

1. Introduction

A large, destructive tornado moved across Butler and Black Hawk Counties in northeast Iowa traveling through the south end of Parkersburg on 25 May 2008 (Fig. 1). The tornado damaged or destroyed more than three hundred residences in addition to two bank buildings, a high school, and many other buildings. Seven people died.

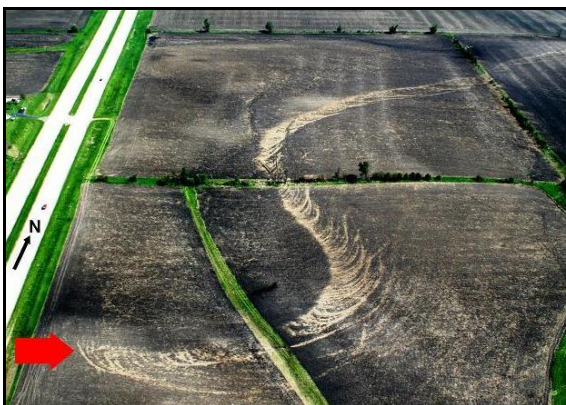
The tornado maintained its size and intensity as it traveled just north of New Hartford completely destroying more than a dozen homes. Circular spiral ground marks were again observed in the corn stubble between Parkersburg and New Hartford and continued east of New Hartford. Then about 5 km east of New Hartford, the tornado path narrowed to about 100 m, then turned abruptly south, before resuming its east-northeast track. The tornado made two more abrupt turns to the southeast prior to reaching Highway 63 passing just north of the cities of Cedar Falls and Waterloo. After crossing the highway, the ground spirals tightened, and became oblong in shape. Then the tornado made an “S-shaped” turn to the north, before heading northeast (Fig. 8). Suddenly, the tornado widened, made a loop, and was joined by a satellite vortex, before heading southeast (Fig. 9). The tornado then resumed its east-northeast heading finally dissipating southwest of Fairbanks.

Figure 8. Aerial view showing the abrupt “S-shaped” turn in the tornado path to the north, just east of Highway 63. The tight spirals in the fields were made visible by the accumulation of corn stubble.

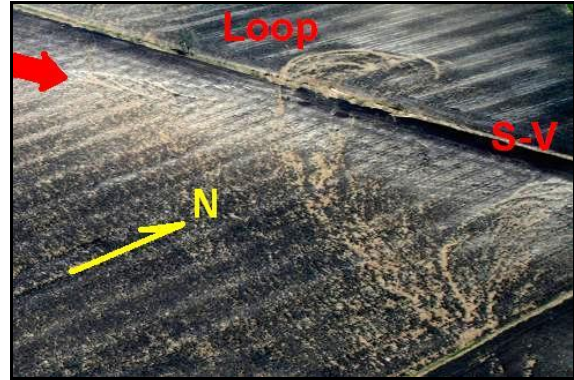
Figure 9. Aerial view showing a loop in the tornado path and merger of a satellite vortex (S-V) made visible by the accumulation of corn stubble.

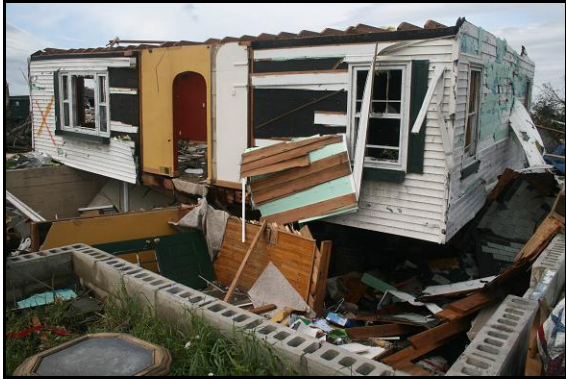
were pulled out of the CMU or the anchored CMU was dragged along with the floor. Such failures are common and have been described by Marshall et al. (2003). We found 33 homes that slid off their foundations. These homes were rated EF-2 or assigned an EF number of the adjacent home that did not slide off its foundation (Fig. 13).

Figure 13. Unanchored home that slid off its CMU foundation was rated EF-2 due to loss of its roof.

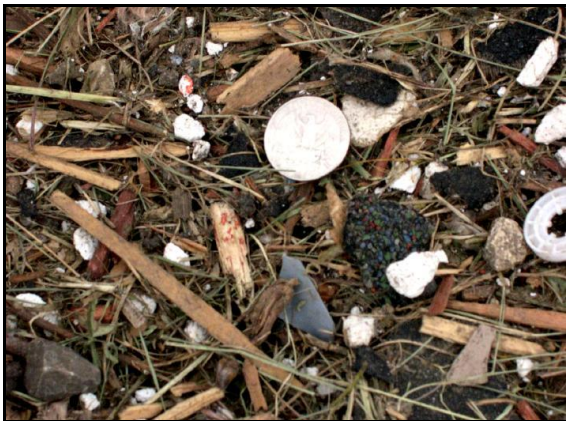
Figure 14. Bits of roof shingles, wood, corn stubble, and gravel along the center line of the tornado damage path in Parkersburg. A quarter coin was added for size. Image from NWSFO/DSM.

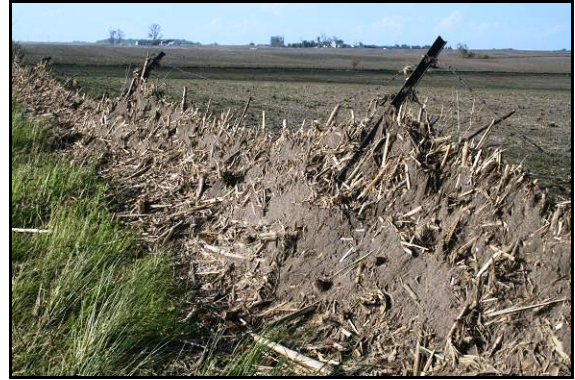
The fact that homes were swept away did not by itself indicate EF-5 damage. Consideration was given to the type of foundation and anchorage, as well as the degree of the surrounding damage to homes and trees. We did notice that flying debris appeared to play a role in the degree of damage as the tornado traveled through town. Wind rows of fine debris were visible along the center line of the path which included bits of roof shingles, wood, corn stubble, and gravel (Fig. 14). Debris impact marks were observed on debarked trees in town. In rural areas, the tornado picked up wet top soil and corn stubble and plastered buildings, utility poles, and barbed wire fences up to 3 cm thick (Fig. 15).

Figure 15. Mud and corn stubble plastered barbed wire fence.

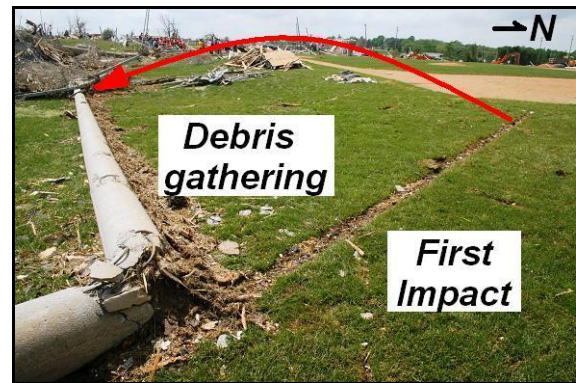
Six, hollow spun, steel reinforced concrete light poles toppled to the west and northwest in a baseball field located just east of the high school. Each pole was about 30 m tall and was broken at its base. All six poles left impact marks in the ground. However, the wind was strong enough to push the top half of one pole along the ground to the south. Fine debris accumulated up to 3 cm deep upwind of this pole (Fig. 18). This example illustrated that strong inflow winds occurred very close to the ground.

Figure 18. Concrete light pole had impacted the ground, then the top portion was pushed to the south. Debris gathered on the upwind side of the pole. This indicated that strong inflow winds occurred very close to the ground.
