Timothy P. Marshall*
Haag Engineering Co.
Dallas, TX

On 10 May 2008, a large tornado struck Picher, Oklahoma, a small town in the northeast part of the state (Fig. 1). Within days after the event, the author conducted ground and aerial damage surveys of the town. Detailed house-by-house damage assessments were performed and degrees of damage (DOD) were correlated with vehicle damage. Similar damage surveys have been completed by Marshall et al. (2008a, b, and c) after other tornadoes.

The Picher tornado destroyed a large number of manufactured homes. Two failure modes were discovered in the anchoring systems: 1) removal of the anchor heads, and 2) failure of the galvanized steel straps securing the steel undercarriages. This paper will present the results of the damage survey.

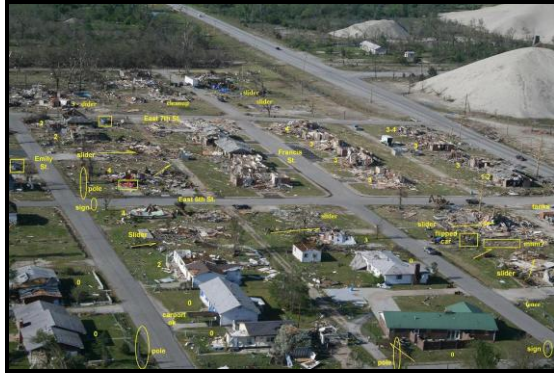
Figure 5. Aerial view of the tornado damage path looking south, just east of Highway 69. Pertinent features are noted. Chat piles are to the right.

The most severe damage occurred in the west portion of town where the tornado rolled or lofted dozens of manufactured homes. Steel undercarriages were mangled and deposited in trees along with large quantities of other debris. The original locations of the manufactured homes were noted by long, rectangular-shaped areas of dirt that contained equally spaced piers constructed with concrete masonry units (CMUs). The piers had supported the steel undercarriages. A few manufactured homes were built on foundation walls constructed with CMUs.

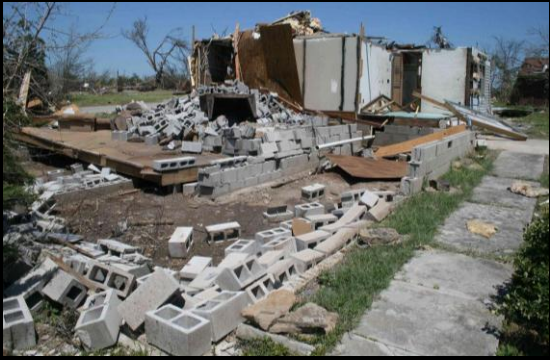
Of the 166 homes in the damage path, 18 were identified as “sliders” where floor platforms moved off their piers. Such homes were assigned DOD numbers based on the levels of damage above floor level. Where such homes had been swept clean from their foundations, they were assigned DOD numbers based on neighboring structures that remained (Fig. 9).

Figure 9. An unanchored home that slid off its pier and beam foundation.

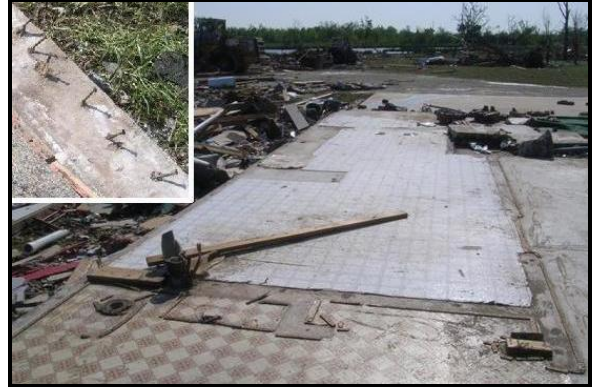
Figure 12. A poorly anchored home swept clean off its concrete slab foundation. The inset image shows nails along foundation perimeter (NOAA).

There were two homes swept clean off their concrete slab foundations. Both homes had bottom plates nailed improperly to the slabs. In addition, an elevated wood porch at one house remained intact along with railings and wood benches. At the other home, vehicles were moved but remained upright (Fig. 12). Thus, the author determined the maximum damage rating should be EF-4, rather than EF-5.

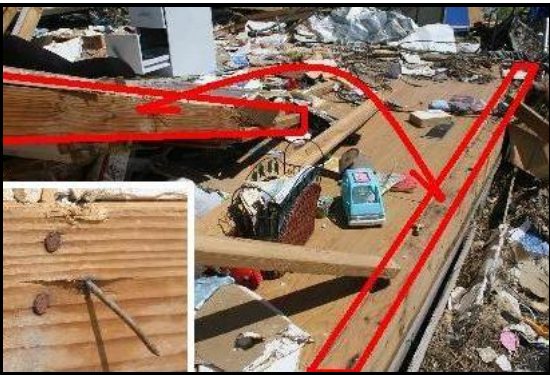
A common failure was separation of the perimeter walls and the floors (Fig. 10). Wall bottom plates fell over where they had been straight-nailed to the floors or wall studs were pulled out of the bottom plates. Wall bottom plates were straight nailed to the floors with nails usually missing the floor joists. Such walls had limited resistance to lateral wind loads once the roofs were removed.

Figure 10. Bottom plate of the wall (left) failed where it was nailed to the floor perimeter (right). The inset image shows a nail that extended from the bottom plate.

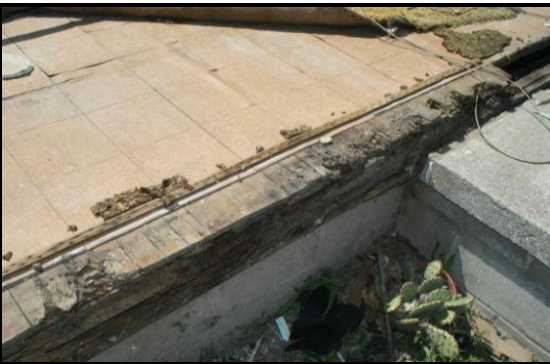
Termite and rot damage was found in many wood-framed houses. In some instances, the damage compromised critical connections between wood floors and wall plates (Fig. 11). As a result, there were a number of homes where the bases of walls were not attached to the floors.

Figure 11. Rot and termite damage to perimeter flooring beneath where the wall bottom plate had been located.

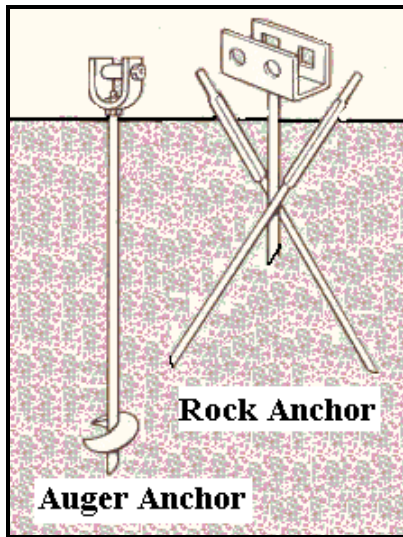
About two-thirds of the 66 manufactured homes had been anchored to the ground. Most homes were secured with rock anchors whereas a few had auger type anchors (Fig. 13). Rock anchors were comprised of a steel head with slotted bolts. The slotted bolts were used to secure the I-beam and wall straps. A vertically oriented shaft was welded to the

base of the anchor head and two diagonally oriented square tubes were welded to the shaft. Steel rods, up to 1.3 m long, were driven through the diagonal tubes into the ground forming an “X”. However, the crossed rods were designed to be pneumatically driven into solid rock or coral, not unconsolidated soil. Thus, rock anchors were improperly used for securing manufactured homes in Picher. In many instances, anchor heads slipped out of the crossed rod connections as the rods shifted. Steel undercarriages were then rolled or lofted. Within the wreckage of the mangled debris, anchor heads remained intact still strapped to the I-beams (Fig. 14).

Figure 13. Types of anchors that secured manufactured homes in Picher, Oklahoma.

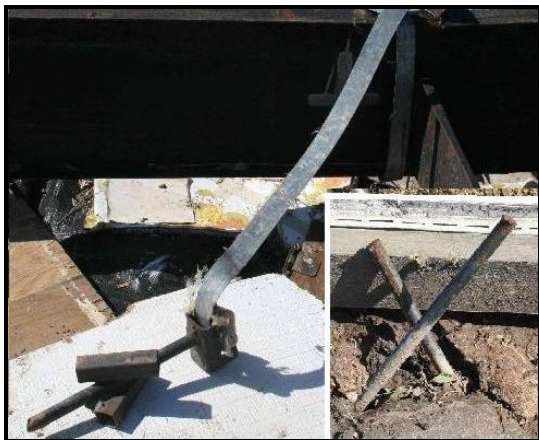
Figure 14. Failure of rock type anchor on a manufactured home. The anchor remained strapped to steel I-beam. The inset image show crossed steel rods remained in the ground.

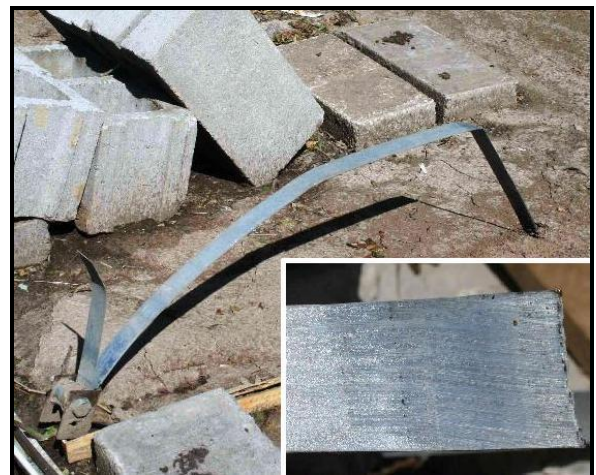
The proper anchor to be used in soil is the auger type. Auger type anchors have a vertical steel rod up to 1.5 m long welded to the base of the anchor head. An auger-shaped disk(s) is welded near the bottom of the rod. Auger anchors are mechanically driven into the ground until the anchor heads are flush with the ground surface. When installed properly, auger anchors provide formidable pull out strength. In Picher, none of the auger anchors had been pulled out of the ground. Instead, failure occurred when the galvanized metal straps broke (Fig. 15).

The galvanized metal straps were 3.2 cm wide and .9 cm thick. According to the U.S. Department of Housing and Urban Development (HUD, 2010), the straps should be capable of resisting a working load of 1432 kg and a 50 percent overload. There were only three instances out of the 66 homes, where the straps held the steel undercarriages in place. However, failures of the homes still occurred when the walls separated from the wood floors or when the wood floors detached from the steel undercarriages.

Figure 15. Broken strap on an auger anchor. The inset image shows scrape marks on the strap indicating movement of the steel undercarriage occurred prior to strap failure.

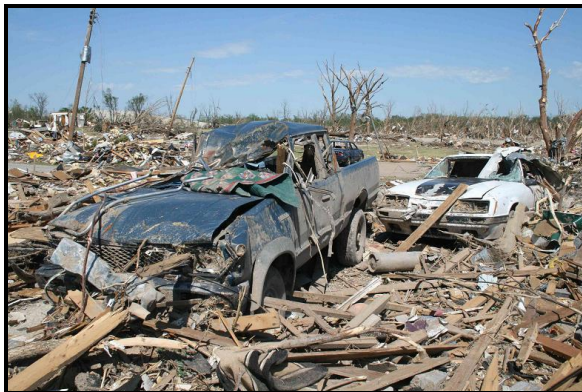
Most vehicles (59%) had not moved, and the vast majority (88%) remained upright (Fig. 16). However, flying debris had broken the windows of most vehicles and thus, they would not have been safe havens during the tornado. Rolled, tumbled, or lofted vehicles were rare and limited to areas where houses sustained EF-4 damage.

Figure 16. Most vehicles remained upright in areas where residences sustained EF-4 damage. However, flying debris had broken the windows and thus, vehicles would not have been safe havens in the tornado.
