Timothy P. Marshall*, Richard F. Herzog, and Scott J. Morrison
Haag Engineering Co.
Dallas, Texas

1. INTRODUCTION

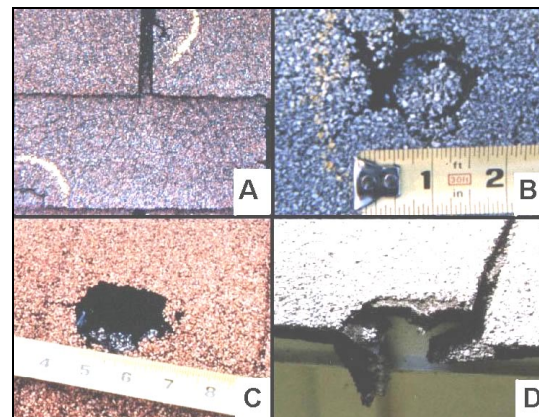
Morrison (1999) defined damage to roofing as a diminution of water-shedding capability or a reduction in the expected long-term life of the roofing material. Marshall and Herzog (1999) more specifically defined functional hail-caused damage to asphalt shingles as punctures, tears, or fractures (bruises) in the shingle mats (Figure 1). Shingle bruises are an indentation with fracture in the mat that feels soft like that of an apple bruise. The bruise is usually obvious as granules are also dislodged from the impact area exposing the asphaltic mat.

Figure 1: Hail damage to asphalt shingles: a) broken edges, b) bruise, c) puncture, d) torn edge.

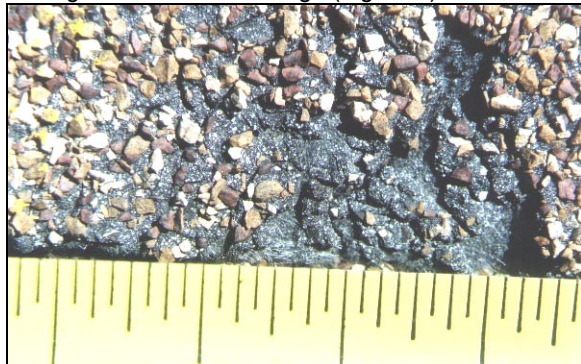
Shingles are particularly susceptible to hail damage if they have little or no underlying support, especially along ridges, rakes, eaves, and valleys. Shingle edges also are vulnerable to being chipped or broken. Therefore, the entire roof must be examined. Recently exposed asphalt appears black or unweathered, whereas asphalt exposed for several months oxidizes forming a surface film that is a grey color. This color difference is one way to tell new hail damage from old hail damage (Figure 9).

Figure 9. An example of 9-year-old hail damage to a glass-fiber mat asphalt shingle.

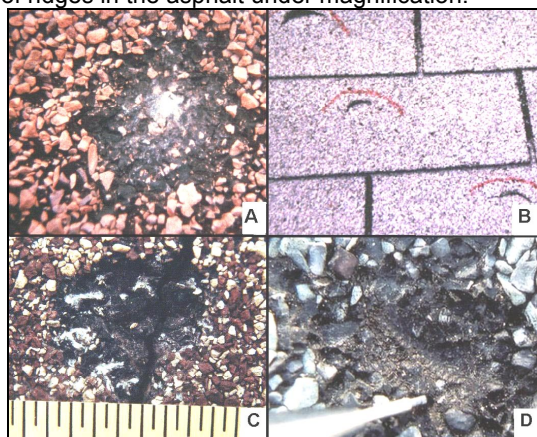
In our inspections of suspicious roof damage, we utilize a series of magnification rings to closely photograph the impact marks. Typically, shingles struck by metal objects will have broken or shattered the ceramic coating on the granules. This will leave a "powder" residue containing shattered ceramic material within the impact mark. Any side-to-side or "rounding out" motions will tend to leave swirl marks within the powder residue and/or leave smudges in the exposed asphalt surface (Figure 12).

When claw hammers are utilized, the metal peen frequently does not strike the roof slopes exactly perpendicular but tends to tilt forward slightly leaving a characteristic curving fracture in the shingles that opens towards the direction of impact. The concave fracture in the shingle resembles a "frowny" face when looking upslope. Granules closest to the concave side of the fracture are frequently compressed uniformly into the shingle mat.

Sometimes coins are utilized to leave small divots in the shingle surface. Quarter coins have small ridges around their perimeters that can leave a series of ridges in the asphalt under magnification.

Figure 12. Close-up views of mechanically caused impacts to shingles using: a) a ball-peen hammer, b) claw hammer, c) screwdriver, and d) quarter coin.

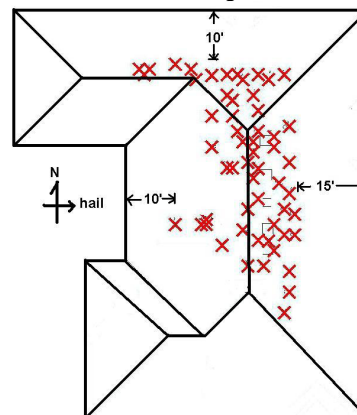
After a general examination of the building surroundings is performed, a roof plan diagram is drawn and shingle marks are plotted. Any pattern or grouping of shingle marks quickly becomes apparent in the diagram (Figure 13). The diagram will indicate those roof slopes or ridges that are notably without shingle marks as well as any grouping of marks. Usually, large areas of the affected roof slopes are without shingle marks as are other, perhaps smaller, roof slopes that face the same direction. Shingle marks closest to the roof edge are measured.

Figure 13. Roof plan diagram showing the distribution of mechanically-caused impact marks in an alleged hail damage claim.
