Timothy P. Marshall^{*1}, William Davis², Steven Runnels²

¹Haag Engineering Company

1. INTRODUCTION

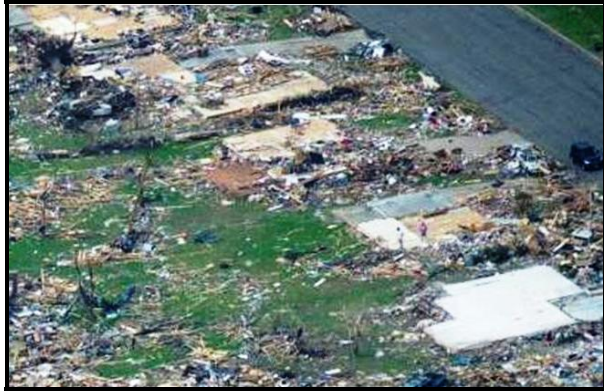
6, with failure wind speeds estimated to be 54 m s^{-1} (121 mph). We identified 12 homes that slid off their foundations. A total of 22 homes sustained EF-5 damage (Fig. 5).

Figure 5. A row of homes swept clean from their concrete slab foundations were assigned EF-5 ratings.

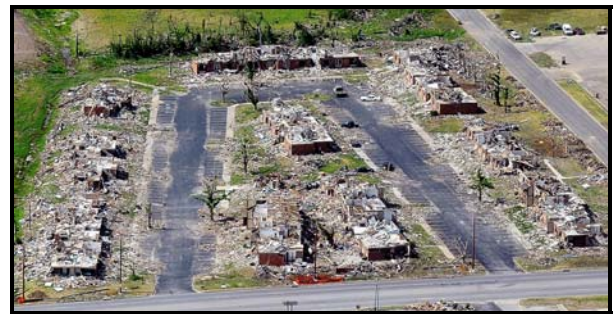
The tornado passed directly over the apartment complex and removed the top stories from all ten buildings (Figs. 6 and 7.) Walls were straight-nailed into the second story floors and toppled when the roof structure was removed. The straight-nailed connections simply pulled out of the floors as the walls rotated.

The expected failure wind speeds for destruction of the top story of an apartment building (DOD 5) was determined to be 71 m s^{-1} (158 mph) or EF-3.

Figure 6. Aerial image of the Hampshire Terrace Apartments looking south. The tornado blew away the second story units. Workers already had cleared most of the debris from the streets.

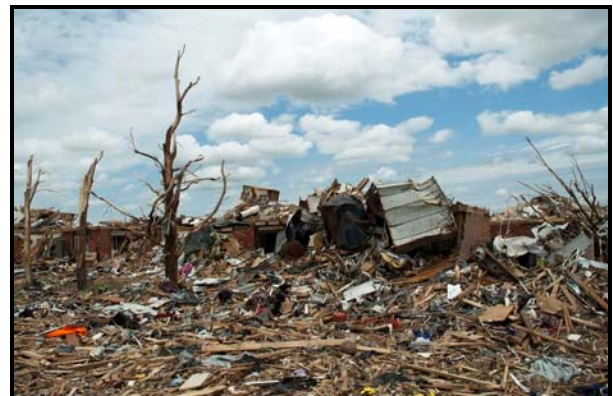
Figure 7. Ground view of one of the apartment buildings at Hampshire Terrace.

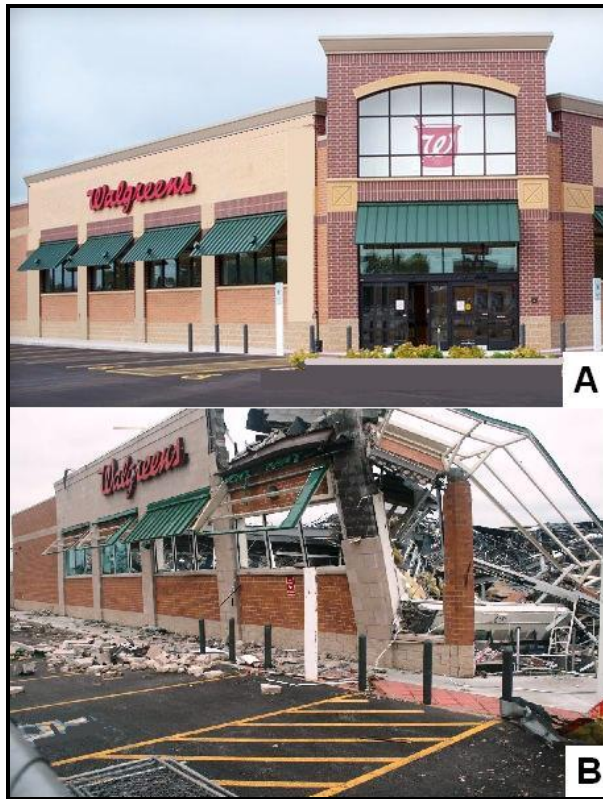
The building was located just south of the tornado core and encountered strong south and west winds. The non load-bearing west wall was pushed inward, rotating about the base of the wall. Positive internal pressures helped push the top of the north load-bearing wall outward, and the roof collapsed (Fig. 8).

Per the EF-scale, the building reached DOD 7, but the building was not totally destroyed (DOD 8). Thus, we estimated the failure wind speed to be 61 m s^{-1} (138 mph), or EF-3.

Figure 8. North elevation of the Walgreens Drug Store: a) before and b) after the tornado.

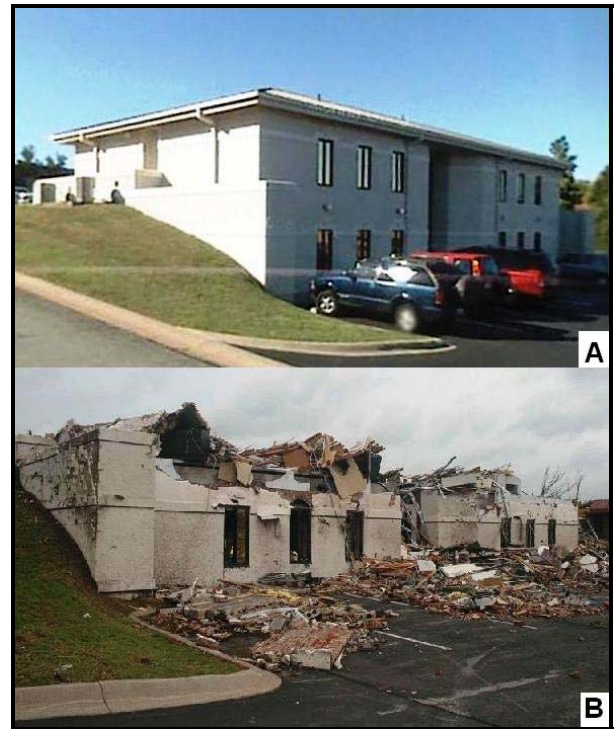
The core of the tornado struck the building removing the roof and entire top story leaving portions of the second story floor slab exposed to the weather (Fig. 9). The DOD of this building was between 8 and 9, indicating an expected failure wind speed of about 67 m s^{-1} (150 mph) or EF-3.

Figure 9. Southeast elevation of the professional building: a) before and b) after the tornado. Strong winds removed the second story wood framing.

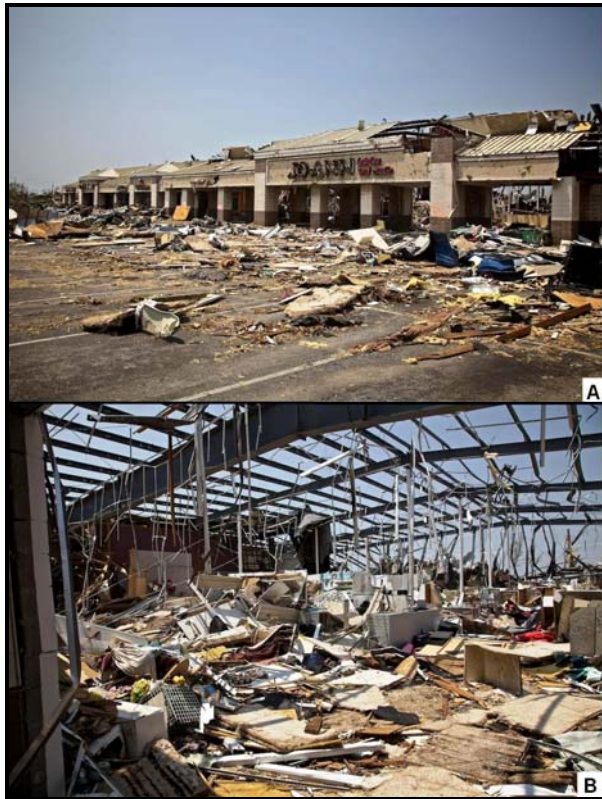
The core of the tornado passed directly over the building, pushing the west walls inward and removing the steel roof deck. The window wall along the front of the building blew outward (Fig. 10). Light standards in the parking lot fell over and wood power poles were snapped near their bases. According to the EF-scale, the DOD was between 8 and 9 indicating failure wind speeds were about 67 m s^{-1} (150 mph) or EF-3.

Figure 10. Front (east) elevation of the Bel-Aire Plaza Shopping Center. Tornadoic winds toppled the back (west) walls and removed the steel roof decking.

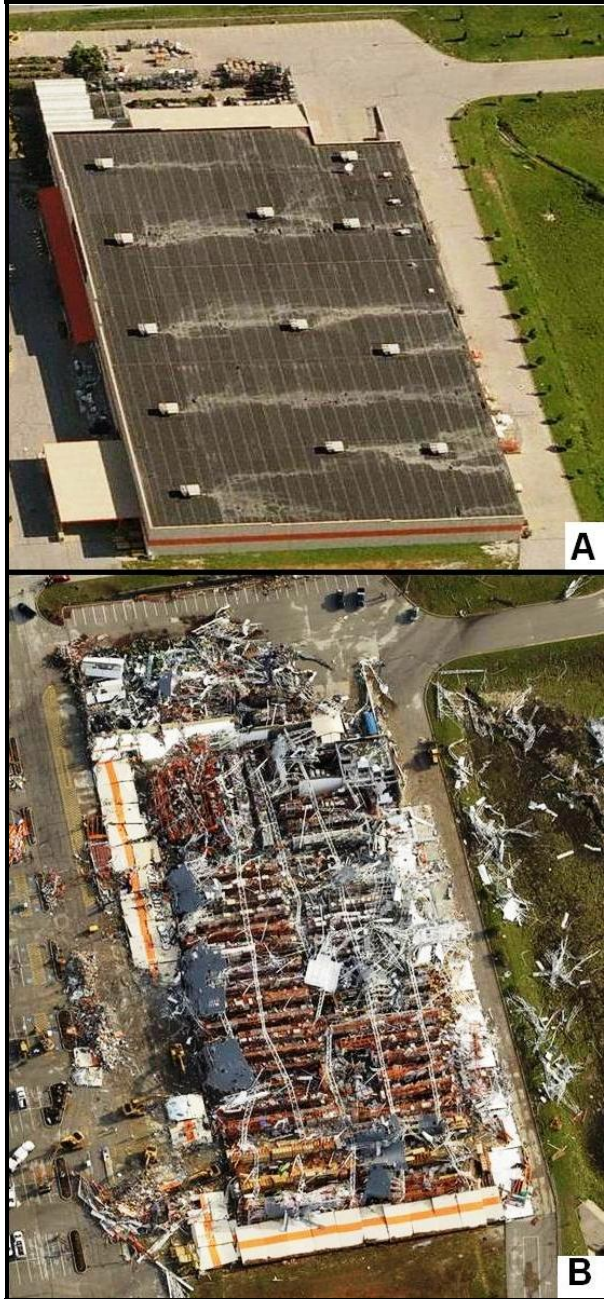
The core of the tornado passed just north of the Home Depot building. Thus, the building experienced strong south and west winds. South and west wall panels fell inward, and east wall panels fell outward. North wall panels remained upright. Bases of the wall panels were attached to the concrete slab with welded plates. The welds broke causing the panels to tip over. Welds also broke where the ends of the joists were attached to the plates in the wall pockets. Thus, the wall panels broke free from the steel frame (Figs. 11 and 12).

According to the EF-scale, the expected value for the complete destruction of a large section of an LIRB building is 77 m s^{-1} (173 mph) or EF-4. These large buildings have the same basic design wind speed requirement as residences, a 40 m s^{-1} (90 mph) three-second gust wind. The rebuilt store now has a storm shelter.

Figure 11. Aerial images of the Home Depot: a) before and b) after the tornado looking north. The superstructure collapsed when the wall panels toppled and the interior steel columns buckled.

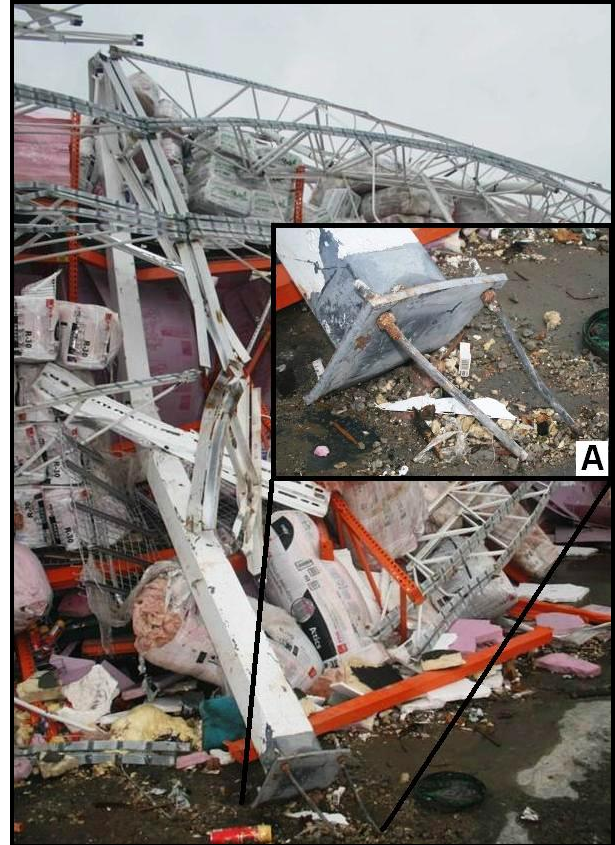
Figure 12. Base of a tubular steel column that failed when the anchor bolts pulled out of the concrete slab. Inset view (a) is a closer image.

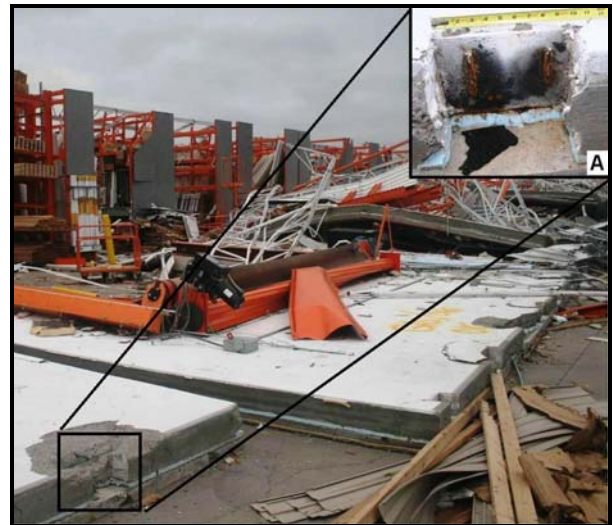
Figure 13. Toppled wall panels on the east side of the Home Depot building. Inset view (a) is a close up of a wall pocket where welds failed that attached the ends of the steel roof joists.

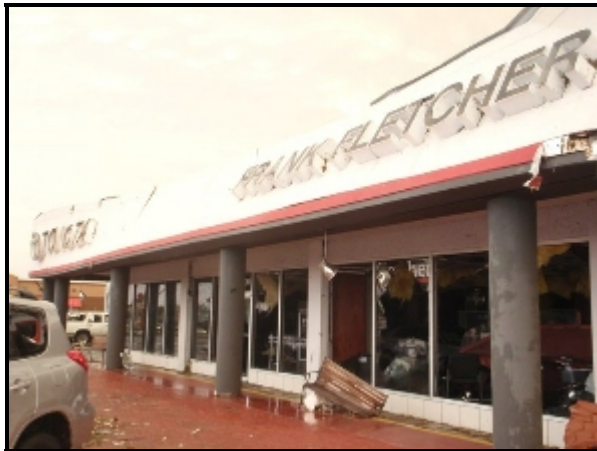
The building was located at the south end of the tornado damage path, and received the strongest winds from the west. Flying debris broke most of the windows around the building and many of the acoustical tiles fell from the suspended ceiling over the showroom (Fig. 14). No roof panels blew off. We determined the DOD to this building was 3 with a failure wind speed of 39 m s^{-1} (87 mph) or EF-1. Vehicles remained in the parking lot but had sustained significant damage from impact by flying debris.

Figure 14. The front (west) elevation of the Fletcher Toyota-Nissan showroom. Flying debris broke the glass windows, and the suspended acoustical tile ceiling fell. This auto showroom was on the south edge of the tornado damage path.

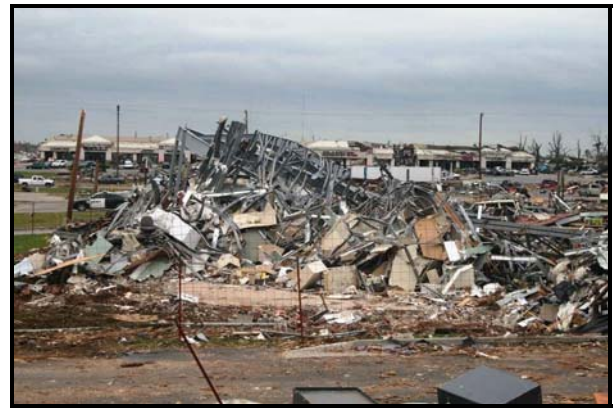
The core of the tornado passed directly over these buildings, causing them to collapse, reaching the maximum DOD of 8 (Fig. 15). Thus, we estimated the failure wind speeds to be about 72 m s^{-1} (160 mph) or EF-3.

Figure 15. The center of the tornado passed directly over the Pennzoil Oil Change facility causing complete collapse of the building.

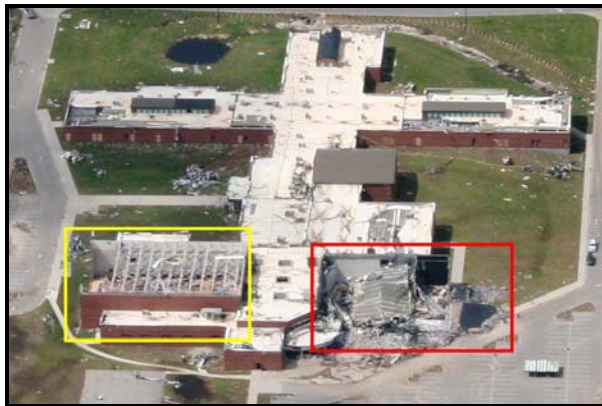
There were three elementary schools that were damaged by the Joplin tornado. One such building was the Joplin East Middle School located on the east end of the tornado damage path. Strong winds had collapsed the gymnasium and auditorium (Figs. 16 through 19).

According to the EF scale, the expected value for the collapse of the roof structure for an Elementary School building (DOD 7) would be 56 m s^{-1} (125 mph) with an upper bound of 66 m s^{-1} (148 mph) and lower bound of 48 m s^{-1} (108 mph). Given that collapses were limited to the two longest spans in the school, and that there was little lateral strength in the large walls, the authors believe the failure wind speeds were around 56 m s^{-1} (125 mph) or EF-2.

Figure 16. Aerial view of the East Joplin Middle School: (a) before and (b) after the tornado. The yellow box outlines the damaged gymnasium and the red box outlines the collapsed auditorium.

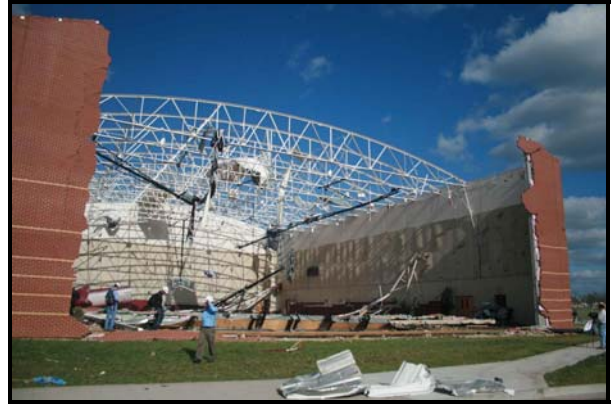
Figure 17. West wall in the gymnasium fell inward. The precast wall panels were attached poorly to each other and were not attached to the foundation.

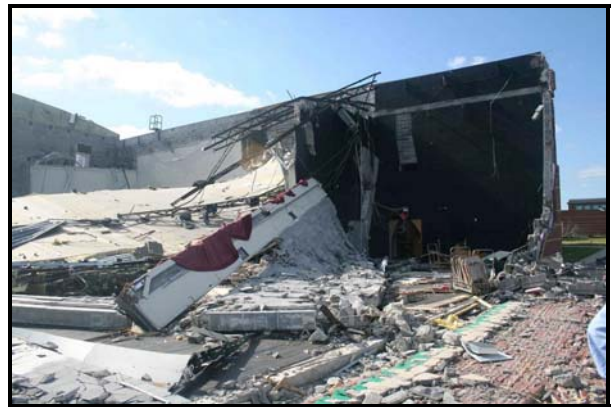
The center of the tornado passed just south of the school. Strong west winds and positive internal pressure caused the auditorium east wall to fall toward the east and the south wall to fall toward the south, resulting in collapse of the entire roof structure. Remaining CMU walls in the school remained intact. Close examination of the toppled CMU walls in the auditorium revealed that rebar extending out of the foundation pulled out of grouted cells at the bases of the walls, and vertical rebar in the walls pulled apart.

Figure 18. Roof on the auditorium collapsed when the south and east masonry walls failed.

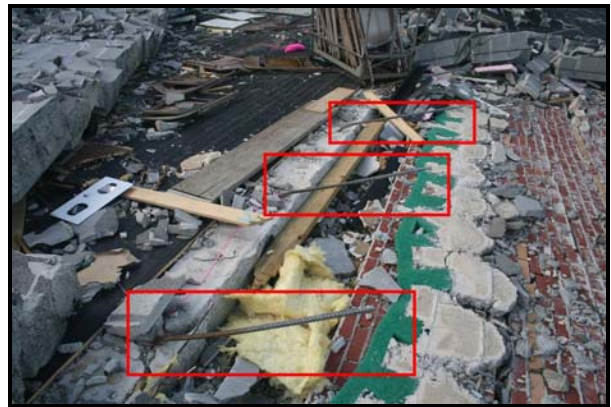
Figure 19. Base of the east auditorium wall showing foundation rebar (red boxes) bent to the east. This wall had little resistance to lateral wind pressures.

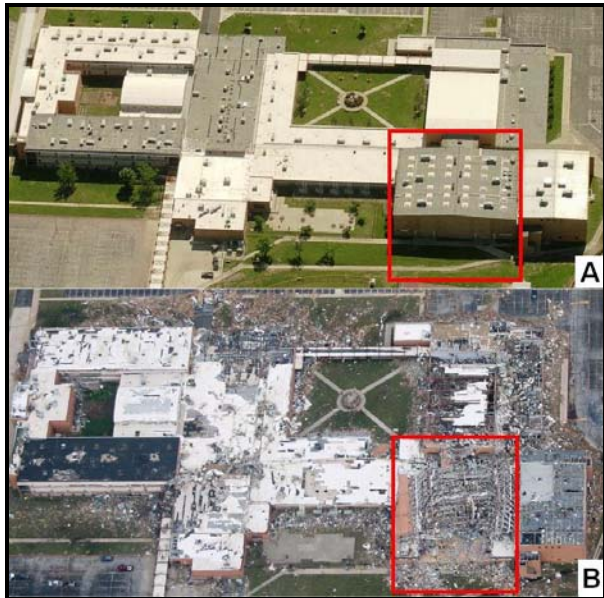
The High School was on the north end of the damage path and experienced the strongest winds from the north and east. A portion of the exterior north CMU wall and several interior partition walls fell into the second story hallway. This could have been tragic had these hallways been occupied during the tornado (Figs. 20 through 22). There was extensive damage to the roof covering and removal of the roof decking. The gymnasium building collapsed. Steel girders fell when the steel reinforced pilasters failed, and the tall, non-load bearing west wall blew outward.

According to the EF scale, the expected value for complete collapse of tall masonry walls at a gymnasium (DOD 7) would be 51 m s^{-1} (114 mph) with collapse of exterior walls in the top floor being 62 m s^{-1} (139 mph). The authors selected the higher wind speed which is at the lower end of EF-3.

Figure 20. Aerial images of the Joplin High School looking east: (a) before and (b) after the tornado. The gymnasium (red box) collapsed.

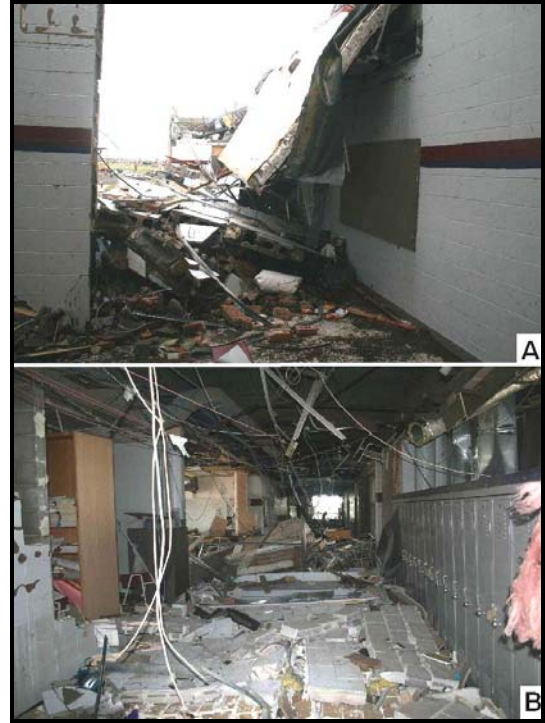
Figure 21. Collapse of second story CMU walls at the Joplin High School: (a) north hallway and (b) center hallway.

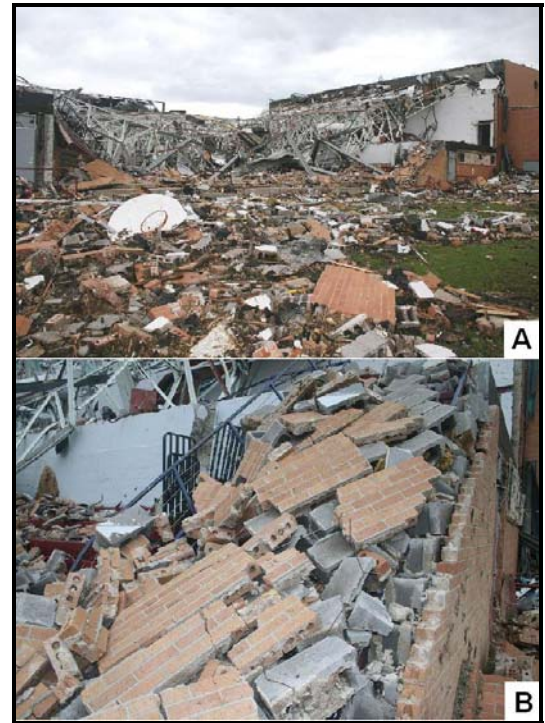
Figure 22. Collapse of CMU walls at the Joplin High School Gymnasium: (a) overall view looking east, and (b) close-up of the non load-bearing west which fell inward.

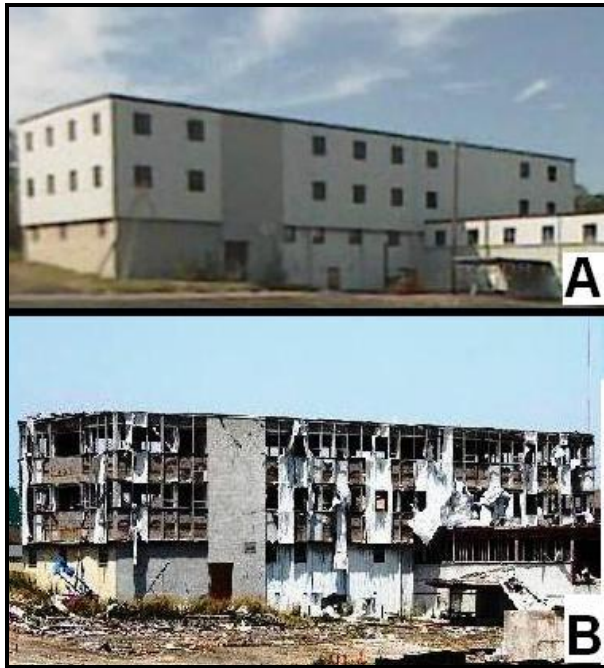
The building was located on the northern edge of the tornado path and experienced strong north and west winds. Windows on these elevations blew inward, and the windows on opposite elevations blew outward. Most of the metal facade was damaged or removed. However, the steel-reinforced concrete frame was not damaged (Fig. 23).

According to the EF-scale, the expected value for such a building to sustain significant damage to exterior walls and some interior walls (DOD 7) is 64 m s^{-1} (143 mph) or EF-3. The Federal Emergency Management Agency (FEMA, 2012) reached a similar conclusion.

Figure 23. Southeast elevation views of the Ozark Center for Autism building: a) before and b) after the tornado.

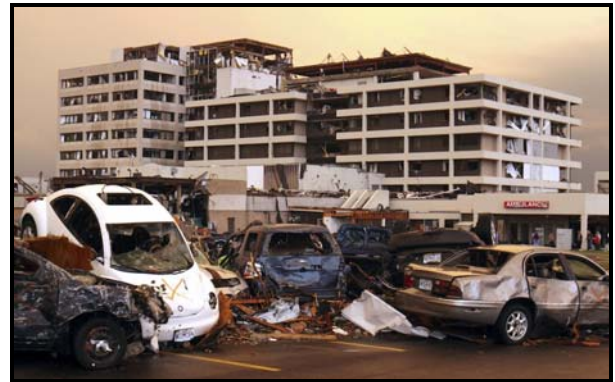
St. Johns Hospital was located just south of the tornado core and experienced strong south and west winds. Windows on these elevations blew into the hospital whereas windows on opposite elevations blew outward. Flying debris traveled through the hospital corridors and caused many injuries and six deaths. Built-up and single-ply roof coverings blew off. However, both concrete and steel framing remained intact. Many vehicles impacted each other in the parking lot, and some concrete parking curbs were shifted or removed (Figs 24 through 27).

According to the EF-scale, the expected value for damaged curtain walls or wall cladding (DOD 7) is 59 m s^{-1} (131 mph). However, there was no uplift of the roof deck (DOD 8 and 9), so failure wind speeds at the hospital were likely less than 64 m s^{-1} (142 mph), or within the EF-3 range.

Figure 24. Northwest elevation view of St. Johns Hospital. The steel-framed structure remained intact. Cars were tossed around and crashed into each other in the parking lot.

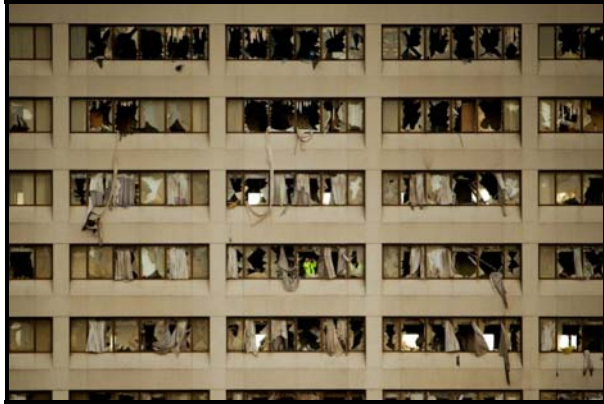
Figure 25. Loss of window glass on the north elevation of St. Johns Hospital.

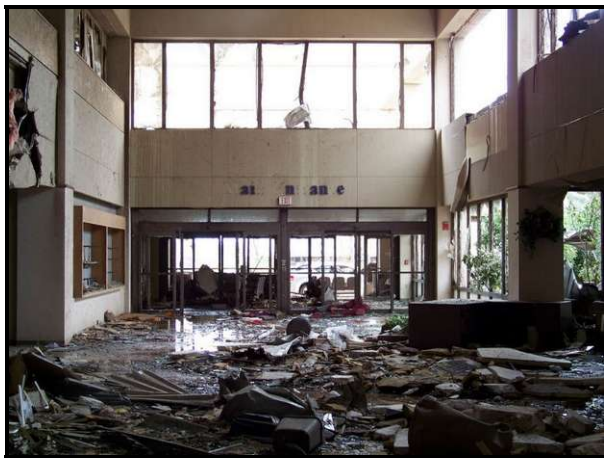
Figure 26. View inside the lobby of St. Johns Hospital. The two-story atrium floor was covered with broken glass.

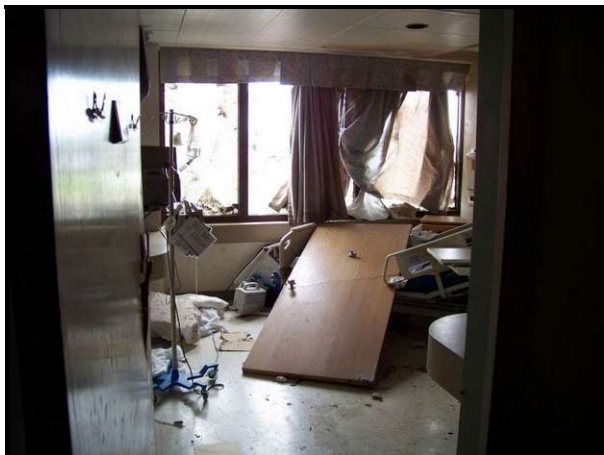
Figure 27. Damage to a patient room adjacent to an exterior wall.

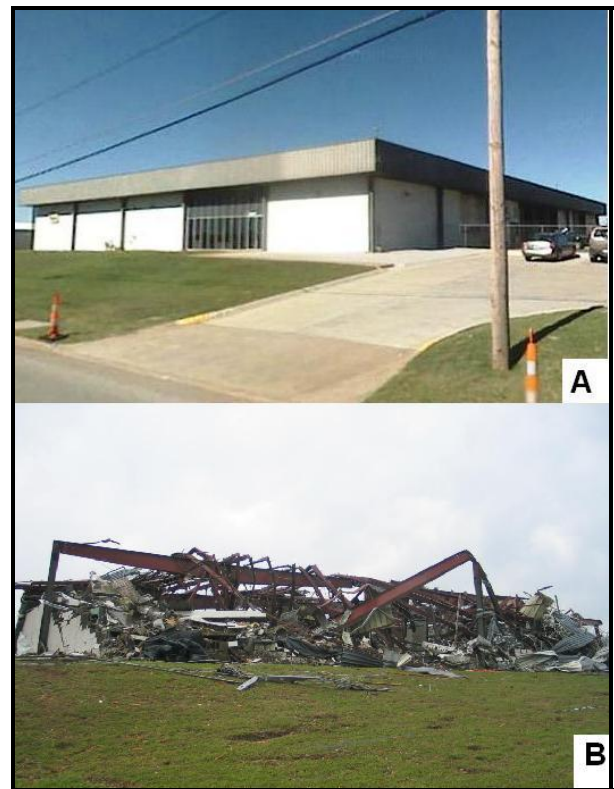
The building was in the center of the tornado damage path and collapsed completely (Fig. 28). South and west walls fell into the building, while north and east walls fell outward. There was no anchorage of the CMU walls to the roof structure or foundation.

The DOD for a destroyed metal building is 8 which puts the expected value failure wind speed at approximately 70 m s^{-1} (155 mph) or EF-3.

Figure 28. Southeast elevation of the Cummins Equipment building: a) before and b) after the tornado. This steel-framed structure had non load-bearing CMU curtain walls that collapsed during the tornado.

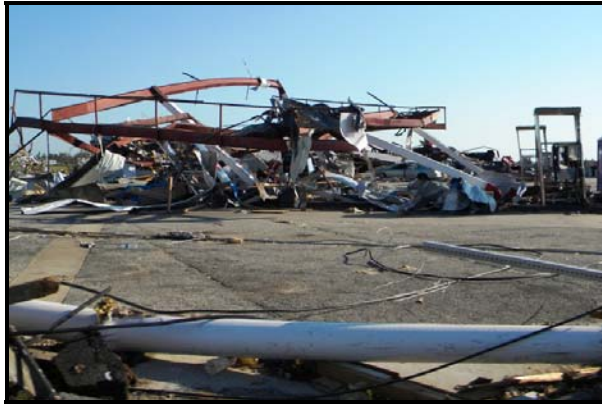
Damage to the canopies ranged from the removal of the metal cladding to toppling of the steel columns (Fig. 29). Destroyed canopies were assigned a DOD of 6, and had expected value failure wind speeds of about 59 m s^{-1} (133 mph) or EF-2. In some instances, actual wind speeds were higher than that needed to fail the canopies as noted by the DOD for the adjacent store. For example, the Fastrip gas station in front of the Walmart collapsed (Fig. 30). This small retail building had a DOD between 7 and 8 yielding a failure wind speed of about 67 m s^{-1} (150 mph).

Figure 29. Collapse of a service station canopy in the Joplin tornado.

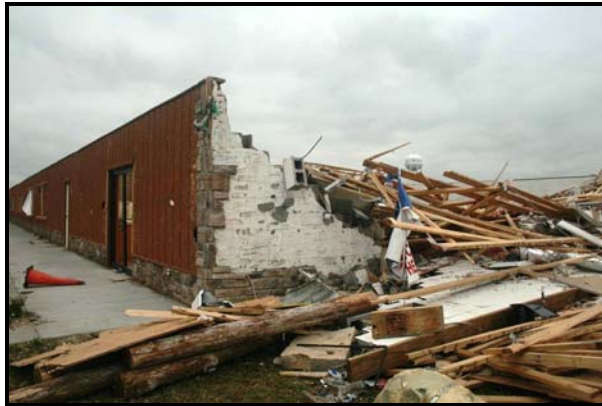
Figure 30. Collapse of a store with gas station canopy in front of the Walmart.

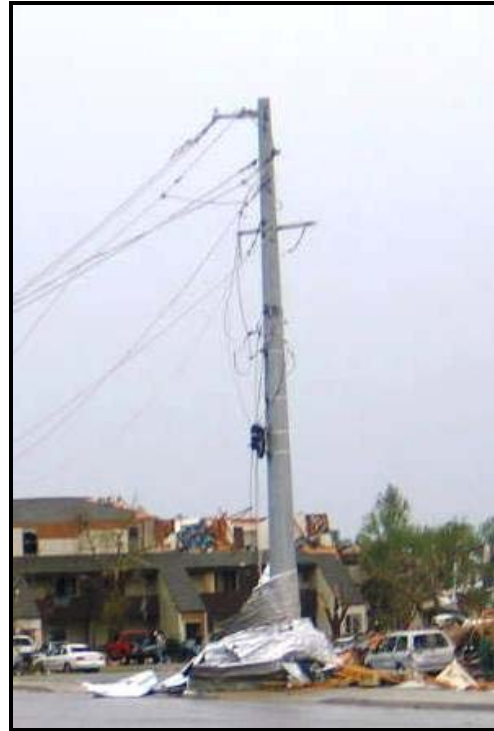
According to the Missouri Public Service Commission (MPSC, 2011), the tornado damaged or destroyed 4,000 service poles, 1,500 transformers, 110 miles of line, and one substation, leaving about 20,000 customers without electricity after the Joplin tornado. Most of the lost poles were wood, and there were approximately 130 tapered steel poles damaged or destroyed by the tornado. These tapered steel poles extended from the main substation located at 26th and Pearl Streets (Fig. 31). This intersection happened to be in the center of the tornado. According to the EF-scale, wood poles are expected to break at wind speeds around 53 m s^{-1} (118 mph) while steel poles bend or break at about 62 m s^{-1} (138 mph).

Figure 31. Damage to a tall, tapered steel pole that had supported power lines from the substation.

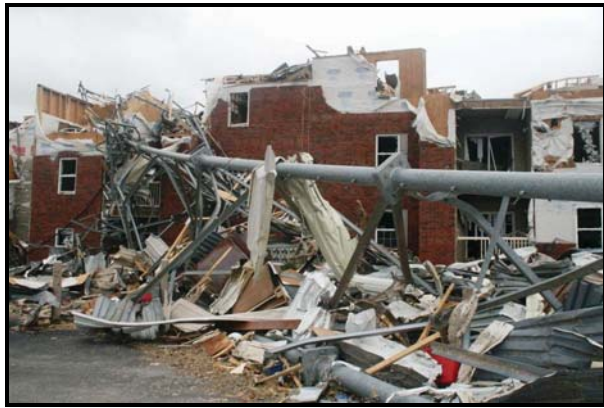
Two cell phone towers collapsed at the Plaza Apartments, just east of the Walmart. One tower was a single pole while the adjacent tower was triangular tower. Both towers fell toward the north before the tornado arrived. The core of the tornado then passed to the south. The triangular tower struck one of the apartment buildings and penetrated into the first story (Fig. 32). According to the EF-scale, the expected failure wind speed for cell phone towers is 59 m s^{-1} (133 mph) or EF-2. The loss of cell phone service greatly affected rescue operations.

Figure 32. Cell phone tower toppled into one of the apartment buildings at the Plaza Apartments.

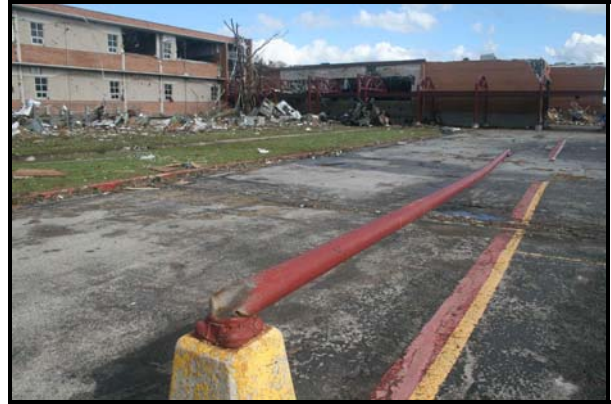
Figure 33. A light pole bent to the south in the High School parking lot.

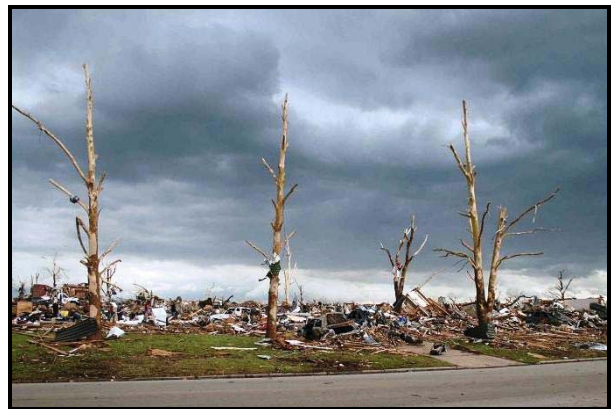
The Joplin tornado destroyed thousands of trees. Many trees were uprooted or had trunks snapped. Trees were debarked and shredded by flying debris (Fig. 34). The direction of the toppled trees (from base to tree top) indicated the direction from which the wind blew at the moment of failure. Near the beginning of the tornado path, we found a spiral pattern of tree falls where there was a brief, stationary vortex (Fig. 35).

Figure 34. Debarked trees near the center of the tornado path in an EF-4/5 area southeast of the High School.

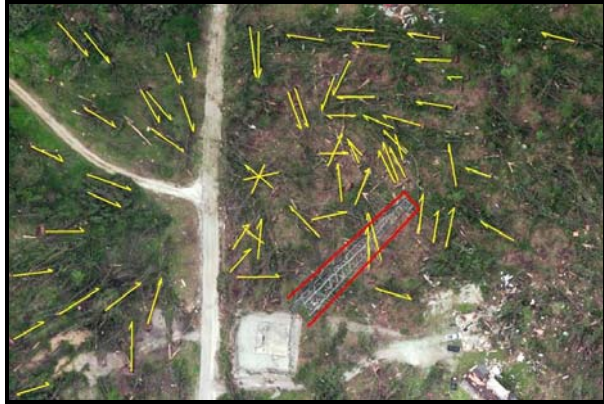
Figure 35. A spiral pattern of downed trees (yellow arrows) caused by a stationary sub-vortex near the beginning of the Joplin MO Tornado. A latticed, steel, cell tower (outlined in red) fell to the northeast.

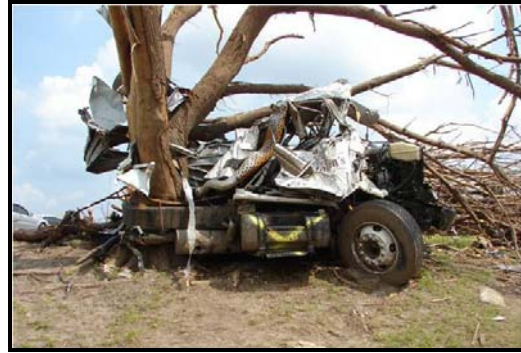
Figure 36. Truck frame wrapped around the base of a tree just east of the St. Johns Hospital.

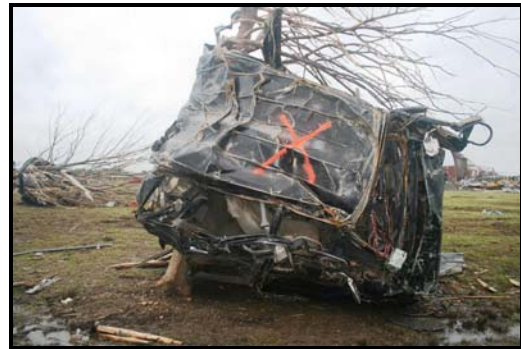
Figure 37. Four-door vehicle bent into a U-shape around a tree just south of the Walmart building.

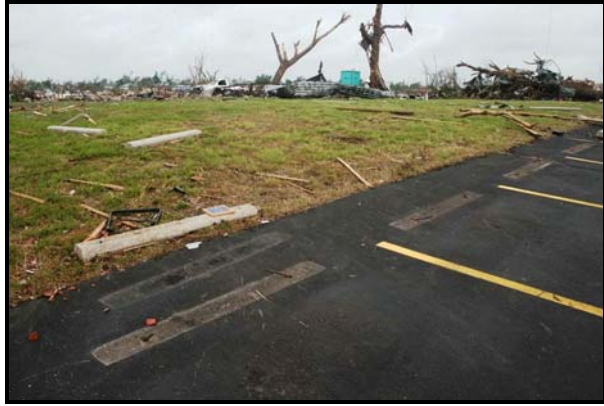
The tornado removed several parking curbs and tossed them up to 20 m away (Figs. 38 and 39). In some instances, the rebar remained anchored in the parking lot but was bent in the direction the curb had moved. Removal of the parking curbs demonstrated how strong tornado winds extend down to just above the ground.

Figure 38. Removed concrete curbs (thrown westward) in a parking lot of a professional building just west of St. Johns Hospital.

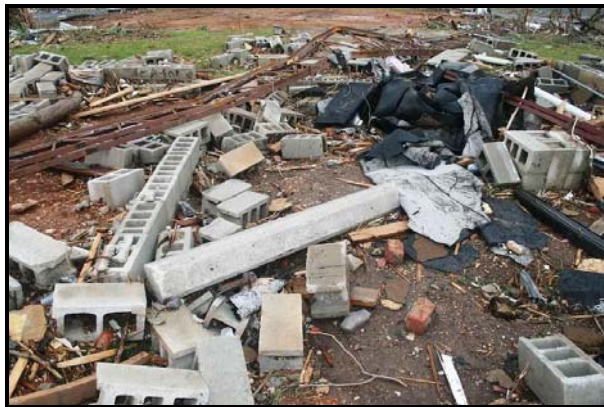
Figure 39. Parking curb found in the crawl space of a destroyed home. The curb traveled 20 m.

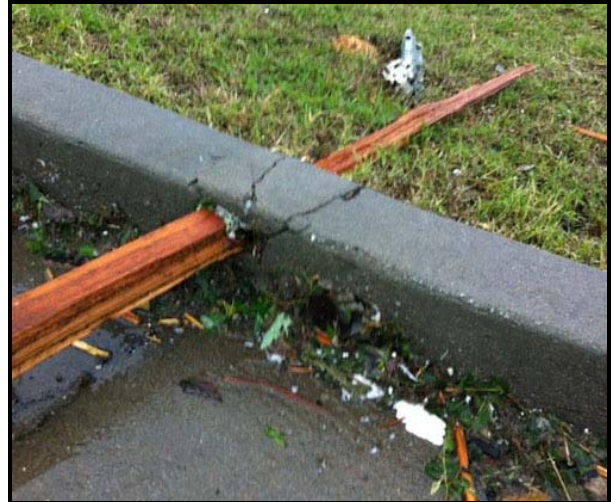
There were a number of oddities found in the damage of the Joplin tornado. A piece of wood was driven through a concrete curb (Fig. 40), cardboard was driven through EIFS siding at the High School, and a steel lawn chair was imbedded in the EIFS siding at Academy Sports. Steel manhole covers were missing. A 5 m long 2 x 10 board had penetrated a partition wall in the principal's office at the High School (Fig. 41). A picture remained unaffected on an adjacent bookshelf. The board had traveled horizontally through a small window in a high speed east wind. A child's play set, made of hard plastic, remained virtually intact within an EF-4/EF-5 area of destroyed houses, uprooted trees, and broken light poles in Cunningham Park (Fig. 42).

Figure 40. Wood splinter driven through a concrete curb.

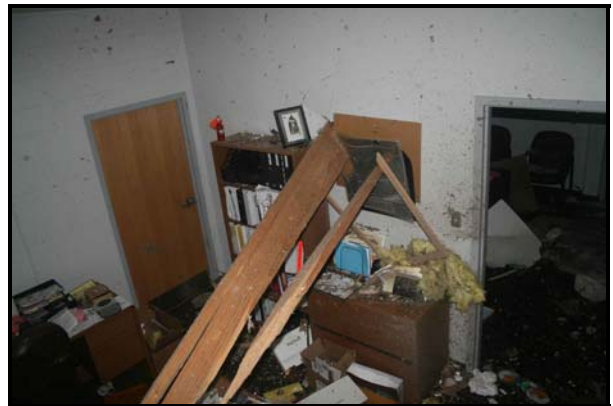
Figure 41. A large wood board penetrated a small window and partition wall in the principal's office at the High School. Note a picture remained upright on the adjacent book case.

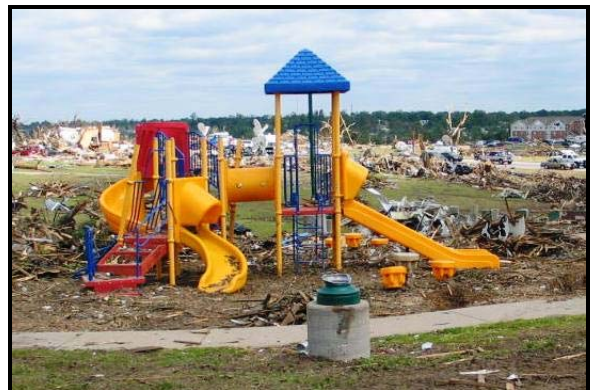
Figure 42. Child's play set was left virtually untouched in the middle of an EF-4/EF-5 area at Cunningham Park. Note the snapped steel pole in the foreground.
