## 5.3 Damage Survey of the Tuscaloosa-Birmingham Tornado on 27 April 2011

Timothy P. Marshall, P.E.<sup>1</sup>, Jim Stefkovich<sup>2</sup>, John DeBlock<sup>3</sup>, James G. Ladue<sup>4</sup>, Chris Karstens<sup>5</sup>

<sup>1</sup> Haag Engineering Co.

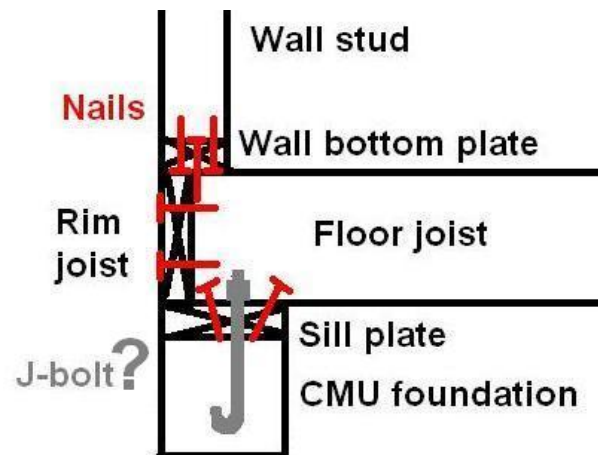
The definition of a well-built house can vary among individual damage surveyors. We defined a well-built house as one that had a continuous load path of straps and anchors from the roof to the ground, without weak connections in the horizontal or vertical planes. Unfortunately, we did not find a single house that was well-built. Almost all homes in the tornado path had CMU foundations. The concrete masonry consisted of hollow cells stacked in a common bond pattern. Wood sill plates rested on top of the foundations but rarely were attached to the masonry (Fig. 2). In a few instances, anchor bolts connected the sill plates to grouted top cells in the foundations. Regardless, such connections had little lateral strength and the bolts

either broke out of the cells or the top block broke out of the foundation.

**Figure 2.** Typical cross section of the base of a house supported on a CMU foundation. Nails are indicated in red. J-bolts were rarely used to attach the sill plates to the foundations.

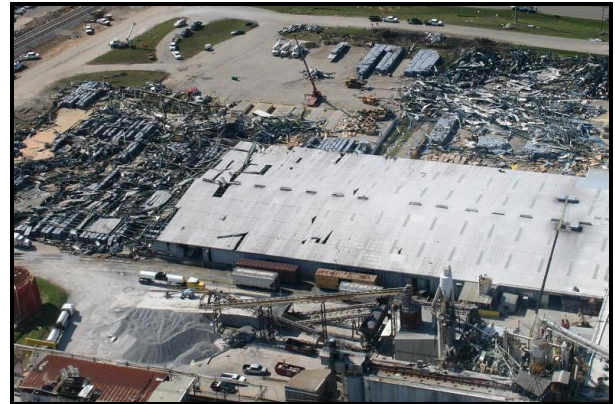
**Figure 5.** Collapse of metal buildings at the Tamko Roofing Plant.

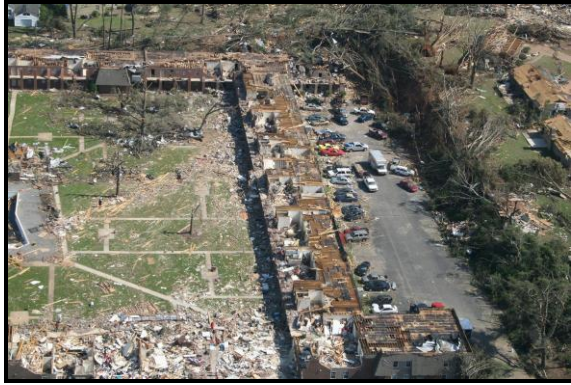
The tornado crossed Interstate-359, overturning several vehicles before traveling through the densely populated area of south Tuscaloosa. Many wood-framed homes sustained up to EF-4 damage while unanchored homes slid off their foundations and collapsed. The tornado passed directly over the Charleston Square Apartments off 27<sup>th</sup> Street. This large, rectangular-shaped building was a two-story, wood-framed structure constructed on a concrete slab foundation. The roof and second story walls blew off (DI 5, DOD 5) and the east end of the south building collapsed (Fig. 7). Failure wind speeds were estimated to be about  $71 \text{ m s}^{-1}$  (158 mph), or EF-3.

**Figure 7.** Removal of the roof and second story walls at the Charleston Square Apartments.

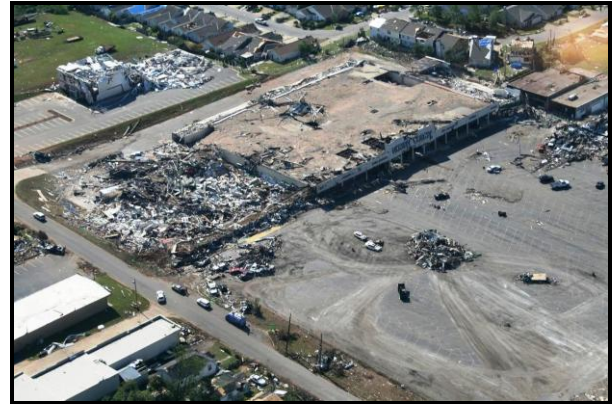
The tornado traveled through another residential area causing EF-4 damage to several houses then crossed Forest Lake before passing through a busy intersection at 15<sup>th</sup> Street and McFarland Blvd. The tornado literally “threaded the needle” between the University of Alabama and University Mall but hit the Wood Square Shopping Center along McFarland Ave. The shopping center consisted of unreinforced CMU perimeter walls and steel interior beams and pipe columns that supported relatively flat built-up roofs. Large portions of the north and west ends of the shopping center collapsed (DI 10, DOD 9). Estimated failure wind speeds were about  $76 \text{ m s}^{-1}$  (171 mph) or EF-4 (Fig. 9). Several light standards in the parking lot were broken (DI 26, DOD 3). Estimated wind speeds to fail such light poles would be about  $53 \text{ m s}^{-1}$  (118 mph) or EF-2.

**Figure 9.** Northwest elevation view of the Wood Square Shopping Center. Large portions of the building collapsed.

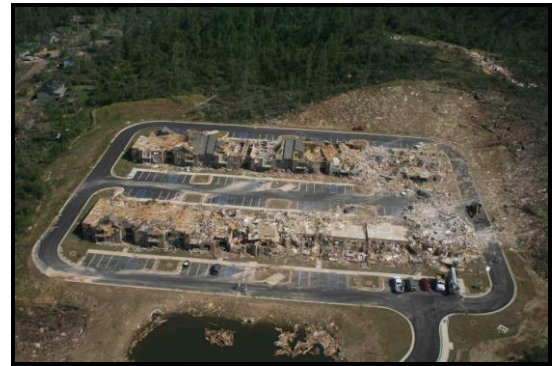
After causing EF-4 damage to residences, the tornado struck the Chastain Manor Apartments located in northeast Tuscaloosa along 34<sup>th</sup> Avenue East. There were two, wood-framed apartment buildings oriented east-west and constructed on the side of a hill that faced south. These buildings were “split-level”, with one-story on the north elevations and two-story on the south elevations. The gable type roofs were constructed with manufactured wood trusses that were attached to the tops of the walls with metal “hurricane” straps. However, the bases of the walls were fastened to the concrete slabs with cut nails instead of anchor bolts. The tornado removed the one story framing down to

the slab along the east end of the south building (DI 5, DOD 5 to 6). Given the poor connection between the wall framing and foundation, we estimated failure wind speeds to be lower than  $76 \text{ m s}^{-1}$  (170 mph) or EF-4 (Figs. 12 through 14).

**Figure 12.** Aerial view of the Chastain Manor Apartments looking north. A portion of the concrete floor slab was exposed on the east end of the south building.

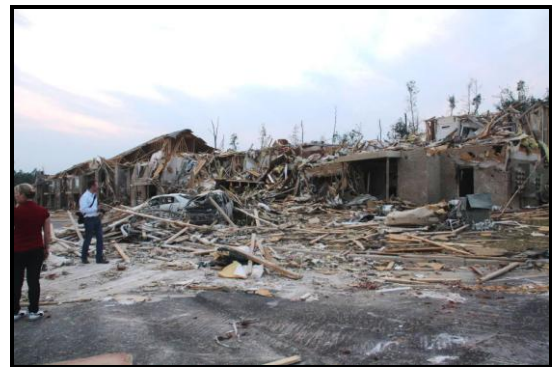
**Figure 13.** Ground level view looking northwest at the Chastain Manor Apartments. The tornado removed the top story.

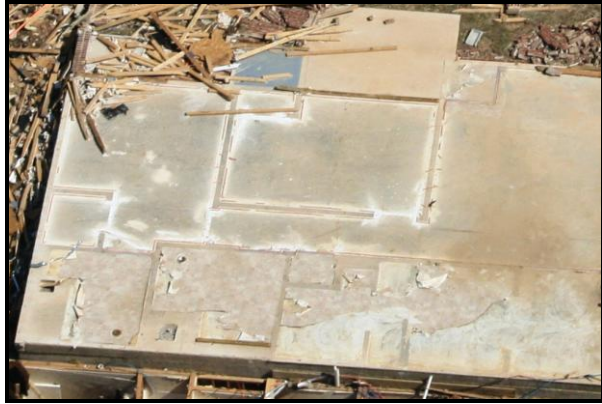
**Figure 14.** Closer view of the slab foundation at Chastain Manor Apartments. Wall plates were secured to the slab with cut nails instead of anchor bolts. Such connections had little pull out resistance from lateral or upward forces.

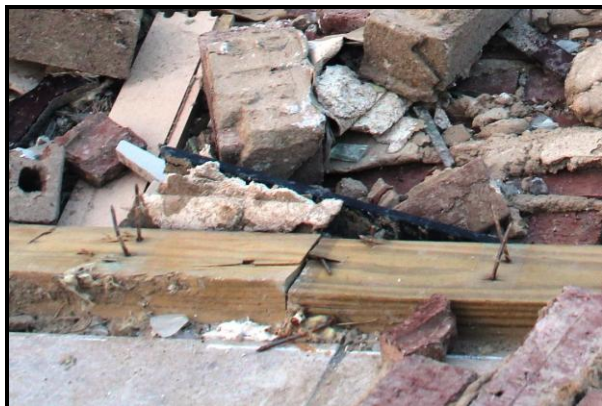
There was a one-story, wood-framed office building on site that was completely leveled by the tornado (Fig. 15). Close examination of this building revealed the wood-frame walls had been bolted to the concrete slab foundation. However, wall failure occurred when the straight-nailed connections between the wall studs and bottom plates pulled apart (Fig. 16). Walls fell outward except for the front (southeast) wall that blew away. Given the weak stud-plate connection, the survey team decided failure likely occurred at or below the EF-4 level. There was a third wood-framed apartment building southwest of the office building. This one-story, wood-framed building was constructed on level grade and sustained less severe damage than the two other buildings constructed on the hillside. Interestingly, a steel manhole cover lifted off a storm drain and was found in a nearby ravine.

**Figure 16.** Closer view of the wall bottom plate at the office building. Straight-nailed connections between the wall studs and the bottom plates had pulled apart, as they had little resistance to lateral or uplift wind forces.

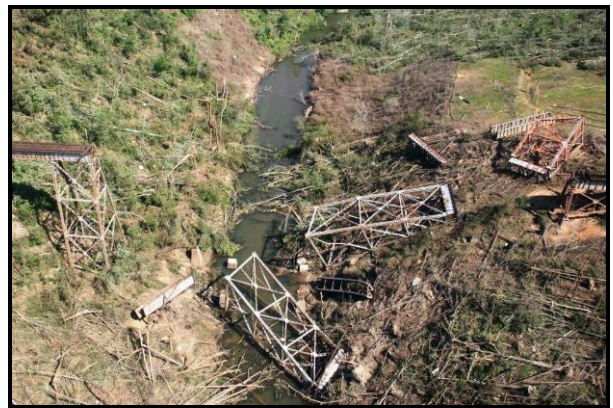
**Figure 17.** Toppled steel towers that had supported a railroad bridge over Hurricane Creek, northeast of Tuscaloosa.

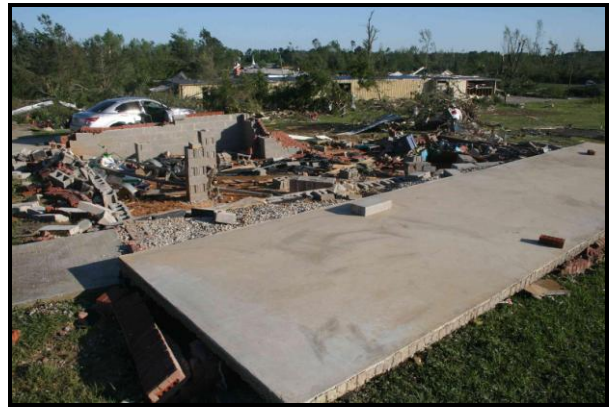
The tornado entered western Jefferson County about 9 km west of North Johns and traveled through Concord, Pleasant Grove, McDonald Chapel, Pratt City, and Fultondale, all northern suburbs of Birmingham (Fig. 18). More than 200 homes had all walls knocked down or were removed from their CMU foundations (DI 2, DOD 9). In many cases, front porch slabs remained in place, and cars remained in their driveways or garages (Figs. 19 and 20). Thus, we estimated failure wind speeds to have been at or below  $76 \text{ m s}^{-1}$  (170 mph) or EF-4.

**Figure 19.** An unanchored home on a CMU foundation. The front porch slab (foreground) and vehicle (background) remained although the unanchored slab did shift.

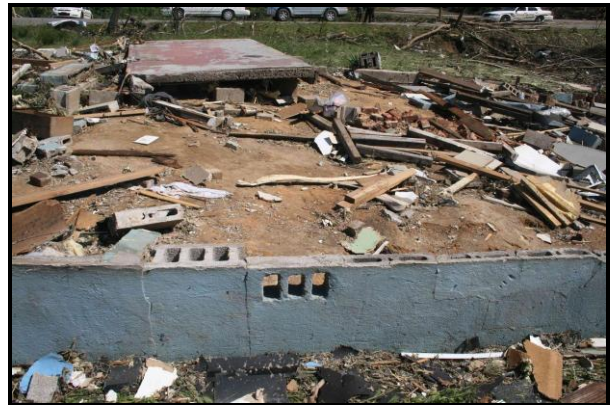
**Figure 20.** Unanchored home that slid off its CMU foundation. Note front porch slab remained.

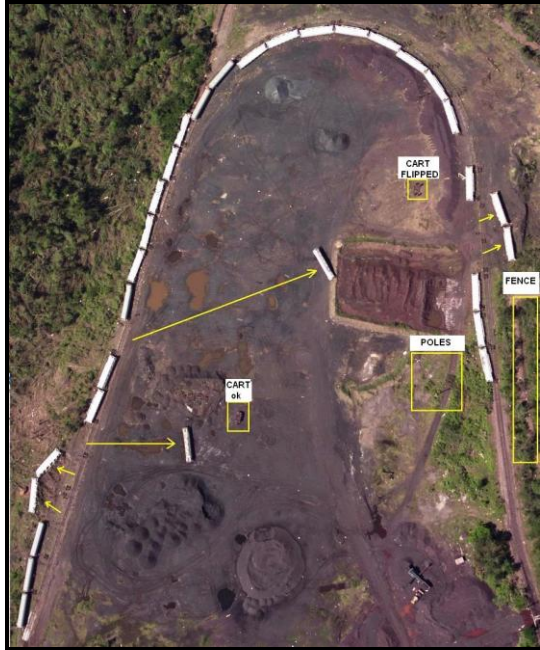
Interestingly, the tornado crossed a coal loading facility just east of Pleasant Grove. Several empty railroad cars overturned and one car traveled (leaving the steel wheels behind) approximately 120 m (Fig.

21). According to McCaul et al. (2012) each rail car weighed 36 tons. Calculations will have to be done to estimate the wind speed necessary to overturn and transport the coal cars. Note, this DI is not listed in the EF-scale, presently. However, a nearby power pole, fence, and cart were not damaged.

**Figure 21.** Empty railcars that were blown off the tracks at this coal loading facility.

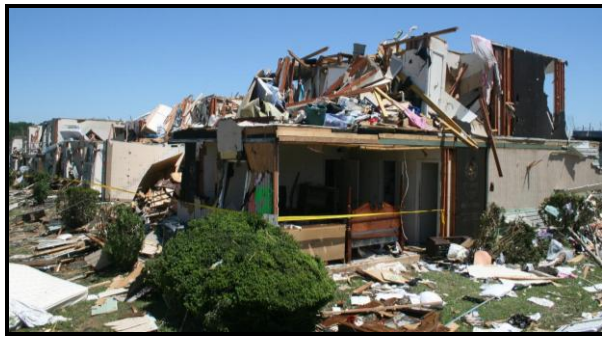
After passing through another residential area and causing up to EF-4 damage, the tornado struck the Southbrook Apartments on Cherry Avenue in Pratt City. This apartment complex comprised of five, two-story, wood-framed buildings oriented north-south. The tornado removed most of the gable roofs and portions of the second stories (DI 5, DOD 5). We estimated failure wind speeds to be  $71 \text{ m s}^{-1}$  (158 mph) or EF-3. Several cars in the parking lot were pushed sideways and crashed into each other (Fig. 22).

**Figure 22.** Tornado damage to the Southbrook Apartments in Pratt City. The roof and most second story walls were blown away.

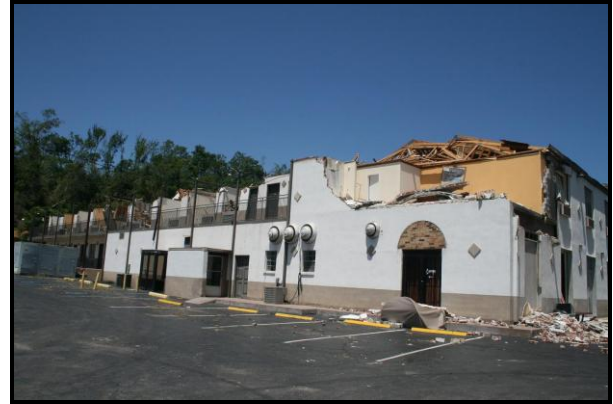
The tornado then paralleled Interstate 65 before it entered Fultondale. Hundreds of trees were toppled and several light poles were bent along the interstate. The tornado struck the Super 8 Motel located at the intersection of U. S. Highway 31 and Interstate 65. The motel was constructed with CMU walls. Wood top plates were attached to grouted cells in the top courses of the masonry using steel J-bolts with nuts and washers. The gable roof was comprised of manufactured wood trusses that were toe-nailed to the wall top plates. The tornado removed a large portion of the roof and toppled several second story walls (DI 7, DOD 5). We estimated failure wind speeds to be  $59 \text{ m s}^{-1}$  (133 mph) or EF-2 (Fig. 24). The tornado began to weaken as it paralleled U. S. Highway 31 and lifted just west of AL Hwy 79, about 6 km north of Tarrant.

**Figure 24.** Tornado damage to the Super 8 Motel in Fultondale. A large portion of the roof blew away and several second story masonry walls toppled.
