## P7.101 Performance of residences and shelters in the Oklahoma tornadoes of 24 May 2011

Timothy P. Marshall<sup>1</sup>, James G. Ladue<sup>2</sup>, Kiel L. Ortega<sup>3</sup> and Gregory J. Stumpf<sup>4</sup>

<sup>1</sup> Haag Engineering Co., Irving, Texas  
<sup>2,3,4</sup> NOAA/NWS

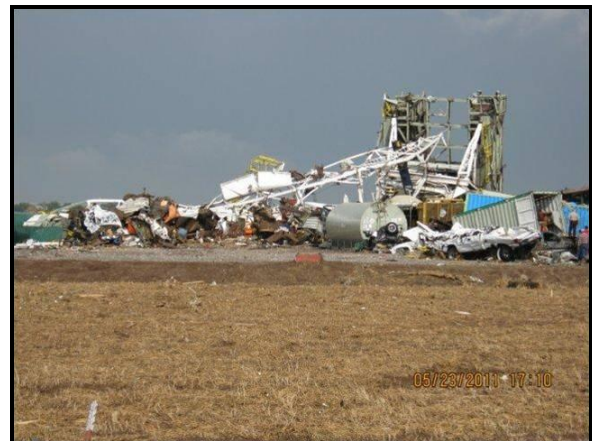
The Cactus 117 oil rig site was struck by the tornado just north of Interstate 40. The rig reportedly weighed 862 metric tons and toppled onto its side (Fig. 2). At the time of the tornado, the drill head and pipes extended deep into the well bore. According to Baker (2011), twelve workers sought shelter in a shipping container called the “change house” that was anchored by four, 2.56 cm diameter steel cables hooked to steel augers extending 1.7 m into the ground (Fig. 3). One of the cables broke and flying debris dented the change house. The workers escaped serious injuries. Nearby, the blowout preventer was bent at a 30 degree angle toward the north. A number of vehicles and unanchored cargo

**Figure 2.** Overturned oil rig at the Cactus 117 drilling site.

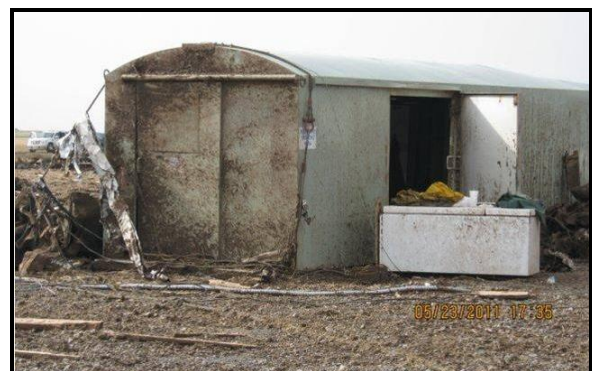
**Figure 3.** Steel container at the Cactus 117 drilling site where 12 workers survived the tornado.

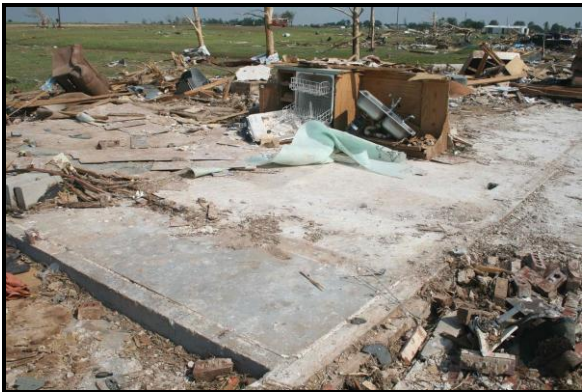
Ten wood-framed houses were leveled on Northridge Lane, 5 km north of Piedmont. These houses had concrete slab foundations (Fig. 4). Close inspection revealed that cut nails had fastened wall bottom plates to the slab perimeters. In these instances, the plates had pulled away from the slabs leaving divots or broken portions of the slabs where nails had been driven (Fig. 5). Other homes had bottom plates properly bolted to their slabs but failed where the wall studs were straight nailed into the bottom plates. Such homes were deemed not well constructed and were assigned a maximum DOD rating of 9.

**Figure 4.** A home nearly swept clean from its concrete slab foundation on Northridge Lane northwest of Piedmont, OK.

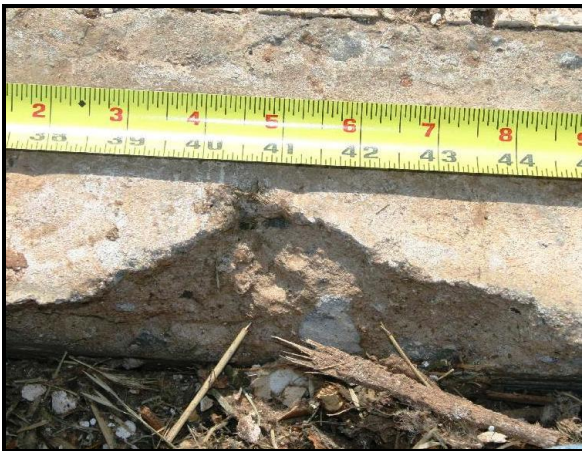
**Figure 5.** Broken edge of the concrete slab foundation where a perimeter wall plate had been secured with a cut nail.

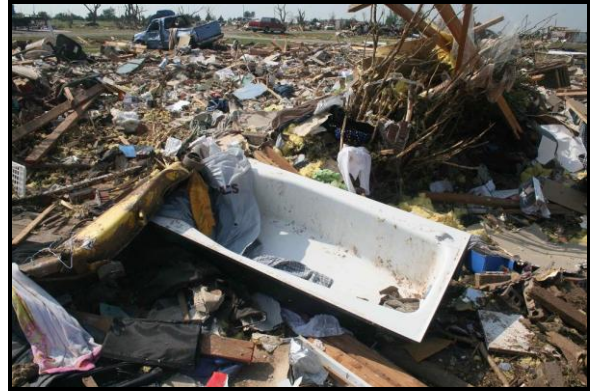
Each home surveyed also had a steel bathtub. Some tubs remained in place and contained debris while other tubs were removed from their slab foundations (Fig. 6). Regardless, none of the steel bathtubs would have provided adequate shelter from the tornado. Also, several vehicles were rolled or lofted into an adjacent farm field and would not have been safe places of refuge.

**Figure 6.** Example of a steel bathtub removed from house foundation. This tub would not have provided adequate shelter during the tornado.

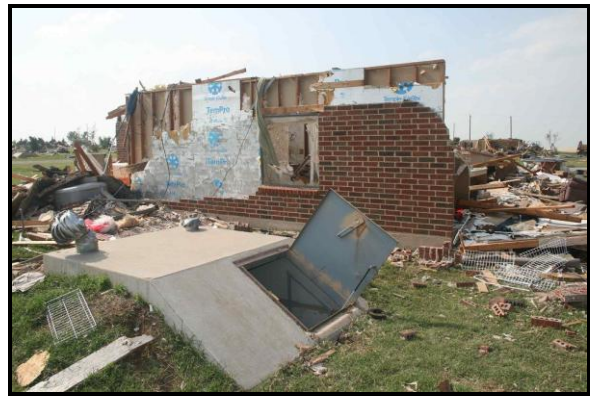
Each of the ten destroyed homes surveyed had an exterior, pre-cast concrete storm shelter installed partially below grade. Each shelter had a single steel door that swung outward with pivoting latch. A few shelter doors also contained pairs of spring loaded locks. In each instance, the doors remained attached to their hinges, although one door was bent. A number of people survived in these shelters (Fig. 7).

**Figure 7.** Storm shelter adjacent to a destroyed house. Note the steel door swung outward and had a single, pivoting latch.

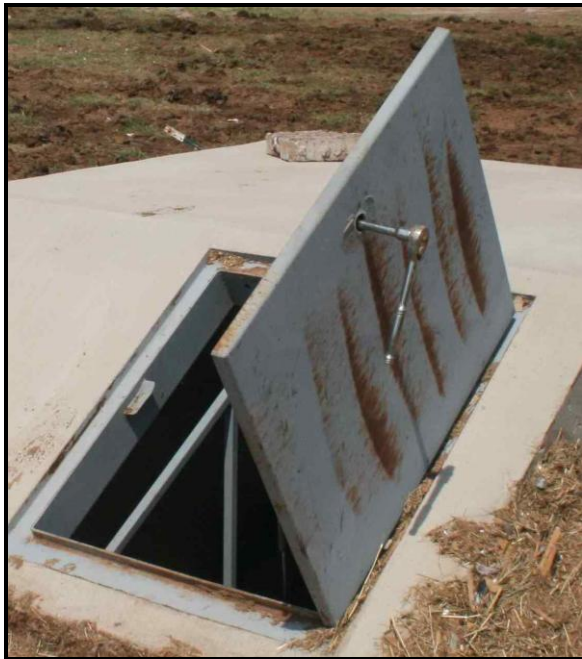
One home had a pre-cast exterior shelter installed partially below grade. The door remained intact but the handle had broken off where struck by flying debris (Fig. 8). A red-colored Chevrolet Avalanche vehicle, initially parked in the garage, was blown to the northeast 650 m and impacted a tree in a ravine. The engine block and axles were located nearby (Fig. 9). Trees in the ravine were debarked, and branches were removed.

**Figure 8.** A partially below grade storm shelter had lost its door handle. A wrench was used to open the door.

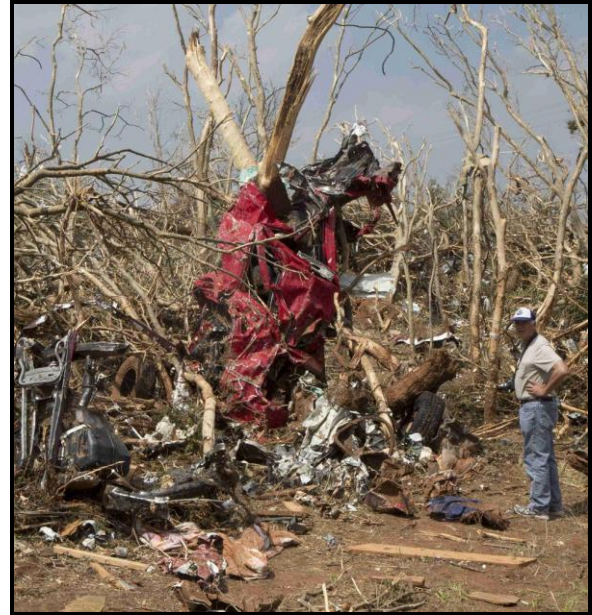
**Figure 9.** Metal skin of Chevrolet Avalanche vehicle that traveled 650 m and impacted a tree.

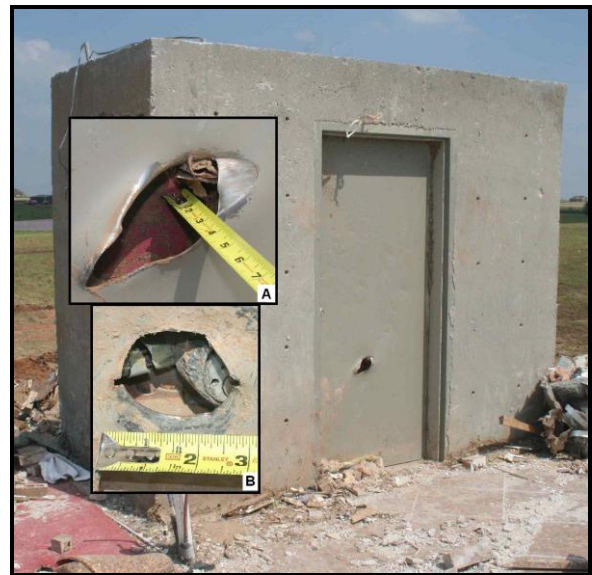
The other home had a poured-in-place, steel-reinforced above-ground shelter that was installed at the southeast corner of the concrete slab. Flying debris had penetrated the outer panel of the inward swinging steel door but the interior panel of the door remained intact. The door had three deadbolt locks, and one lock had been pushed into the hollow door by debris impact. As a result, the door lock was jammed and could not be opened (Fig. 10).

**Figure 10.** A cast-in-place, steel reinforced concrete shelter survived the tornado but had a damaged door: a) outer panel penetration, and b) damaged deadbolt lock mechanism.

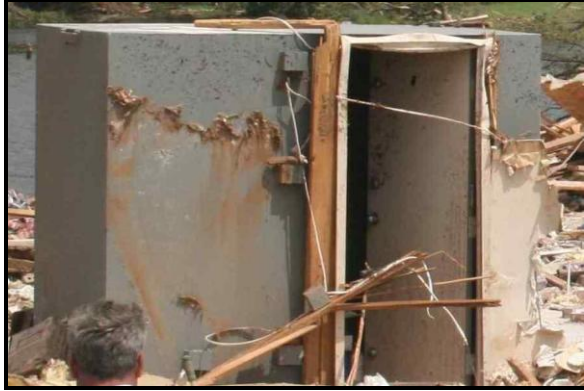
**Figure 11.** An above ground steel shelter with a steel door survived the tornado.

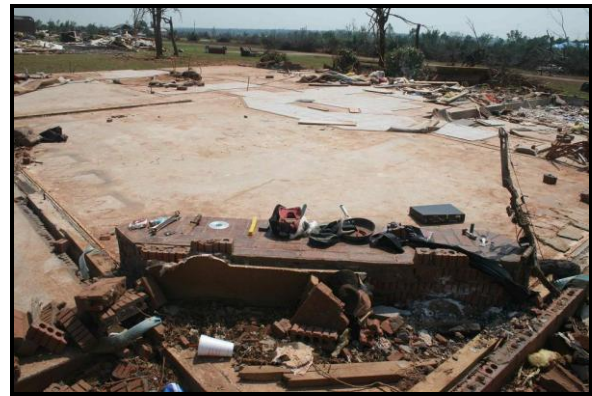
**Figure 12.** This house was swept clean from its concrete foundation at the intersection of Kitty Hawk Road and Meadowlark Lane.

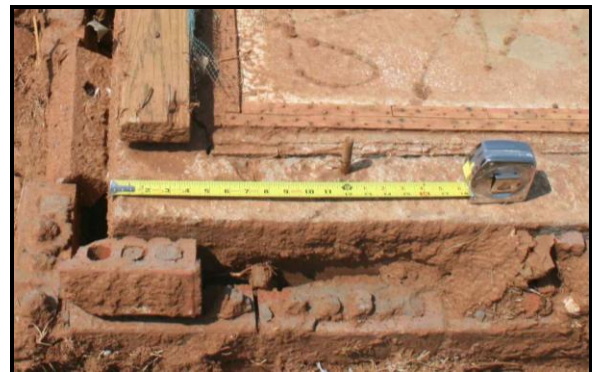
This tornado developed on the south side of Chickasha in Grady County and destroyed several mobile homes killing one person. A mesonet station in Chickasha measured a gust of  $24 \text{ m s}^{-1}$  just outside the vortex. The tornado moved northeast of town and gained significant strength as it traveled through rural areas. Many trees were debarked and/or broken with only stumps remaining. The most intense damage occurred at the intersection of Kitty Hawk Road and Meadowlark Lane, just across the McClain County line, about 8 km north of Blanchard. Three homes were leveled on their concrete slab foundations (Fig. 12). Wall bottom plates were secured to the slabs with steel anchor bolts. However, some bolts were missing their nuts and washers. Several wall bottom plates remained anchored to the concrete slab foundations. However, wall studs had pulled apart from their straight-nailed connections to the bottom plates (Fig. 13).

**Figure 13.** Close up view of southwest corner of concrete slab foundation. Anchor bolts were missing nuts and washers.

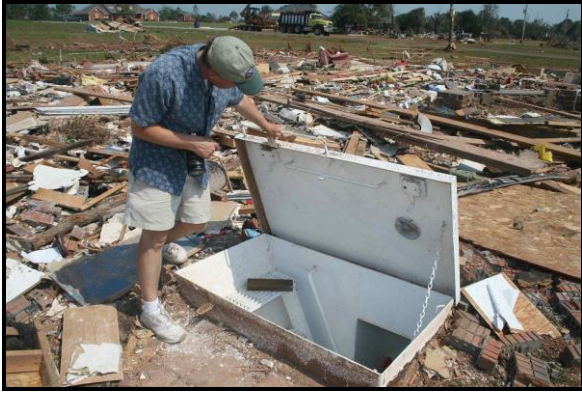
One home had an exterior, below grade, steel storm shelter. The steel door opened outward and had two sliding latches; the door remained undamaged (Fig. 14).

**Figure 14.** A below-grade steel shelter. The steel door was not damaged.

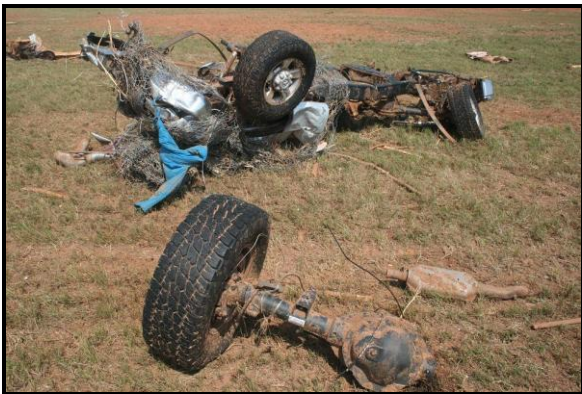
axles. The engine block was found just northwest of the frame, and the cab continued another 150 m to the northwest (Fig. 15). A  $1.2 \times 20 \text{ m}$  section of asphalt pavement was removed by the tornado from the east side of Meadowlark Lane.

**Figure 15.** Portions of a Dodge Ram pickup truck deposited 300 m from its original location.

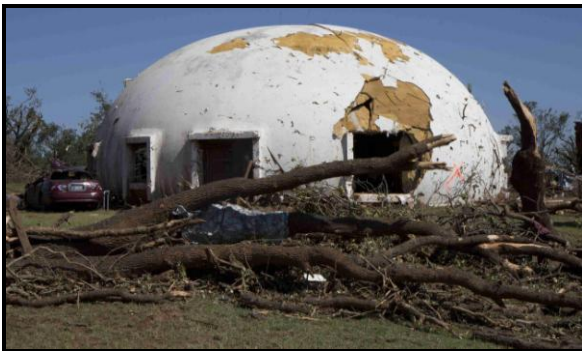
The tornado directly struck a fiber and steel reinforced concrete domed home. The concrete walls varied in thickness from 7 to 14 cm and the exterior surface was covered with 20 – 25 cm of sprayed-in-place polyurethane foam (SPF) coated with a white elastomeric sealant. Occupants were sitting at the kitchen table when the tornado struck. Windows blew in and a skylight at the top of the dome blew off. A long crack reportedly developed in the dome when impacted by a large object, but the shell remained intact. The occupants survived without serious injury (Fig. 16).

**Figure 16.** A fiber and steel-reinforced concrete dome home survived a direct hit by the tornado.

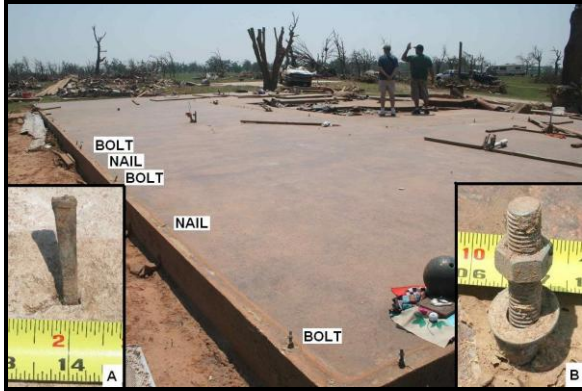
intersection of Rockwell Road and Highway 76. Close examination revealed that anchor bolts (with nuts and washers) alternated with cut nails had secured the perimeter walls (Fig. 17). A wire fence remained intact in the backyard, but it was bent slightly where impacted by flying debris. Given the less than adequate attachment of the home to its foundation (use of cut nails) and limited damage to the adjacent fence, the home was rated EF-4. The home was equipped with a below grade storm shelter that had a sliding steel door. The door was not damaged (Fig. 18).

**Figure 17.** A single-story house at Rockwell Road and Highway 76 was swept clean from its concrete slab foundation. Perimeter wall plates were secured with alternating: a) cut nails and b) anchor bolts.

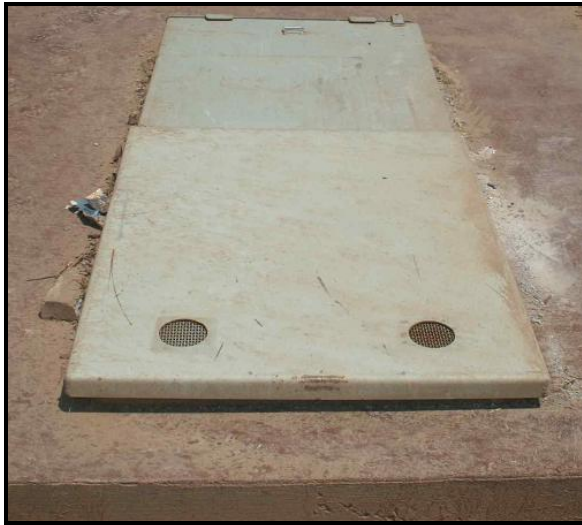
**Figure 18.** This house had a below ground storm shelter with sliding steel door that was not damaged.

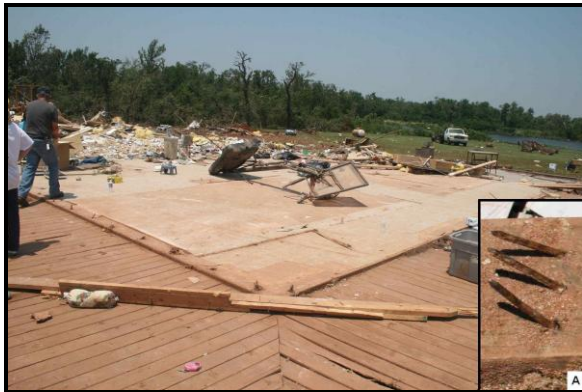
The tornado continued northeast shredding trees along Criner Creek. The tornado then crossed Highway 39 and leveled a one- and two-story, wood-framed house at 212<sup>th</sup> Street and Cedar Lane. The second story was deposited in a heap in the backyard. Bottom wall plates were 2 x 6's anchored to the concrete slab foundation with closely spaced anchor bolts (with nuts and washers). However, wall studs were straight-nailed to the plates. The second story wall plates also were straight-nailed into the floor. Failure occurred when the straight-nailed connections were pulled apart (Fig. 19). Although the rafters were secured to wall top plates with metal straps, the inherently weak straight-nailed connections caused the house to collapse in the tornado. A metal frame of a nearby mobile home found in the debris may have also contributed to the collapse of all walls, so the authors rated the damage at EF-4. Significant ground scouring was noted just south of the house and nearby vehicles had been thrown and wrapped around trees.

**Figure 19.** A leveled one- and two-story home at 212<sup>th</sup> Street and Cedar Lane: a) wall failure occurred when straight-nailed connections pulled apart.

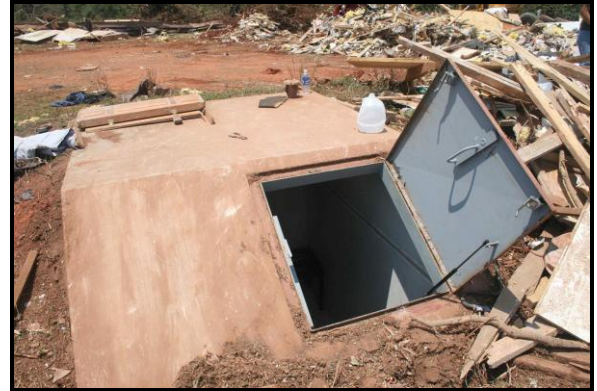
An exterior, pre-cast concrete storm shelter was located adjacent to the house. The shelter had a steel door that opened outward. The door contained a swinging bar latch and two spring-loaded steel dowel locks. The shelter and door remained undamaged (Fig. 20).

**Figure 20.** This house had an exterior, below grade storm shelter with steel door that was not damaged.

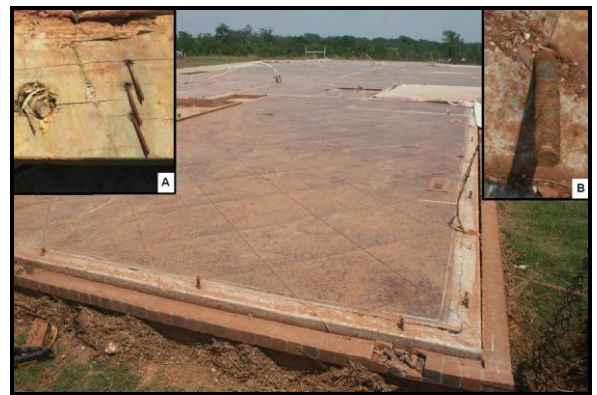
A large, two-story, wood-framed house was leveled on Highway 74B and just west of High Road. Close examination revealed perimeter wall bottom plates had been secured with anchor bolts (with nuts and washers) alternated with cut nails (Fig. 21). Vehicles were moved, rolled, or tossed into the back yard; a pickup truck was found in a creek bed 50 m behind the house. Given the less than adequate attachment of the house framing to its foundation (use of cut nails), the home was rated EF-4.

**Figure 21.** This house was swept clean from its concrete foundation on Highway 74B just west of High Road: a) wall failure occurred at straight nailed connections, and b) not all anchor bolts had nuts and washers.

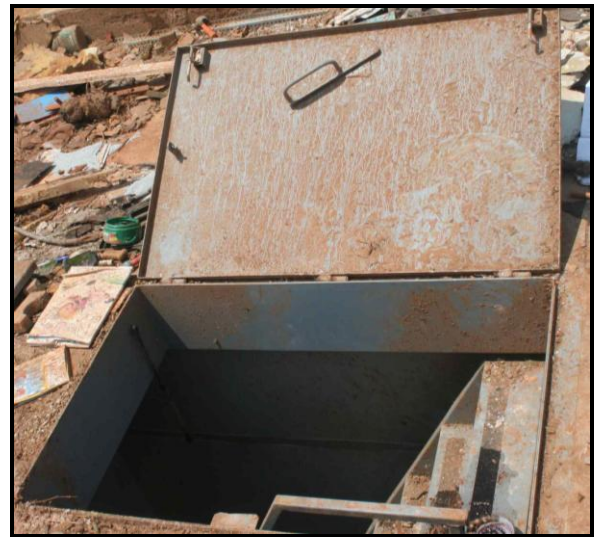
The house had a below ground, pre-cast concrete storm shelter in the garage. The shelter had a steel door with swing latch and two spring-loaded dowels. Occupants sought refuge in the shelter but became trapped when a vehicle moved on top of the door (Fig. 22). The tornado lifted west of Goldsby with EF-3 damage occurring just prior to dissipating.

**Figure 22.** Occupants survived in this below ground storm shelter but were trapped when a vehicle slid over the door during the tornado.
