Timothy P. Marshall<sup>1</sup>, John Robinson<sup>2</sup>, Ernst Kiesling<sup>3</sup> and Larry Tanner<sup>3</sup>

<sup>1</sup>Haag Engineering Company, Irving, Texas

## 1. INTRODUCTION

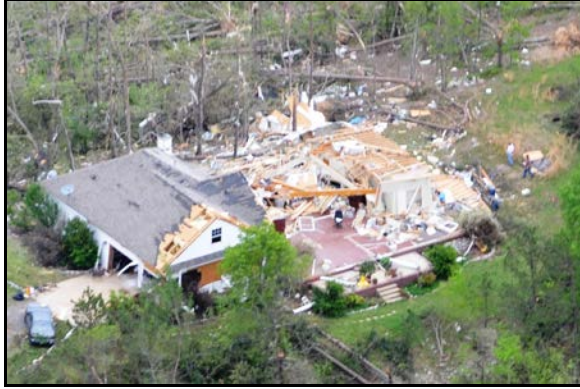
The tornado developed in a sparsely populated, wooded area near Brush Mountain within the Ouachita Range around 0006 UTC on 28 April 2014. Brush Mountain rises about 60 m above the adjacent Little Maumelle River. The point of touchdown was about 35 km west of downtown Little Rock, but only 15 km west of the urban area. Trees (mainly pine, oak, and hickory) toppled in converging lines that pointed northeast. The first residential damage occurred on Turkey Trail where a portion of the roof was removed including the southeast (windward) wall (Fig. 2). The house was elevated on a basement/crawlspace covered with a wooden floor platform. Wall failure occurred where the bottom wall plate was straight nailed into the floor. As soon as the roof was removed, the wall simply fell over pulling the straight-nailed connections from the floor. Damage to the house was rated EF2.

**Figure 2.** One of the first houses damaged by the tornado lost a portion of its roof and perimeter walls. This home was rated EF2.

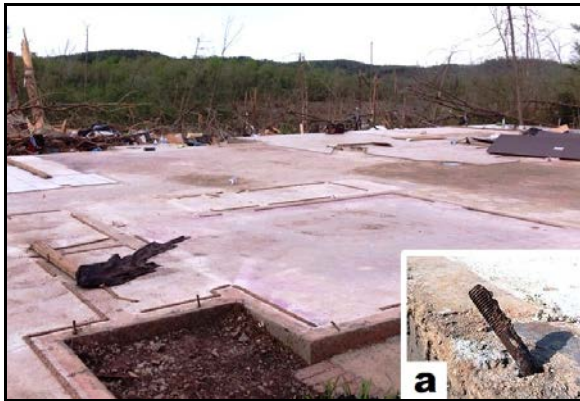
The tornado destroyed three homes along Deer Drive including one home that was swept clean from its concrete slab foundation. Steel anchor bolts were meant to fasten the wall bottom plates to the slab, however, the bolts did not have nuts or washers (Fig. 3). Since the home was not anchored, it was rated EF3 instead of EF5. Also, vehicles adjacent to the home did not move but did sustain window and body damage from wind-borne debris.

**Figure 3.** This house was swept clean from its concrete slab foundation as: a) anchor bolts did not have nuts or washers. Because of this deficiency, the unanchored home was rated EF3 instead of EF5.

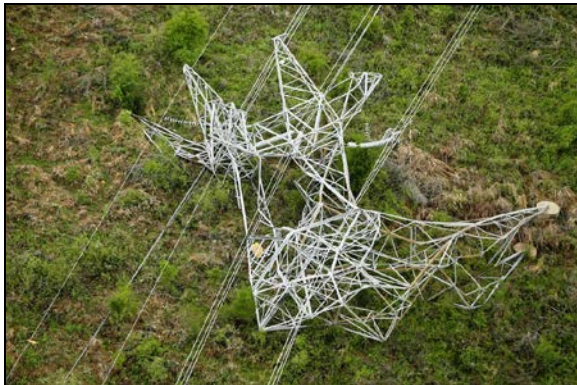
**Figure 4.** One of several collapsed steel transmission towers that was rated EF-2.

After crossing Kanis Road, the tornado downed several electrical transmission lines that cut through the forest. The lines were supported by open-trussed, steel towers (Fig. 4). The towers collapsed, but bases remained connected to their support piers. These towers were rated as EF-2 damage.

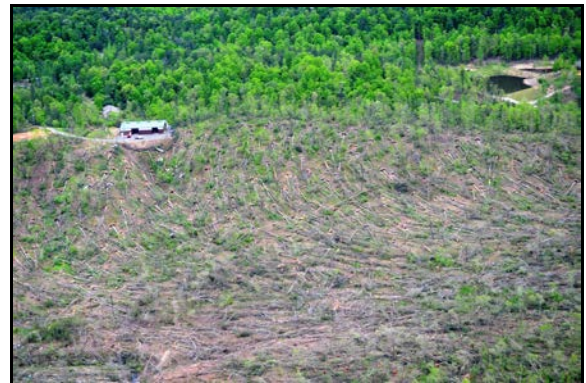
The tornado continued northeast, flattening the forest reaching its maximum width of 1200 m (Fig. 5). Trees were uprooted and laid down in a pair of converging arcs with the centerline pointing northeast. By the time the tornado reached Highway 10, the damage path had narrowed. A few homes in this area lost roofs on Somerset Court and Goodson Road and were rated EF2.

**Figure 5.** Flattened forest with most trees being uprooted and laid down in a converging arc pattern.

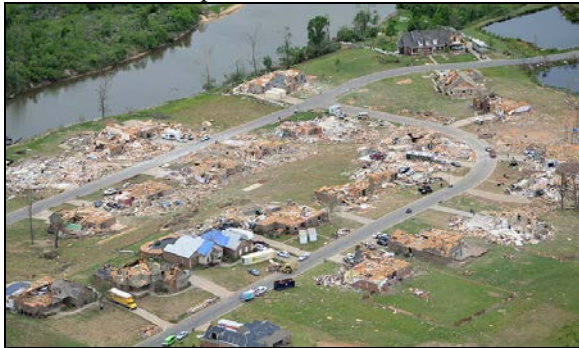
The tornado traveled through the River Plantation subdivision on the north shore of the Arkansas River destroying several homes (Fig. 7). This community was comprised of upscale, one- and two-story, wood-framed homes on large lots. Houses were constructed on concrete slab foundations or split-level, concrete (basement) wall foundations. These newer and larger homes had basic foundation attachment issues which prevented a rating of EF5 damage. Many homes had wall bottom plates attached with cut nails around the slab perimeters instead of anchor bolts. The plates either pulled through the nails leaving the nails in the slabs or were removed along with the plates. Some homes did have wall bottom plates properly bolted to the slabs (with nuts and washers), but failed where studs were nailed to the plates.

**Figure 7.** Homes sustained up to EF4 damage in the River Plantation subdivision.

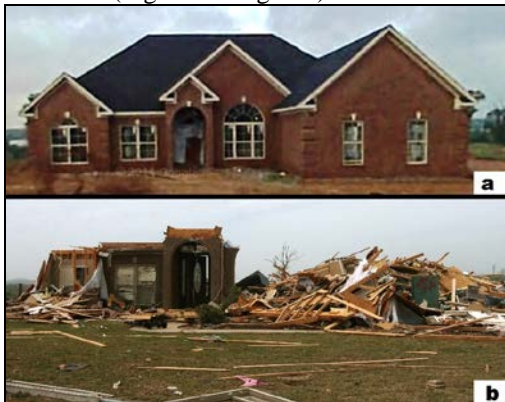
**Figure 8.** A one-story home: a) before and b) after the tornado. The home was rated EF3 damage. The top image is from Google Street View.

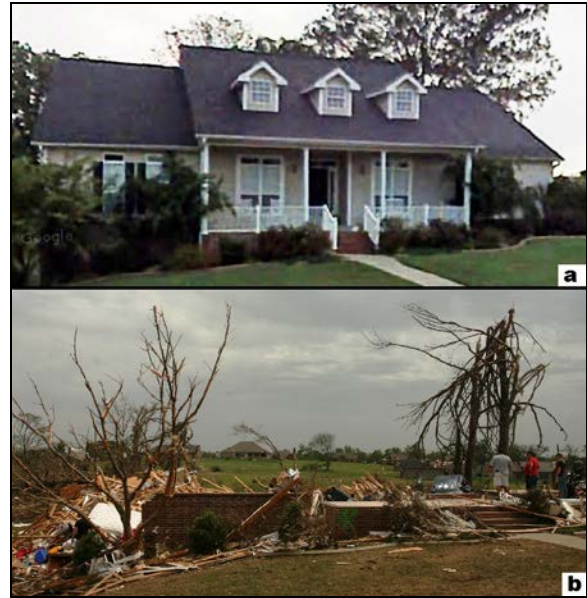
**Figure 9.** A two-story home: a) before and b) after the tornado. The home collapsed when basement walls supporting the first floor toppled. This home was rated as EF3 damage. The top image is from Google Street View.

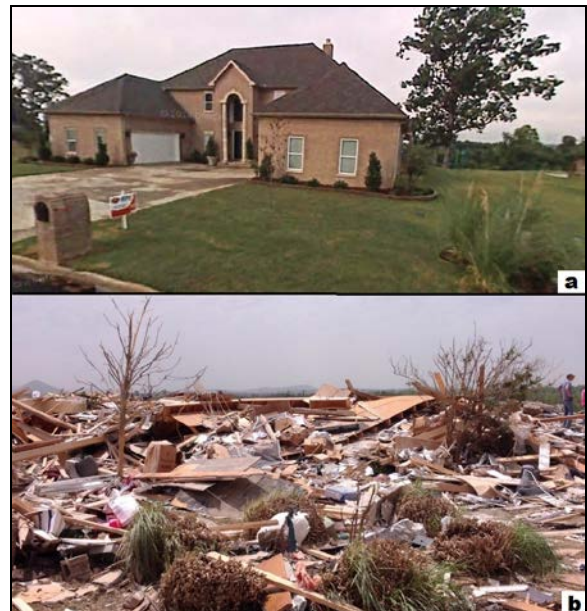
**Figure 10.** A two-story home: a) before and b) after the tornado. All walls collapsed leaving a pile of debris in the front yard. Damage to this home was rated EF4. The top image is from Google Street View.

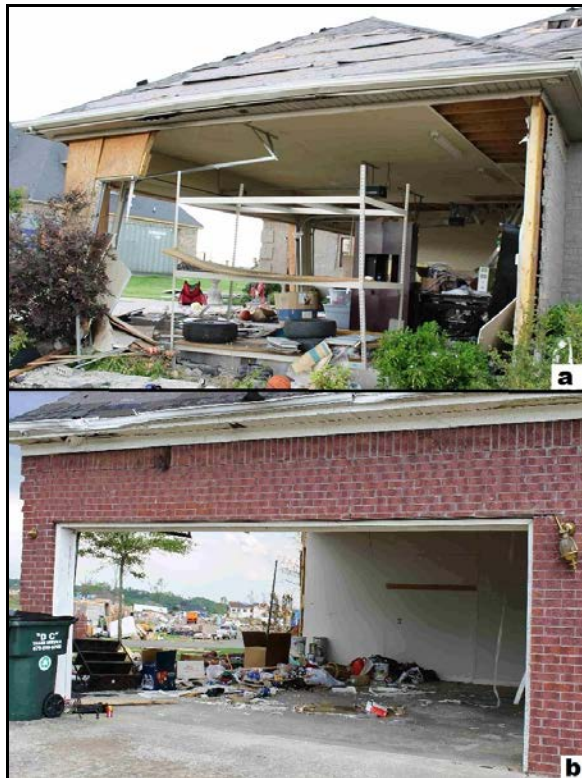
Many homes in the River Plantation subdivision had attached garages. Garage doors failed allowing internal wind pressure to lift the roof and/or blow out the sidewalls. Marshall and McDonald (1982) recognized the detrimental effects of attached garages

to homes. When the garage door fails, internal wind pressure usually results in the failure of a sidewall or portion of the roof. In the River Plantation subdivision, radial inflow on opposite sides of the tornado caused the same types of garage failures (Fig. 11). Thus, houses with attached garage doors facing the wind had greater DoDs than houses with garage doors leeward to the wind. Garage walls failed in three ways: 1) when the wall bottom plate split, 2) when the wall studs pulled out of the wall bottom plate, or 3) when the wall studs pulled out of the wall top plate.

**Figure 11.** Identical garage failures on the: a) east side and b) west side of the tornado path.

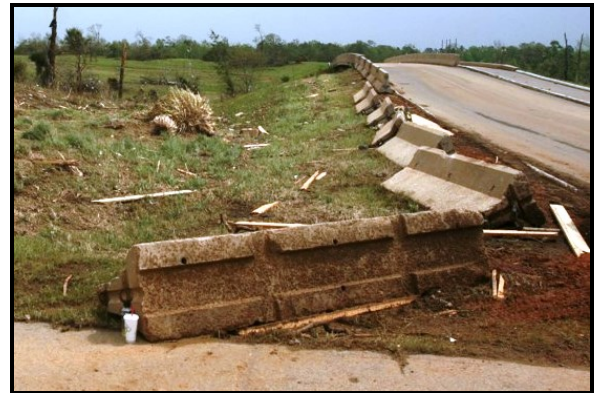
Just as the tornado was leaving the River Plantation subdivision, it toppled seven concrete highway barriers near the approach to a bridge (Fig. 12). The barriers are not listed as a DI, however, they afforded an opportunity to approximate the wind forces necessary to overturn them. Barriers were free-standing, not connected to each other. Each concrete barrier weighed about 1800 kg, was 81 cm tall, and 3 m long. The center of gravity was approximately 37 cm above the ground (Fig. 13). From this information, the resisting moment was calculated, then equated to the moment created by the applied wind pressure, solved for wind pressure, then

computed the failure wind speed. The wind speed necessary to overturn the concrete highway barriers was determined to be approximately 83 m/s (185 mph). However, it was assumed that the wind load was static (which it was not) and that pressure coefficients were known, (which they were not). Pressure coefficients were derived using standard values from buildings (not a barrier) in a wind tunnel (not a tornado). These coefficients were +0.8 front, -0.7 top, and -0.5 back. Also, the computed wind speed was for an instantaneous load (not averaged over three-seconds) and centered on a beam much lower than the 10 m height used for the EF-scale. That said, the highway barriers were adjacent to homes that experienced EF3 and EF4 damage. So, the calculated wind speeds were at least consistent with those estimated for nearby homes.

**Figure 12.** Toppled concrete highway barriers in the River Plantation subdivision.

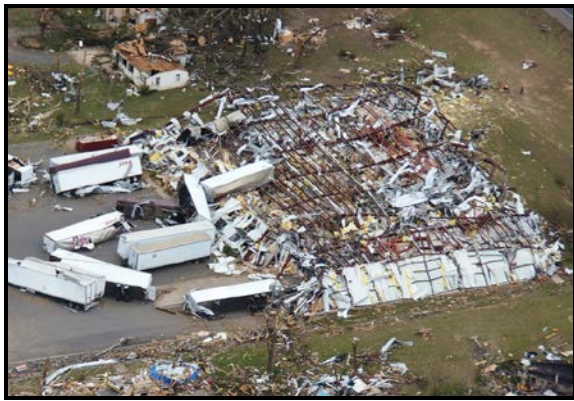
The tornado continued through south portions of the town of Mayflower, destroying several homes and collapsing a metal building (Fig. 14). Total destruction of a metal building system (MBS) yielded an EF3 rating (DoD 10). Many truck trailers in an adjacent parking lot were flipped or moved. One truck trailer ended up on top of the metal building. Nearby homes sustained EF3 damage.

**Figure 14.** Complete collapse of a metal building with moved truck trailers. Damage to this building was rated EF3.

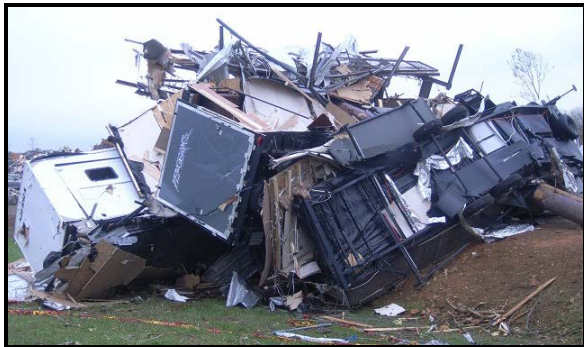
The tornado crossed Interstate 40, tossing a number of vehicles. According to eyewitnesses, the tornado was rain wrapped at this time and difficult to see until it was quite close. The tornado struck an RV business on the east side of the Interstate, tossing many RVs. Three RVs were wrapped around a toppled billboard (Fig. 15).

**Figure 15.** Three recreational vehicles wrapped around a toppled billboard adjacent to Interstate 40.

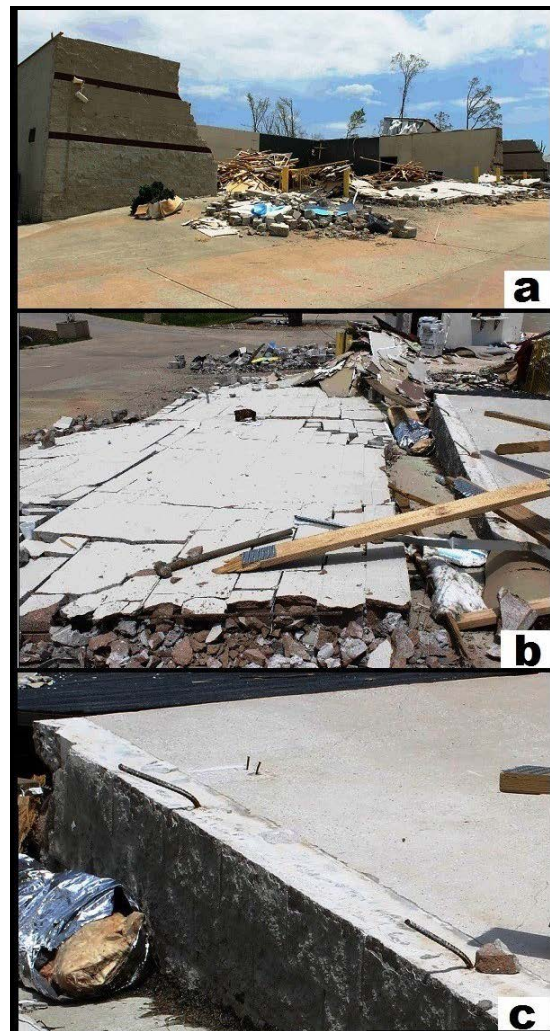
The RV dealership was located just north of the tornado center and experienced strong east through north winds. The rectangular-shaped building was constructed with loadbearing CMU block walls with steel roof joists. Portions of the south and west walls fell outward (Fig. 16) and the roof was removed. Close examination revealed that foundation rebar was 1.3 cm (#4) in diameter and spaced 1.2 m apart. Foundation rebar extended only 30 cm into the base of the CMU wall. Normally, rebar should extend much further into the walls. Regardless, the walls were weak against lateral loads and the foundation rebar bent easily as the walls fell. The closest building type was that of a large isolated retail building (LIRB). A DoD of 6 was selected. So, this building damage was rated as EF3 damage.

**Figure 16.** CMU walls fell over at this RV dealership: a) front (west) elevation view, b) front wall fell outward, and c) close-up of foundation rebar. The building was assigned an EF3 rating.

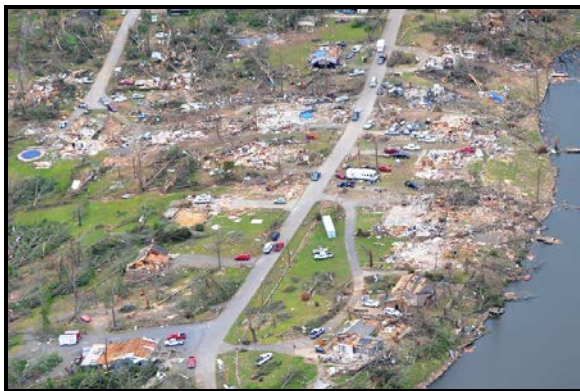
The tornado crossed Lake Conway, located just east of Mayflower, and destroyed several lakefront homes (Fig. 17). These homes had concrete slab or perimeter concrete masonry foundations and were smaller in area than River Plantation homes. However, each home had the same foundation attachment deficiencies. Thus, the maximum damage rating in this area was EF3. Some debris from the destroyed homes ended up in the lake. Reportedly, the Arkansas Game and Fish Commission removed 569,000 kg of tornado debris from the lake.

**Figure 17.** Destroyed homes on the shores of Lake Conway, just east of Mayflower.

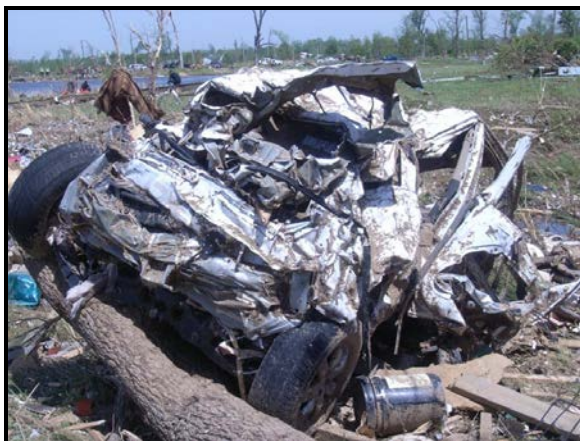
There were several single- and double-wide mobile homes that were destroyed by the tornado, and were assigned a maximum EF2 damage rating. Several cars were rolled and flipped by wind forces as well as battered by wind-borne debris (Fig. 18). Vehicles are not listed as a DI due, in part, to variations in size, weight, and orientation to the wind. Marshall et al. (2008a, 2008b, 2012a) found substantial variability in vehicle performance after several violent tornadoes.

**Figure 18.** Vehicle tossed by wind forces and battered by wind-borne debris near Lake Conway.

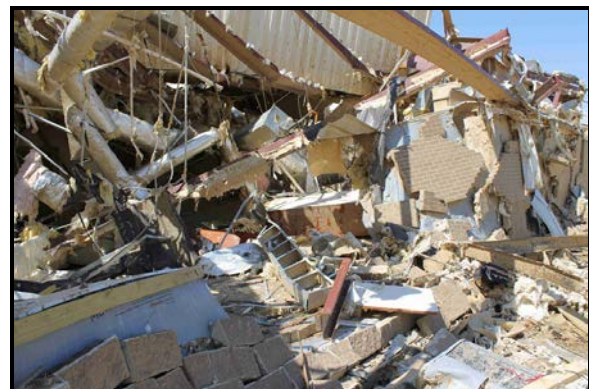
The next community impacted by the tornado was Vilonia. The tornado struck the Intermediate School that was under construction and nearing completion. The school complex consisted of three, steel-framed structures with masonry veneer exterior walls and metal panel roofs (Fig 19). Masonry walls fell inward on windward sides, and outward on leeward sides, exposing the classrooms to wind-borne debris (Fig. 20). Steel purlins and girts buckled. However, most of the large steel frame remained intact except for the west building which had successive frames collapse. Metal roof panels were removed when they became unclipped from steel purlins. Center hallways would have been the only places of relative safety for occupants had school been in session (Fig 21). Overall, damage to the elementary school (ES) building was rated EF3 (DoD 8).

**Figure 20.** Masonry walls fell into the classrooms on the windward side of the Vilonia Intermediate School. Obviously, these classrooms would not have been places of safe refuge during the tornado.

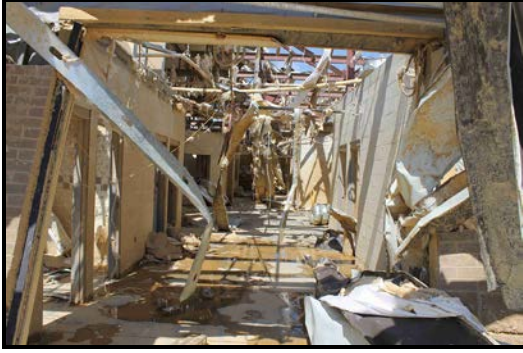
**Figure 21.** The only relatively safe place for occupants in the Vilonia Intermediate School were the center hallways.

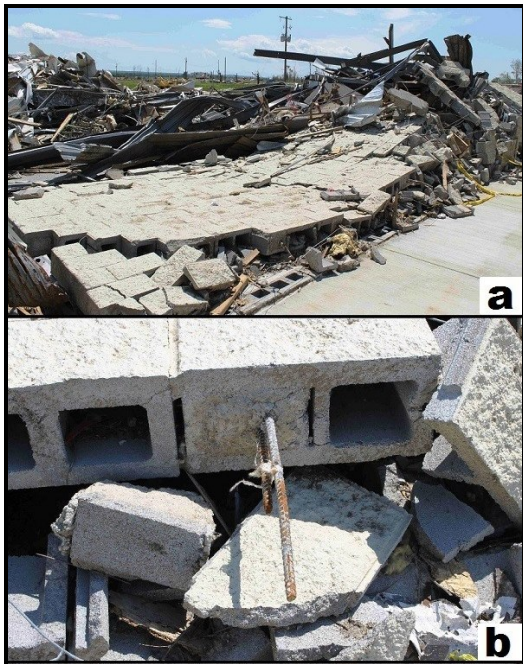
The tornado destroyed several businesses as it crossed Main Street in Vilonia, including a large, isolated retail building (LIRB) on the west side of the tornado track. This building was a steel-framed structure with perimeter CMU walls built on a CMU stem wall foundation capped with a concrete slab. As the tornado passed, north and south walls fell to the south while east and west walls fell to the east (Fig. 22). Foundation rebar pulled out of the grouted cells and the walls failed along horizontal joints aligned with the top of the slab. Since these walls had little resistance to lateral wind forces, damage to the building was rated as EF3 (DoD 10 lower bound).

**Figure 22.** Collapse of a large, isolated retail building: a) wall failure at the top of the slab, and b) foundation rebar pulled out of the CMU foundation. Damage to the building was rated as EF3.

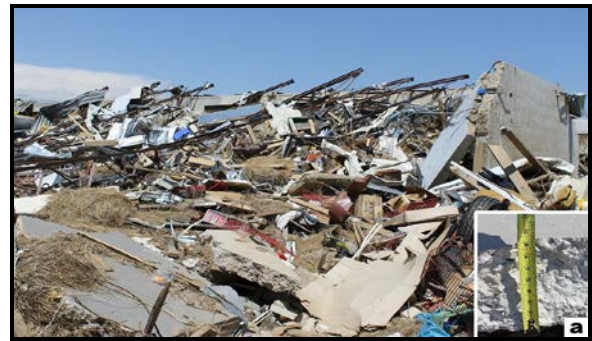
Just east of the large, isolated retail building was a strip shopping center. The strip shopping center had poured-in-place, 20 cm thick concrete walls (instead of typical light-steel framing) and open steel web roof joists. The building was oriented east-west, facing Main Street. The center of the tornado passed directly over this location. South walls of the strip shopping center fell inward, while north walls fell outward, leaving interior shear walls intact (Fig. 23). Close examination revealed that wall rebar was 1.3 cm (#4) diameter and spaced 1 m apart. Although the walls were poured concrete, there was minimal reinforcement, and the walls crumbled. Therefore, damage to the strip mall (SM) was rated EF3 (DoD 8).

**Figure 23.** Collapse of the Vilonia Shopping Center constructed with 20 cm thick, poured-in-place, concrete walls. Damage to this building was rated as EF3.

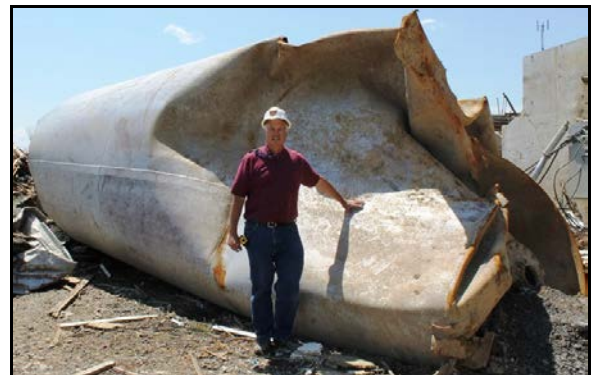
A large, steel tank was deposited in the alley behind the shopping center (Fig. 24). The tank was 10 m tall and 5 m in diameter. According to the owner, the tank was empty at the time of the tornado, and was one of five liquid fertilizer tanks lying on the ground. The tank reportedly weighed 13,607 kg and traveled 1192 m, before coming to rest along the tornado centerline.

**Figure 24.** A large steel tank that traveled 1192 m and was found behind the strip shopping center.

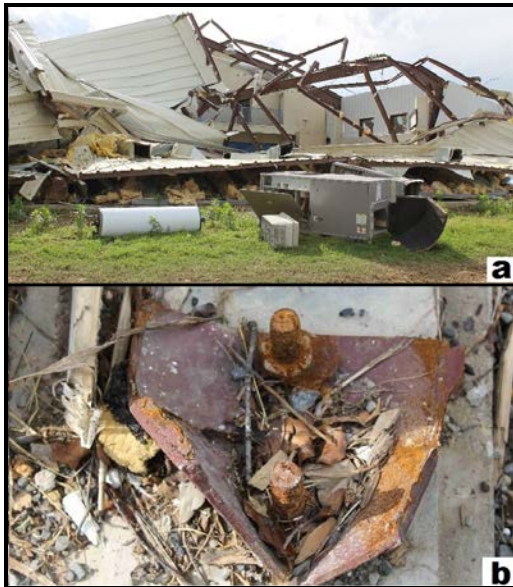
On the east side of the tornado track, at the southeast corner of Church and Main streets, was the Vilonia United Methodist Church. There were three buildings at this location: the main church, parsonage, and Life Center. The main church and parsonage were one-story, wood-framed structures constructed on concrete foundations. They sustained only minor roof damage, and were rated EF0. However, the Life Center was a two-story, metal building constructed on a concrete slab foundation. The east end wall was pushed inward resulting in the collapse of successive bays (Fig. 25). Failure occurred where steel columns were torn from their welded base plates. The steel plates remained bolted to the concrete slab. Damage to this metal building was rated as EF3 (DoD 7). Internal pressure build-up was vented when the west wall panels blew outward.

**Figure 25.** Collapse of this metal church building: a) south wall was pushed inward, and b) torn welds at the base plate. Damage to this building was rated as EF3. However, the adjacent one-story, wood-framed building sustained only EF1 damage.

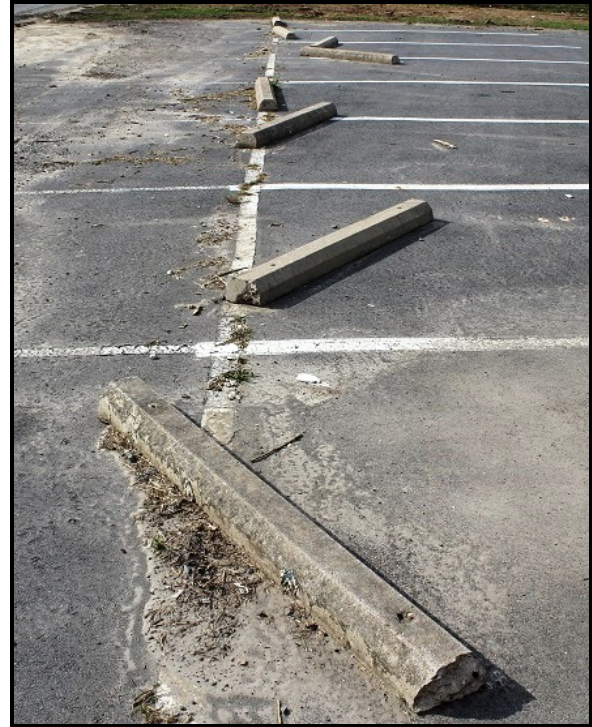
There was a parking lot north of the main church building where several concrete parking stops slid sideways in the tornadic winds (Fig. 26). Parking stops measured 1.9 m long and weighed 111 kg. Each parking stop was 12.6 cm tall and 23.9 cm wide (Fig. 27). There were two vertically-oriented holes in the parking stops for anchoring with rebar. However, no rebar was installed. Thus, the parking stops were lying loose on the pavement surface. Marshall et al. (2012b, 2014) had observed lofting and lateral movement of parking stops in the Joplin and El Reno tornadoes, respectively.

**Figure 26.** Lateral movement of several unanchored concrete parking stops in front of the Vilonia United Methodist Church. Damage to the main church building was rated EF0.

The wind speed necessary to slide the parking stops depended on the coefficient of friction (COF). Also, there would also be an uplift component from wind traveling over the top of the parking stop. Assuming wet pavement, the COF is about 0.5. Using the same assumptions as the highway dividers mentioned earlier in this paper, including the same pressure coefficients, the wind speed necessary to slide the concrete parking stops was calculated to be

36 m/s (80 mph). This was reasonable given the EF0 rating to the main church building.

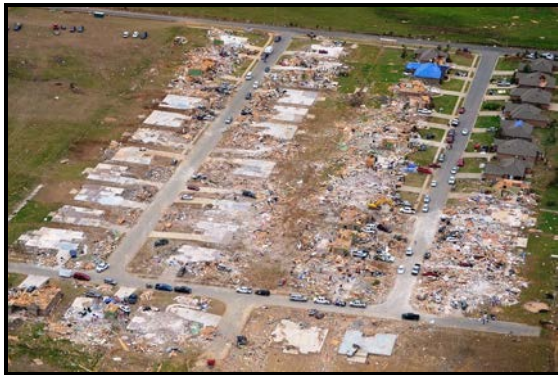
There were at least two residential subdivisions north of Main Street in Vilonia. Dozens of wood-framed homes were swept clean from their concrete slab foundations in the Parkwood Meadows subdivision (Fig. 28). At first glance, it appeared these homes were candidates for EF5 damage ratings. But closer examination revealed poor quality construction of these houses. Cut nails were found around the perimeters of the concrete slabs indicating where wall bottom plates had been attached. These connections had little lateral or rotational strength. When wall failure occurred, cut nails either were pulled out of the slabs or wall bottom plates (Fig. 29). Because of this deficiency, damage to these homes were rated EF4 instead of EF5. It should be noted that the damage is a lower bound rating, and doesn't preclude the possibility that EF5 winds could have occurred.

**Figure 28.** Aerial view of the Parkwood Meadows subdivision in Vilonia where dozens of homes were swept clean from their concrete slab foundations. This appeared to be EF5 damage. However, closer inspection from our ground survey found poor attachment of the houses to their foundations.

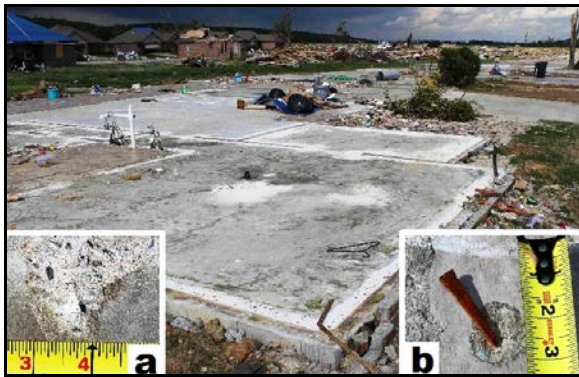
**Figure 29.** Two modes of failure where cut nails were used to secure the wall bottom plates: a) a nail pulled out of the slab, and b) a wall plate pulled away from the nail leaving the nail bent in the slab.

Standard building codes require that wall bottom plates be secured with anchor bolts fitted with nuts and washers. This would have provided stronger connections than cut nails.

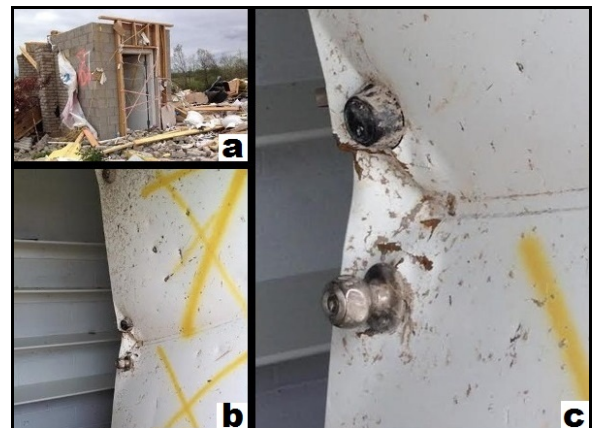
One person was killed in an above ground shelter on Plantation Drive. A couple had sought refuge in the shelter just prior to the tornado. The shelter was constructed with steel-reinforced CMU walls and had a poured concrete slab roof. The entry door had three deadbolts and a steel skin, but had a hollow core. A piece of debris hit the middle of the door during the tornado causing a crease in the door (Fig. 30). The house was completely destroyed.

According to the lone survivor, the deadbolt at the bottom of the door remained intact while the top and middle bolts pulled out of the frame. The door never opened completely. Bending deflection of the door was sufficient to throw an occupant against the back wall in the shelter and she died of a head injury. The male occupant received broken bones and head lacerations, apparently from wind-borne debris. Both occupants were in contact with the door when the door failed.

**Figure 30.** Failure of a shelter door which resulted in a fatality. The door was struck by wind-borne debris.

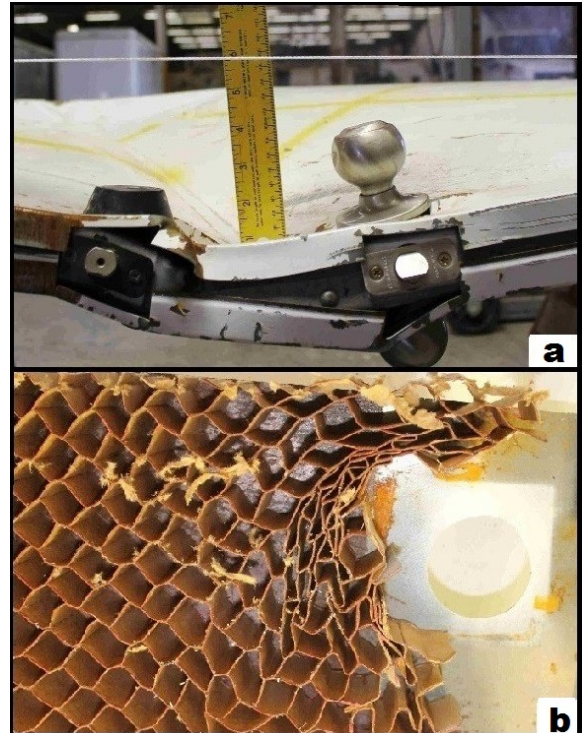
With the assistance of the National Storm Shelter Association (NSSA), the failed door and frame assembly were shipped to the National Wind Institute Debris Impact Facility at Texas Tech University and examined by a panel of experts (Fig. 31). The door was cut into three sections to examine the interior. No internal steel stiffeners were found, only a cardboard honeycomb core. Such a core did not strengthen the door. In conclusion, Tanner and Kiesling (2014) found that door failure resulted from improper usage of a door, frame, and hardware for a tornado safe room. They indicated that the steel door used in the shelter was not strong enough to be used as a shelter door.

In order for a door to be approved as a shelter door, it must meet or exceed the design and testing criteria established in the ICC-500 standard. Approved shelter doors typically are constructed with 14 gauge steel skin (1.9 mm). By comparison, the skin on the failed Arkansas shelter door was 18 gauge steel (1.2 mm), a thinner material. Approved shelter doors have hinges that typically are 7 gauge (4.76 mm). By comparison, the hinges on the failed Arkansas shelter door were 11 gauge (3.18 mm).

Part of the ICC-500 standard involves resistance to missile impacts, including door systems. Doors must be able to resist three impacts of 244 cm long 2x4 (nominal) traveling at 45 m/s. Impacts shall be within 15.2 cm of the primary lock, upper latch, and hinge. Doors shall not be perforated, opened, dislodged from the frame/hinges, or deformed more than 76.2 mm. These are stout requirements and not every steel door will pass.

**Figure 31.** Examination of substandard door that failed resulting in a fatality: a) excessive door deformation (15.2 cm), and b) cardboard honeycomb core.

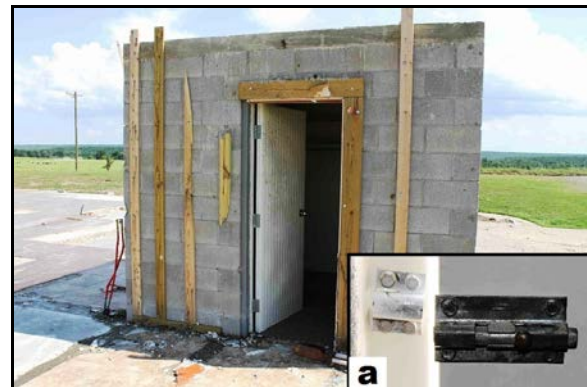
Three additional above ground shelters were examined along Rocky Point Road in Vilonia. The shelters were constructed with steel-reinforced CMU walls and had poured concrete slab roofs. Steel doors had hollow cores. Two of the three doors had deadbolt locks while the third shelter door had three small, sliding barrel bolt locks attached to the inside of the door frame (Fig. 32). However, none of the three shelter doors had been struck by wind-borne debris, and the doors remained intact. A total of 22 people survived in the three shelters along Rocky Point Road.

**Figure 32.** Shelter where six occupants survived the tornado. The substandard door had sliding barrel bolt locks (inset). Fortunately, this door was not struck by wind-borne debris.
