P1A.3 Damage survey of the North Texas Tornadoes: 26 December 2015

Timothy P. Marshall¹, Mark Fox², Melissa Huffman³, and Dennis Cavanaugh⁴

¹Haag Engineering Co., ²NOAA/NWS

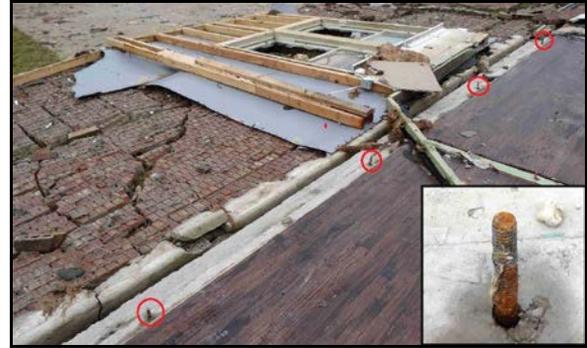
Most of the damaged homes had bottom wall plates bolted to concrete foundations. However, some bolt installations lacked nuts and washers. (Fig. 18). The nut is an important component as it secures the bottom wall plate to the foundation. The washer is also important as it helps spread lateral and overturning loads. Thus, it was no surprise that unattached walls toppled more easily than walls that were properly bolted and secured with nuts and washers.

Fig. 18. This toppled wall was not attached properly. Note the absence of nuts and washers on the bolts (red circles). The inset image is a closer view of an anchor bolt missing the nut and washer.

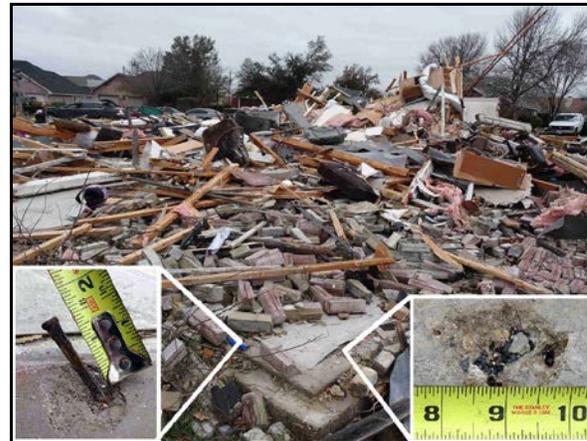
In other instances, cut nails were utilized to secure perimeter wall plates to the foundations. Such nails extended only about 1 to 1.2 cm into the concrete. As these walls overturned, the nails either pulled out leaving divots in the concrete surfaces or pulled through the wall bottom plates remaining embedded in the foundations (Fig. 19). Poor connections sometimes led to complete collapse of homes. The size of the home and/or location did not affect the quality of construction. Large, expensive homes had the same connection problems as smaller homes. When such connection problems were encountered, EF ratings were adjusted downward or defaulted to the value of another DI nearby.

Fig. 19. This home collapsed due to poor attachment of perimeter walls to the concrete slab foundation. Inset images show cut nails and divots left in the foundation.

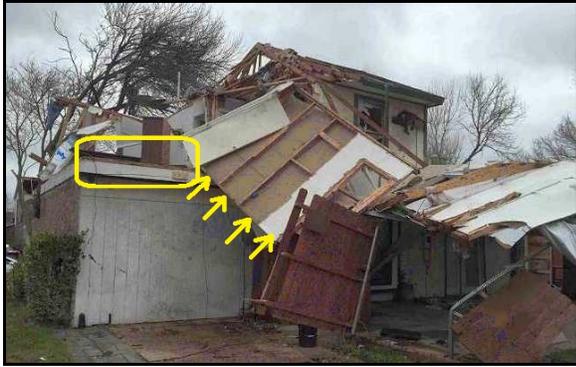
Many two-story homes lost second story walls. Typically, second story walls were straight-nailed to the wood floor. Usually, there was one nail installed in the wall bottom plate between each stud. The nails usually did not extend into the floor joists. As a result, second story walls were prone to overturning as the nails pulled out of the floor. This action was similar to using a claw hammer to remove nails from wood (Fig. 20). We also noticed that two-story homes sustained more roof structure damage than adjacent one-story homes. One reason was that two-story homes were higher above the ground and experienced stronger winds. Rafters lifted off the wall top plates as toe-nailed connections pulled apart.

Fig. 20. Removal of the second story wall occurred when straight nails in the wall bottom plates (yellow arrows) pulled out of the floor plates (yellow circled).

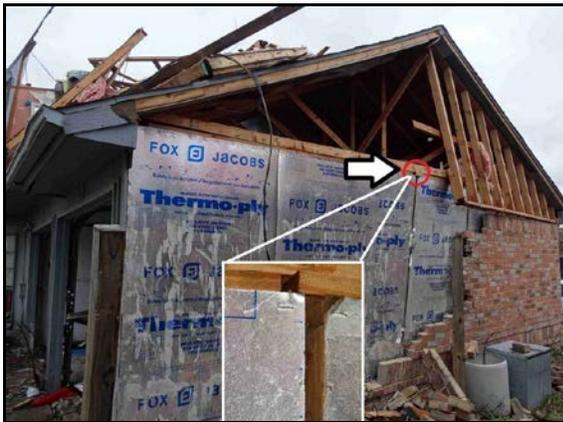
Certain exterior walls had built-in “hinges” that failed during the tornado. Such walls had minimal overlap between the doubled top plates. As a result, walls bent inward or outward depending on wind direction. Long walls in garages and living rooms were particularly prone to this type of failure (Fig. 21).

Fig. 21. A “hinge” (arrow) formed when joints aligned in the double top plate. Inset image shows close up view of the “hinge”.

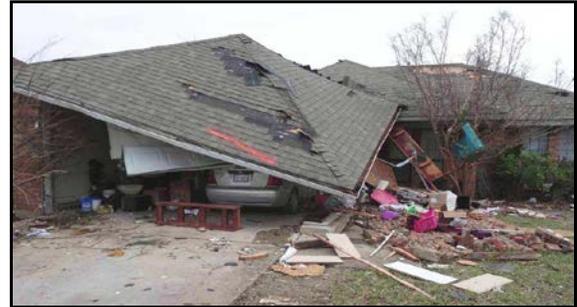
Marshall and McDonald (1982) found that homes with attached garages were more likely to sustain greater damage than homes without attached garages, especially when garage doors faced the wind. As garage doors buckle inward, wind pressures increase inside the structure creating additional uplift on the roof and outward pressures on the walls. Eventually, either the roof or wall(s) failed. Leeward garage doors were frequently blown outward due to

internal pressure created when winds breached the windward sides of homes (Figs. 22 and 23).

Fig. 22. Collapse of the garage roof after a loadbearing side wall toppled. Wind pressure blew in the garage door.

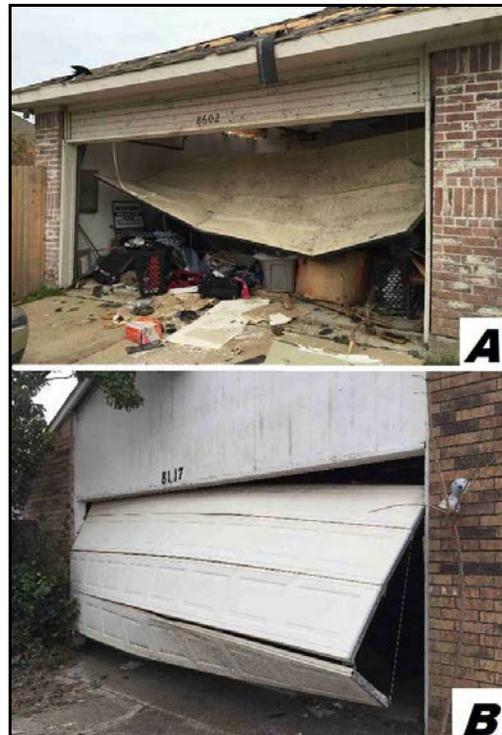
Fig. 23. Examples of (a) inward and (b) outward wind pressure-caused failures of garage doors.

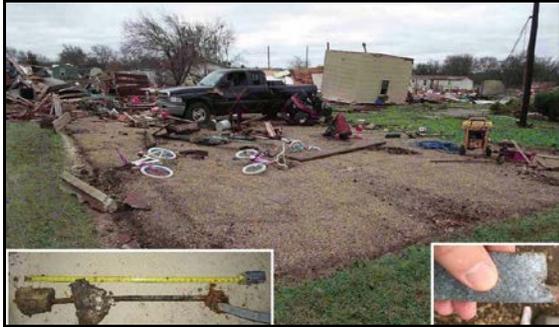
welded to a steel rod. Failure of manufactured homes occurred when the straps broke or the anchors pulled out of the ground. Manufactured homes were rolled or lofted usually leaving nearby vehicles and anchored porches untouched (Fig. 24).

Fig. 24. This double-wide manufactured home vaulted into the background before the pickup truck rolled into the space where the home had been.

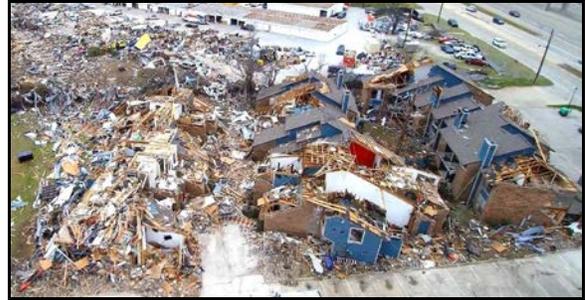
The southwestern-most building sustained the greatest damage with the removal of the roof and most second story walls, a DoD of 5. Expected wind speeds for this level of damage was 71 m/s or EF3 (Fig. 25). Eight buildings lost portions of their roof structures consistent with DoD 4. Expected wind speeds for this level of damage was 62 m/s or the borderline between EF2 and EF3. Roofs were comprised of long and slender manufactured wood trusses with steel gang-nailed connector plates. Remaining buildings sustained some loss of roof decking and significant damage to the roof coverings, and were assigned a DoD of 3. Expected wind speeds for this level of damage was 55 m/s or EF2.

Fig. 25. Damage to three apartment buildings at the Landmark at Lake Village West. Much of the top floor was removed on the southern-most (left) building. Source: ADV.

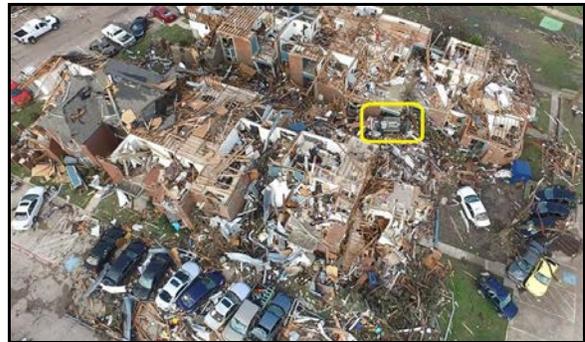
Many vehicles were moved or shifted in the parking lot. One vehicle was found upside down in the alley between two apartment buildings (Fig. 26). Movement of vehicles occurred throughout the damage path when EF2 or greater damage was found to adjacent buildings.

Fig. 26. Roofs removed from the Landmark at Lake Village West Apartments. Several vehicles also were moved with one being flipped (circled). Source: ADV.

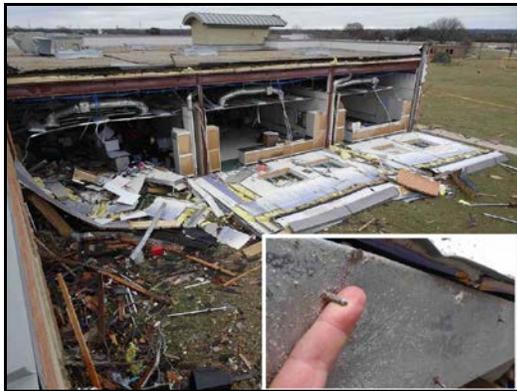
The Donald T. Shields Elementary School sustained moderate damage by the MOG tornado. The school was constructed in 2008 and finished in 2009. Exterior walls consisted of brick veneer and cold-formed, galvanized steel studs. This wall assembly was designed to be attached to the steel frame with powder-actuated fasteners and plates. The tornado toppled several non-load bearing walls, exposing classrooms, and revealing connection details (Fig. 27). Our close inspection revealed that none of the toppled walls were attached to the steel frame. No fasteners had penetrated the

Fig. 27. School walls fell outward during the tornado leaving the steel-frame intact. Close examination (see inset) revealed that nails attached the bottoms of the walls to the concrete foundation and walls were not attached to the steel frame.

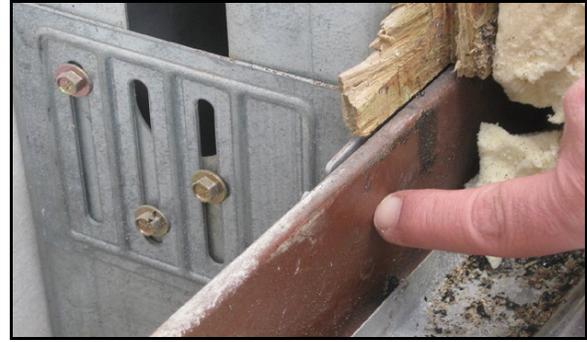
steel beams or columns (Fig. 28). Windows and blinds remained intact on the toppled walls, indicating the walls failed at relatively low wind speeds. Bases of the walls were nailed to the concrete slab foundation. However, nails penetrated only 1 cm into the concrete. Small divots were left in the concrete where nails had pulled out. Such walls had little lateral or overturning resistance. Given poor attachment of the walls, team members used the lower bound wind speed for DoD 8 of 62 m/s which led to an EF2 rating. However, failure wind speeds probably were below this lower bound value, so team members looked at other DoDs at the school.

Fig. 28. Bracket on perimeter wall stud was never attached to the steel frame. Bracket fasteners should have penetrated structural steel (finger pointing) at the Donald T. Shields school.

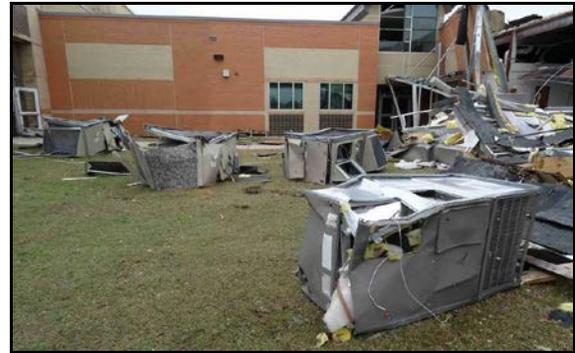
Breach of the school building led to increased internal pressure and uplift of a small section of steel roof decking and damage to the built-up roof. Several unanchored air conditioners were removed from the roof and deposited north of the school (Fig. 29). Damage to the roof and HVAC equipment was consistent with a DoD of 5 where the expected wind speed of 45 m/s. This led to an EF1 damage rating for the school which seemed more reasonable.

Fig. 29. Unanchored HVAC equipment was blown off the school roof.

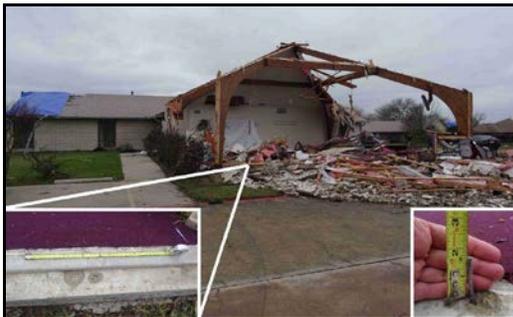
Frame walls toppled during the tornado but the glulam beam-columns remained undamaged (Fig. 30). Nails either pulled out with the wall plates, leaving small divots in the perimeter of

the concrete slab, or the wall plates split around the fastener leaving the fasteners still embedded in the concrete foundation. Outside the sanctuary, there was little roof damage to remaining portions of the church. We selected the residential DI=2 for this church, and given the poor attachment of the failed frame wall, we used the lower bound wind speed for DoD=7 of 51 m/s yielding an EF2 rating. However, minimal damage to the roof covering suggested a wind speed closer to DoD=4 or 43 m/s, yielding an EF1 rating.

Fig. 30. Sanctuary frame walls collapsed at the Ovilla Road Church of the Nazarene but the glulam frame remained upright. Bottom wall plates on the frame walls were poorly attached with concrete nails.

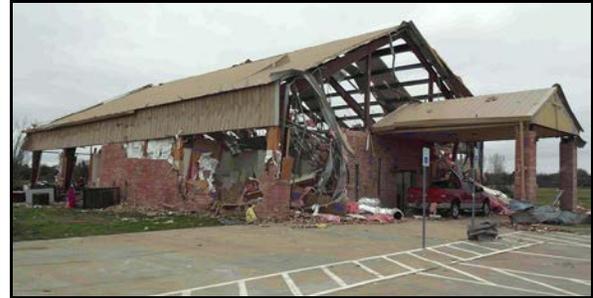
Much of the metal cladding was torn away from the roof during the tornado, and brick veneer walls fell. Both east and west gable ends collapsed, but the main steel frame, including the roof structure, remained intact (Fig. 31). This church building was a metal building system (MBS) which is DI=21. The level of damage to this building was consistent with DoD=3 with an expected wind speed of 42 m/s or an EF1 rating.

Fig. 31. Wall and roof cladding were removed from the steel frame at the Harvest of Praise Ministry Church. However, the steel frame, carport, and parking signs remained intact.

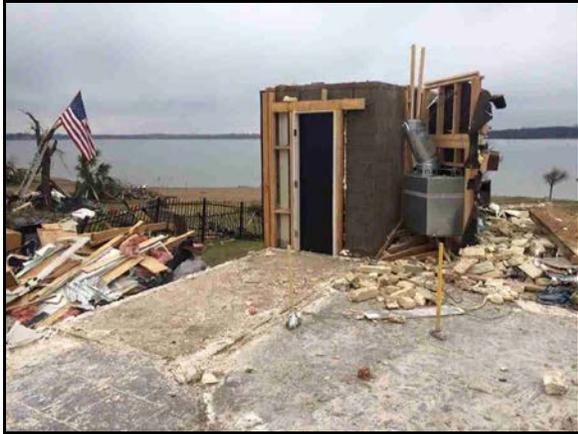
Fig. 32. This above ground shelter was all that remained after the tornado. Nine people took refuge inside the shelter and escaped injury.

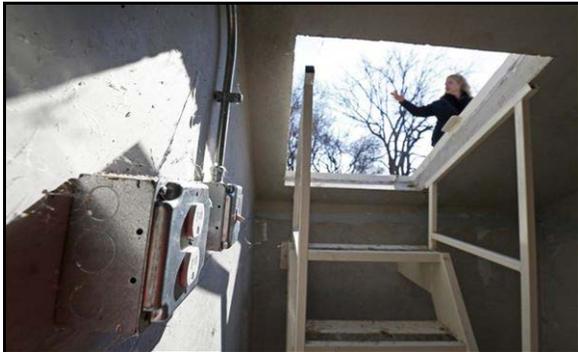
Fig. 33. A partially below ground concrete shelter where 12 people reportedly survived in Rowlett. Image by the Dallas Morning News.

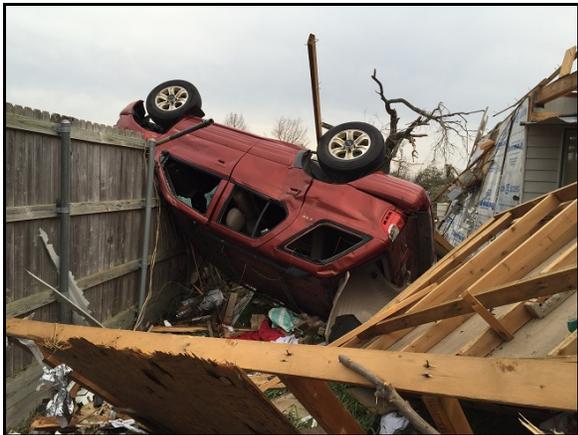
Many vehicles were tossed, rolled, or thrown during both tornadoes where residential damage was EF2 or greater. Marius et al. (2016) conducted a comprehensive study of vehicle movements in tornadoes and found similar results. One SUV traveled more than 100 m from a garage on Glenloch Drive and ended up in an open field. About a dozen gouge marks were found in the ground leading from the destroyed garage, indicating the vehicle rolled and tumbled. Another SUV was lofted and found in the back yard of a home with EF2 damage (Figs. 34 and 35).

Fig. 34. This flipped SUV end up in the back yard of a home that sustained EF2 damage.

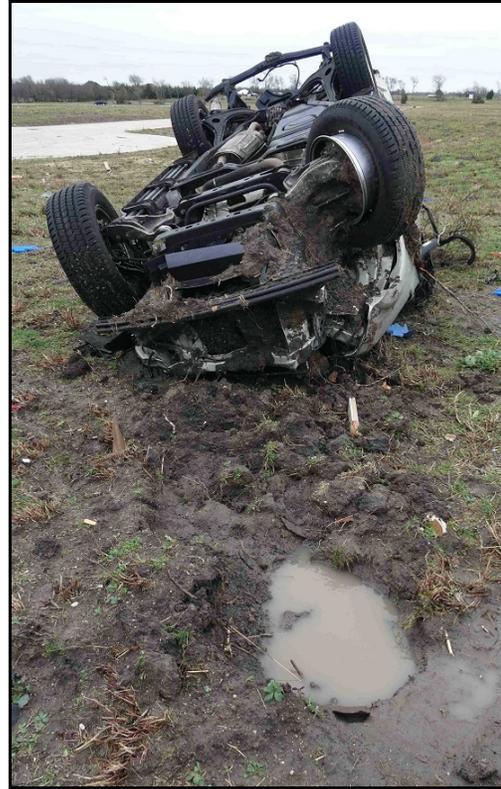
Fig. 35. This SUV tumbled more than 100 m leaving about a dozen impact marks in the ground.

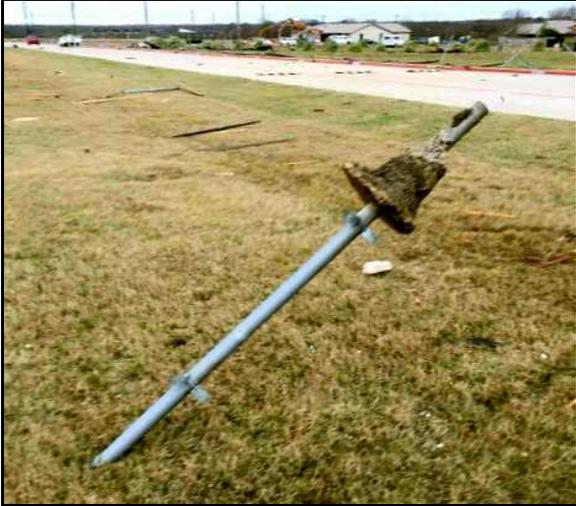
Fig. 36. Fence post was removed then driven upside down into the ground near Shields Elementary School.

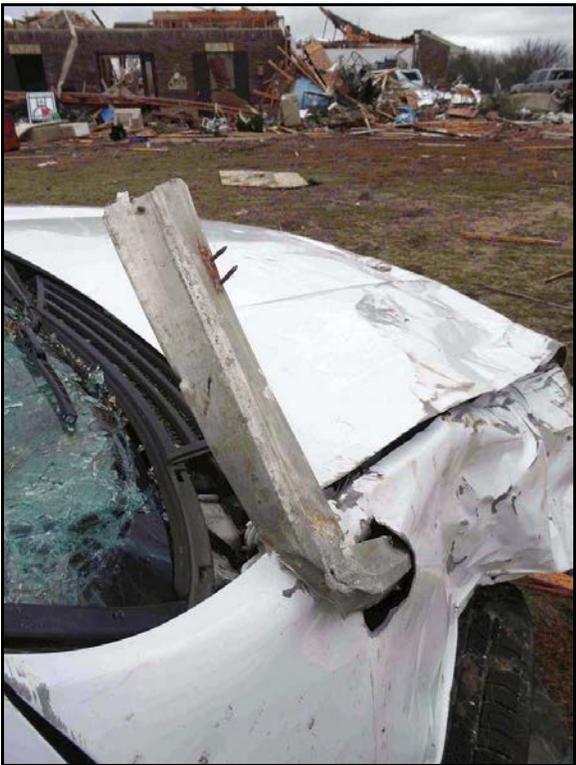
Fig. 37. Portion of a metal post that pierced the front panel on a vehicle.

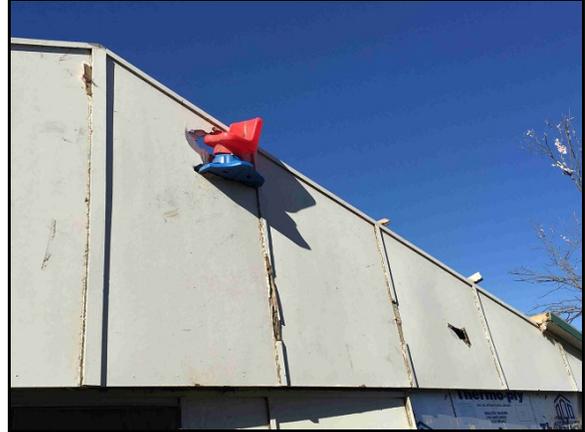
A plastic child's seat penetrated a wood-fiber siding panel on an east-facing gable end (Fig. 38). The siding was relatively soft and easily penetrated.

Fig. 38. Child's plastic seat impaled wood-fiber siding on a gable end.

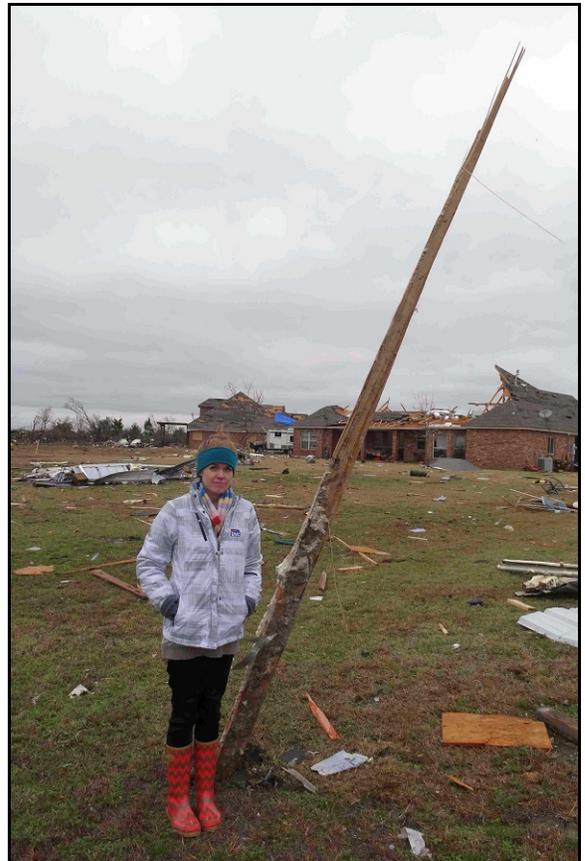
Wood projectiles were common in both tornadoes. Boards up to 4m long were found stuck into the ground downwind of residential areas (Fig. 39). Some boards punctured roofs and brick masonry.

Fig. 39. One of several long boards sticking out of ground after the tornado.

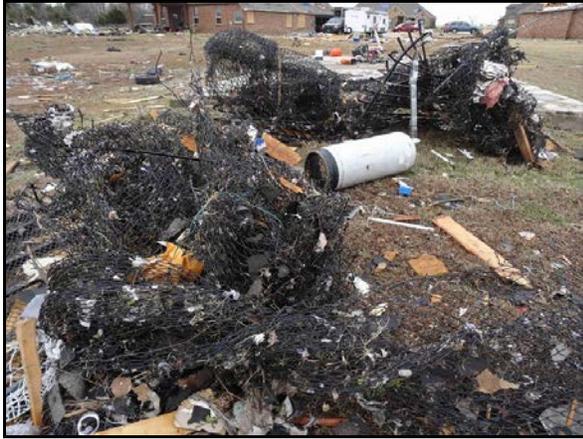
We found sections of cyclone fencing rolled up into ribbons or balls by both tornadoes (Fig. 40). This occurred as portions of fencing became detached and rotated or pivoted around anchored sections.

Fig. 40. Chain link fences rolled up into balls.
