# Damage Survey of the Nashville, TN Tornado: 3 March 2020

Timothy P. Marshall<sup>1</sup>, Christine Standohar-Alfano<sup>1</sup>, Christopher Bright<sup>1</sup>, Krissy Hurley<sup>2</sup>  
<sup>1</sup>Haag Engineering Company, <sup>2</sup>NOAA/NWS

## 1. INTRODUCTION

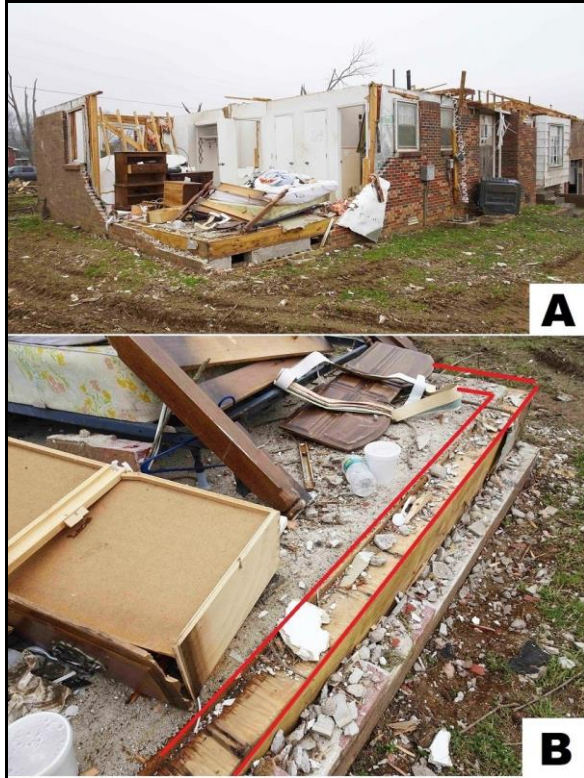
Hundreds of wood-framed residences were damaged by this tornado. The typical damaged home had a pitched roof with wood trusses or rafters toenailed to wall top plates. This was a “weak link” as toenailed connections were pulled out when the roofs were uplifted and removed. It was common to see roofs removed with most walls still standing.

Wood framed walls were erected on floor platforms where the wall bottom plates were straight nailed to the floor. Nails were placed indiscriminately in wall bottom plates and usually missed the floor joists; thus, walls were attached to the floor sheathing. This attachment was the another “weak link” and these walls had little lateral wind resistance once the roof was removed. We saw several homes where exterior walls fell over. Refer to Figure 3. In the 2006 EF-scale, the loss of the roof and some exterior walls is equivalent to DoD 6 in DI 2 with expected failure wind speeds of 55 m/s (122 mph). Refer to Table 1.

The worst damage to residences was found in Donelson and Mt. Juliet where houses lost their roofs and had collapsed exterior walls with only interior rooms remaining. This damage was assigned DoD 8 with estimated failure wind speeds of 68 m/s (152 mph).

**Fig. 3.** Damaged home due to the tornado: A) loss of roof and a portion of the exterior frame wall, and B) failure point was where frame walls were attached to the floor (outlined in red).

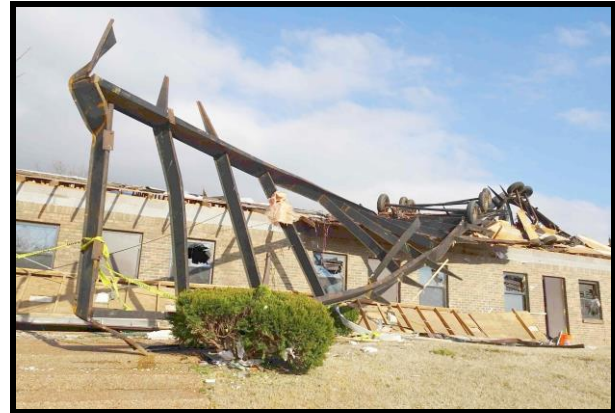
As expected, manufactured homes performed poorly in the tornado. These homes usually were anchored in the ground with metal straps and auger type anchors. However, either the straps broke, or the anchors pulled out of the ground as manufactured homes shifted off their stacked CMU piers. Some homes were not anchored at all as was the case with one we found at the Donelson Christian Academy. This home had been located just south of the school and was not

anchored. The home disintegrated during the tornado and the steel frame was lofted to the north and deposited on the school. Refer to Figure 4.

According to the 2006 EF scale, complete destruction of a manufactured home (DI 3) is listed as DoD 9 with estimated failure wind speeds of 57 m/s (127 mph). Refer to Table 2.

**Fig. 4.** Steel frame of unanchored manufactured home deposited on the Donelson Christian Academy.

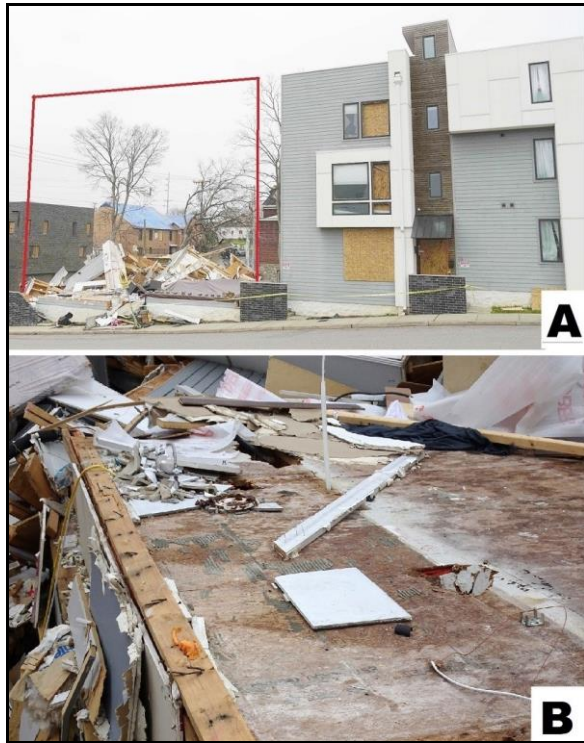
Three studio style apartments collapsed in the 100 block of north 8<sup>th</sup> Street. These units were three-story, wood-framed structures. Close examination revealed failure occurred where the bottom plates were straight nailed into the ends of the wall studs. The nailed connections pulled out as the walls leaned to the north. Adjacent buildings lost windows due to flying debris but remained intact. There also was little to no damage to trees around the building. Refer to Figure 5.

According to the 2006 EF scale, the collapse of a three-story apartment building (DI 5) is not listed. However, total collapse of the top two stories is listed as DoD 6 with failure wind speeds of 80 m/s (180 mph). But given the failure of the straight nailed connections and lack of damage to the building surroundings, we lowered the failure wind speed to just 45 m/s (100 mph). Refer to Table 3.

**Fig. 5.** Part of a three-story apartment building that collapsed: A) outline of building, and B) closer view showing floor platform where base of wall was straight nailed.

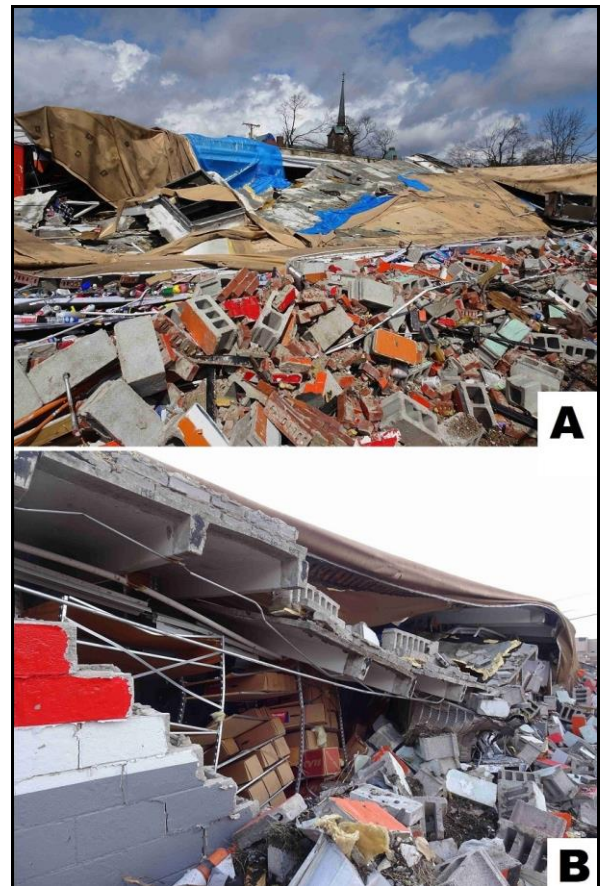
constructed with load-bearing CMU perimeter walls and pre-cast, double tee concrete roof planks. Google Street View imagery, taken before the tornado, showed an array of large windows extended along the front of the building, which faced west. Strong west winds blew these windows inward and blew out the front half of the CMU walls causing that portion of the roof to collapse. Refer to Figure 6.

According to the 2006 EF scale, the partial collapse of a small retail building (DI 8) would be equivalent to DoD 7 with expected failure wind speeds of around 62 m/s (138 mph). Refer to Table 4.

**Fig. 6.** Collapse of Auto Zone store: A) unreinforced, loadbearing, masonry walls, and B) heavy concrete tee roof deck.

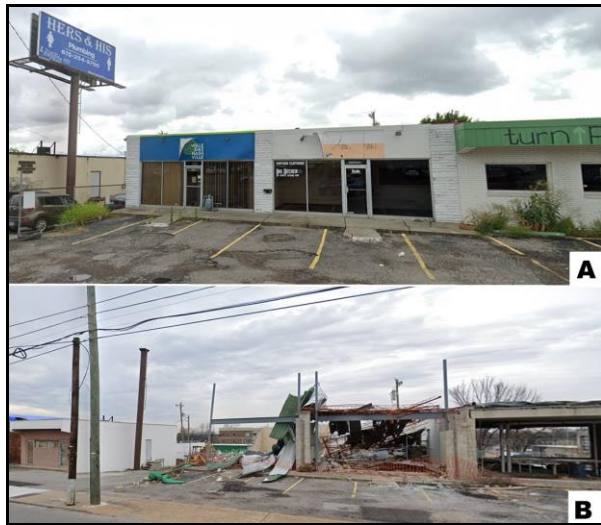
The strongest winds from the tornado were from the southwest which caused the southwest end of the building to topple inward. Roof joists and decking also were uplifted on the two southwesternmost stores. Close examination revealed the ends of the steel roof joists were welded to plates that were nailed to a wood nailer secured to the tops of the CMU walls. The nailed connections pulled apart as the steel joists were uplifted. Refer to Figures 7 and 8.

**Fig 7.** Strip shopping center: A) before the tornado on Google Street View, and B) after the tornado.

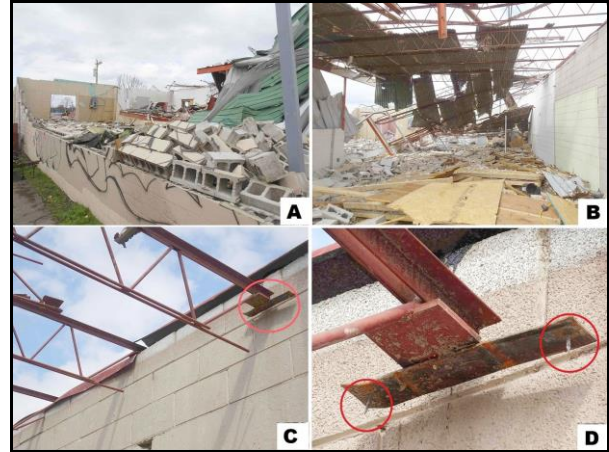
According to the 2006 EF scale for strip shopping malls (DI 10), collapse of exterior walls with interior walls remaining would be DoD 8 with an expected failure wind speed of 63 m/s (140 mph). Refer to Table 5.

**Fig 8.** Damage to a strip mall: A) toppling of the southwest unreinforced masonry wall, B) loss of roof decking, C) steel joist hanging off wall, and D) nails (circled) in steel plate had pulled out of wood nailer secured to the top of the CMU wall.

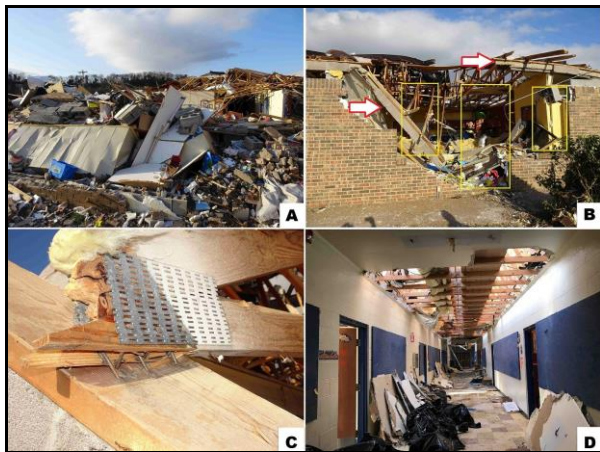
The strongest winds from the tornado were from the west. Masonry walls failed in V-shaped

patterns centered on the doors and windows. Thus, the west ends of the roof trusses were no longer attached to the walls. The interior hallway remained intact, although, most of the gypsum board clad ceiling fell to the floor. Refer to Figure 9.

According to the 2006 EF scale for elementary schools (DI 15), collapse of loadbearing walls would be DoD 9 with total destruction of a large section of the building being DoD 10. However, less than half of this building was totally destroyed. Therefore, the survey team selected DoD 9 with an estimated failure wind speed of 68 m/s (158 mph). Refer to Table 6.

**Fig 9.** Damage to Donelson Christian Academy: A) collapse of south wing, B) masonry wall collapse around doors and windows (yellow outlines) with bond beams remaining (arrows), C) toe nailed roof truss, and D) interior hallway.

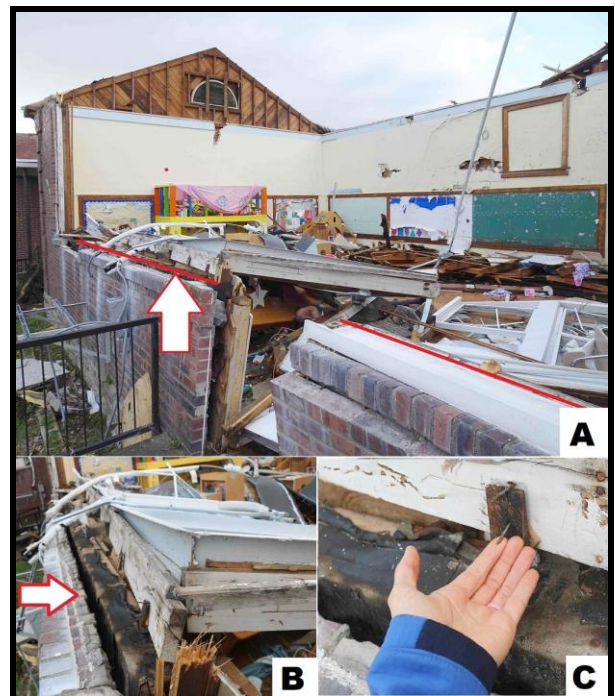
The strongest winds from the tornado were from the south. South windows blew inward, and internal pressure helped remove the roof over the southern end of the school. Similarly, the south end wall of the gymnasium fell inward, and the roof deck was removed leaving the steel joists intact. Refer to Figures 10 and 11.

Damage to this school was consistent with DoD 9 for DI 15 in the 2006 EF scale with estimated failure wind speeds around 68 m/s (158 mph). Refer to Table 6.

**Fig. 10.** Damage to classroom at the Dodson Chapel United Methodist Childcare: A) windows toppled inward at hinge line (red line and arrow), B) closer view showing wood nailer (arrow), and C) nails pulled out of wood window frame.

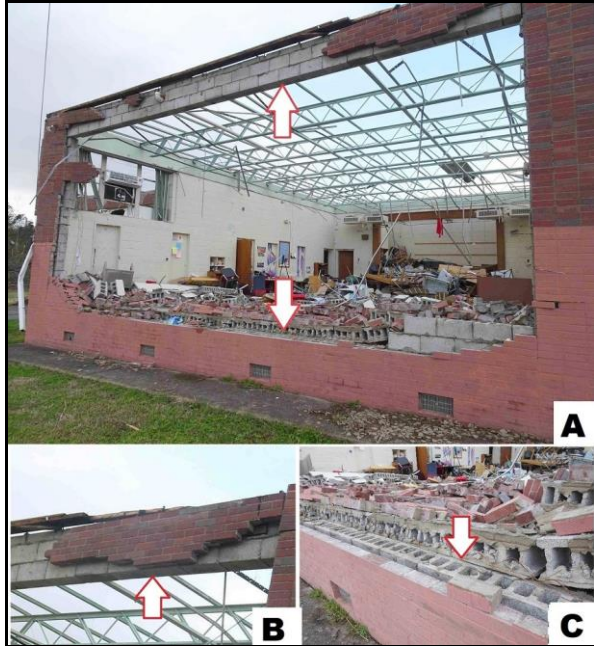
**Fig. 11.** Damage to the gymnasium at the Dodson Chapel United Methodist Childcare: A) removal of roof deck and toppling of masonry end wall (arrows indicate failure plane), B) lack of vertical steel reinforcement at the top of wall, and C) lack of vertical steel reinforcement at base of wall.

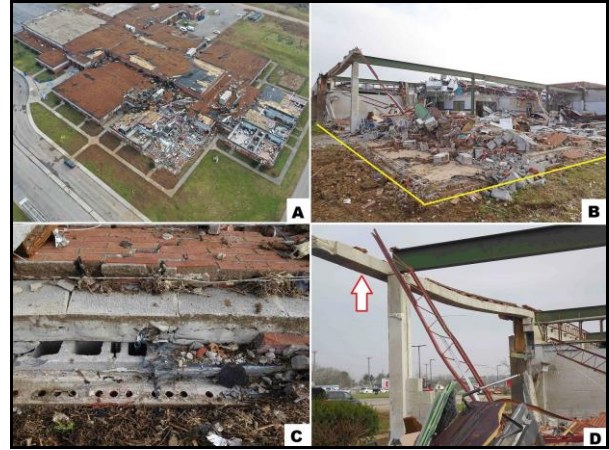
The tornado struck the southern portion of this school toppling the south and west walls into four classrooms and removing the roof decking and steel joists above six classrooms. Masonry bond beams were left hanging as a catenaries between columns. The vast majority of the school remained intact without structural damage. Refer to Figure 12.

Damage to this school was consistent with DoD 9 for DI 15 in the 2006 EF scale with estimated failure wind speeds around 68 m/s (158 mph). Refer to Table 6.

**Fig.12.** Damage to West Wilson Middle School. A) Drone image looking east, B) destruction of southwest classrooms, C) base of masonry wall toppled inward, and D) bond beams (arrow) hanging between supports.

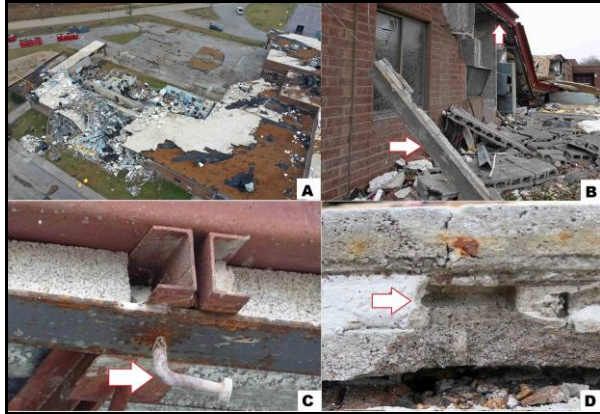
The tornado toppled west facing CMU walls into two of the southwesternmost classrooms and removed the roof system above these rooms. Debris crashed through the roof of one classroom on the opposite side of the school wing. Refer to Figure 13.

Damage to this school was consistent with DoD 9 for DI 15 in the 2006 EF scale with estimated failure wind speeds around 68 m/s (158 mph). Refer to Table 6.

**Fig. 13.** Damage to Stoner Creek Elementary: A) collapse of CMU walls and roof due to poor attachments, B) lack of bond beam (horizontal arrow) attachment to wall, C) bent pegs at roof that were merely set into mortar channel along D) tops of bond beams.

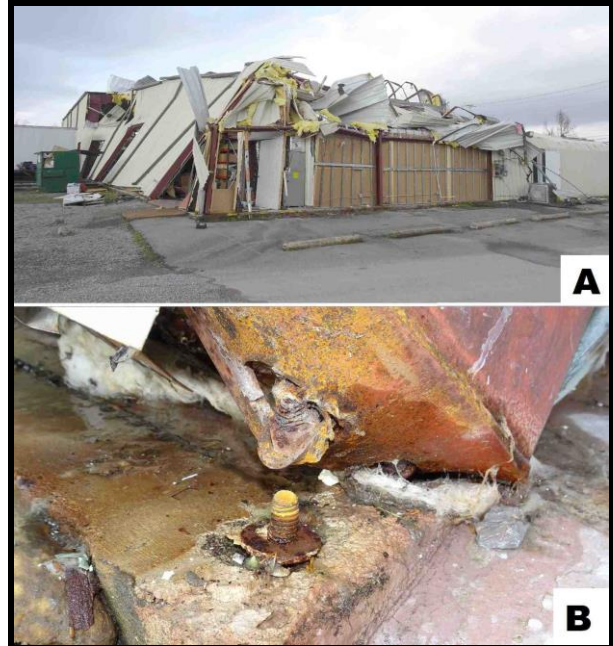
We closely examined the metal building system containing the Nashville Boating Center. Strong south winds pushed the south wall inward and anchor bolts securing the column base plates broke. By contrast, the north half of the building remained intact. Damage to the building was between DoD 5 and 7 in the 2006 EF scale with an average expected failure wind speed of 58 m/s (130 mph). Refer to Figure 14 and Table 7.

**Fig. 14.** Metal building that was surveyed: A) progressive collapse of steel frames leaning north, and B) typical broken anchor bolt and deformed base plate at base of column.

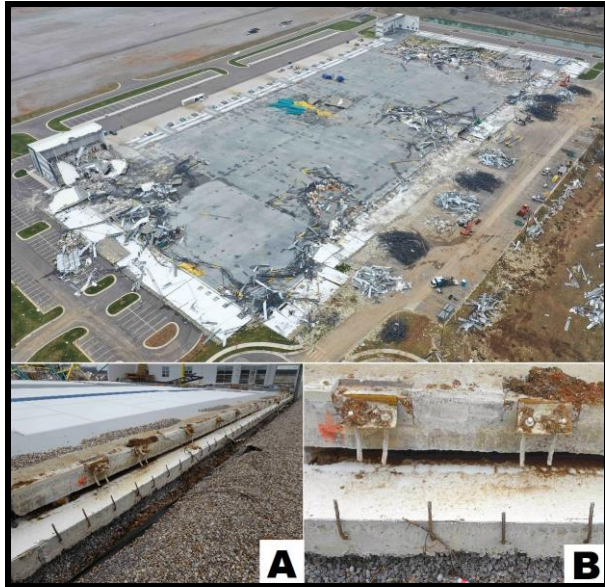
Several large warehouse-type buildings were damaged or destroyed in Mt. Juliet including the three-story, CEVA Logistics building on Athletes Way North. This 274 m (900 ft) long building was completely flattened by the tornado except for the wall panels at the southwest and southeast corners of the building. There was a steel framed interior enclosed with precast concrete wall panels. The bases of the wall panels were anchored to the concrete slab. As the wall panels toppled, the anchor rods either broke or were pulled out of the concrete slab foundation. Refer to Figure 15.

According to the 2006 EF scale, total destruction of a warehouse type building is DoD 7 with estimated failure wind speeds of 71 m/s (158 mph). Refer to Table 8.

**Fig. 15.** Complete destruction of warehouse building: A) drone view of collapsed building, B) fallen wall panel, and C) closer view showing connection details at base of wall.

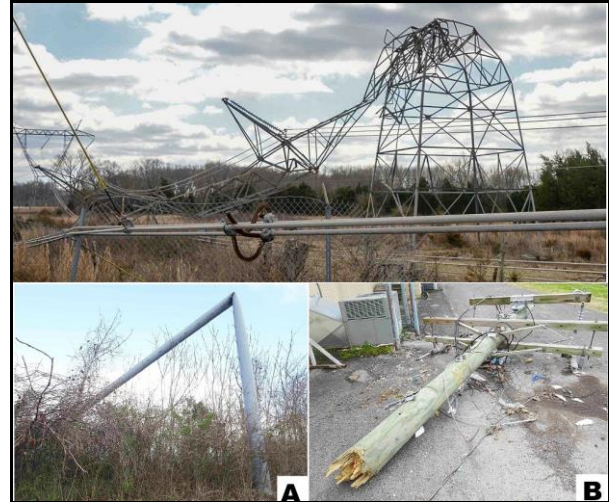
Several steel trussed towers, tapered steel poles, and wood poles were toppled by the tornado. According to the 2006 EF-scale, the collapse of a steel truss tower is DoD 6 with an estimated failure wind speed of 63 m/s (141 mph). The bent, tapered steel pole is DoD 5 with an estimated failure wind speed of 62 m/s (138 mph) and the broken wood pole is DoD 4 with an estimated failure wind speed of 53 m/s (118 mph). Refer to Figure 16 and Table 9.

**Fig 16.** Damage to electrical transmission systems: A) toppled steel truss tower, B) bent tapered steel pole, and C) broken wood pole.

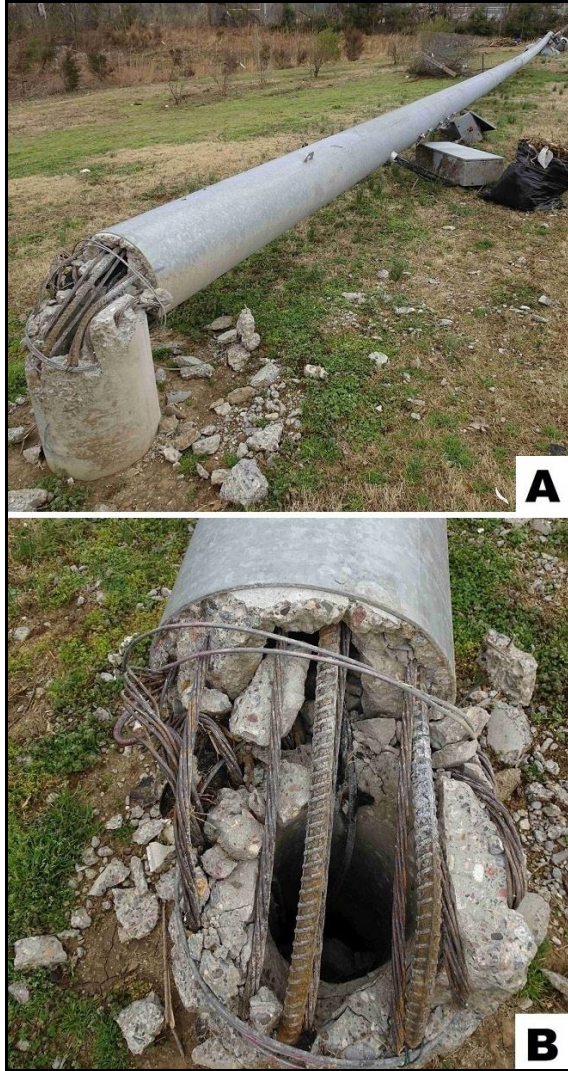
According to the 2006 EF-scale, the collapse of a free-standing pole is DoD 3 with an estimated failure wind speed of 53 m/s (118 mph) while bent poles are DoD 2 with an estimated failure wind speed of 46 m/s (102 mph). Refer to Table 10.

**Fig. 17.** Broken pier cap which supported tapered steel light pole: A) overall view, and B) close-up view of broken concrete pier.

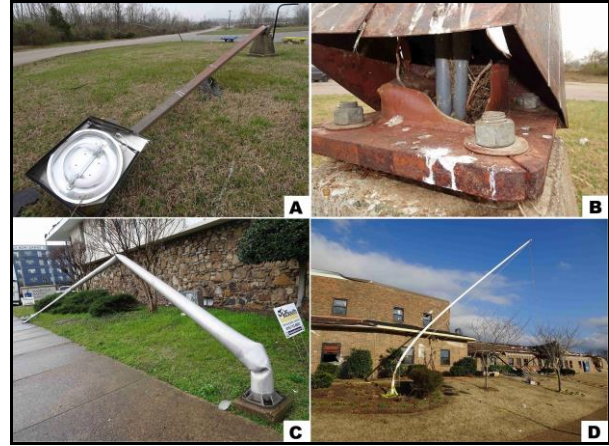
**Fig. 18.** Pole failures: A) failed steel pole, B) torn steel pole, C) toppled aluminum light pole, and D) bent steel flagpole.

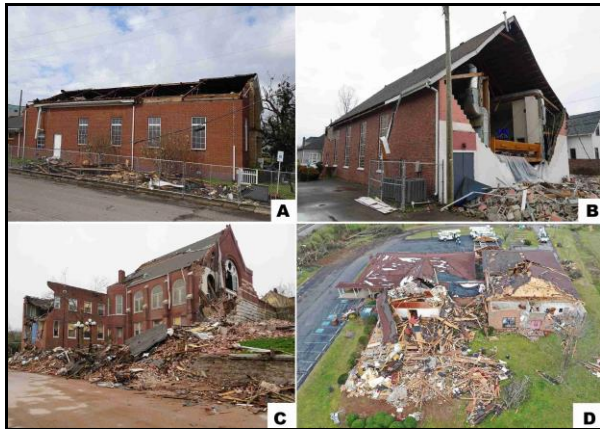
The Mount Bethel Baptist Church was a one-story brick masonry building with gable roof comprised of steel trusses. Wood nailers were bolted to the tops of the steel trusses and wood roof joists were toenailed to the nailers. Strong south winds from the tornado removed the entire south roof slope with the failures occurring at the toenailed connections. Steel roof trusses remained intact. Using the 2006 EF-scale, the DoD for this building was between 3 and 6 with an average estimated failure wind speed of 55 m/s (122 mph). Refer to Figure 19 and Table 11.

Again, using the 2006 EF-scale, the DoD for this building was between 3 and 6 with an average estimated failure wind speed of 55 m/s (122 mph). Refer to Figure 19 and Table 11.

**Fig. 19.** Various degrees of damage to churches: A) loss of roof, B) toppled end wall, C) toppled bell tower and brick façade, and D) collapse of sanctuary.

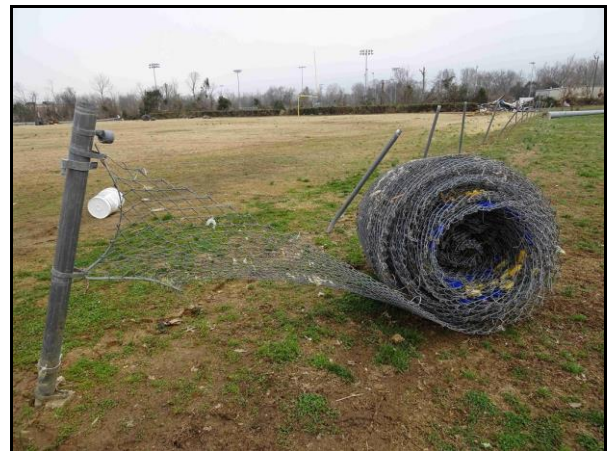
We documented damage to various other items not included in the original EF-scale document such as rolled up chain link fencing and toppled stone monuments at a cemetery. Both these items were located adjacent to the West Wilson Middle School in Mt. Juliet. Recall we estimated the failure wind speed at the school as 68 m/s (158 mph). Refer to Figures 20 and 21.

**Fig 20.** Rolled up chain-link fence at West Wilson Middle School.

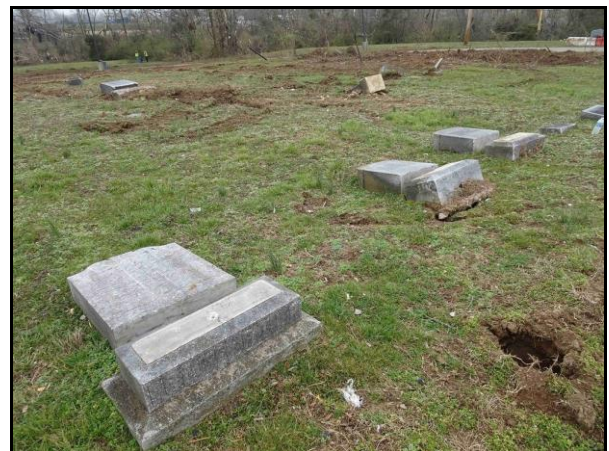
**Fig. 21.** Toppled gravestones adjacent to West Wilson Middle School.
