# Damage Survey of the Mayfield, KY Tornado: 10 December 2021

<sup>1</sup>Haag Engineering Company

<sup>2</sup>NOAA/NWS

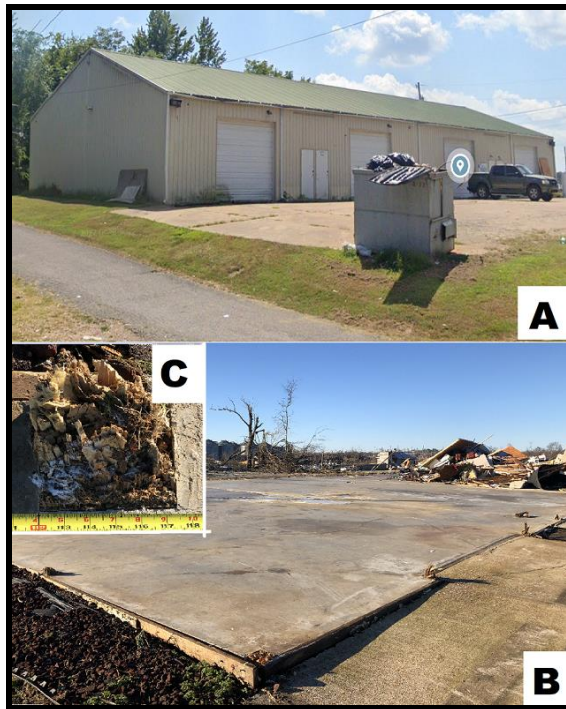
Many rural barns and outbuildings were destroyed by this tornado. According to the 2006 EF-scale, total destruction of a barn or outbuilding has an expected failure wind speed of 50 m/s (112 mph). One such example of a destroyed outbuilding was a one-story, wood post and frame structure at 514 West Walnut Street in Mayfield. Refer to Figures 4 and Table 1. Walls were built with 15 x 15 cm (6 x 6 in) wood posts spaced 3.7 to 4.8 m (12 to 16 ft) apart. The gable roof was wood trusses. The entire building was clad with metal panels. Four roll-up doors were located on the north side of this building. The building was completely destroyed, and posts were snapped off at the concrete floor slab. Such an open post and frame type building would have little resistance to strong winds. It is important to note this was not a metal building system (MBS) as they have interior steel framing.

**Fig. 4.** Wood post and frame building in Mayfield, Kentucky: A) Google Street View of front (north) elevation before the tornado, B) building view after the tornado, and C) wood post snapped at foundation.

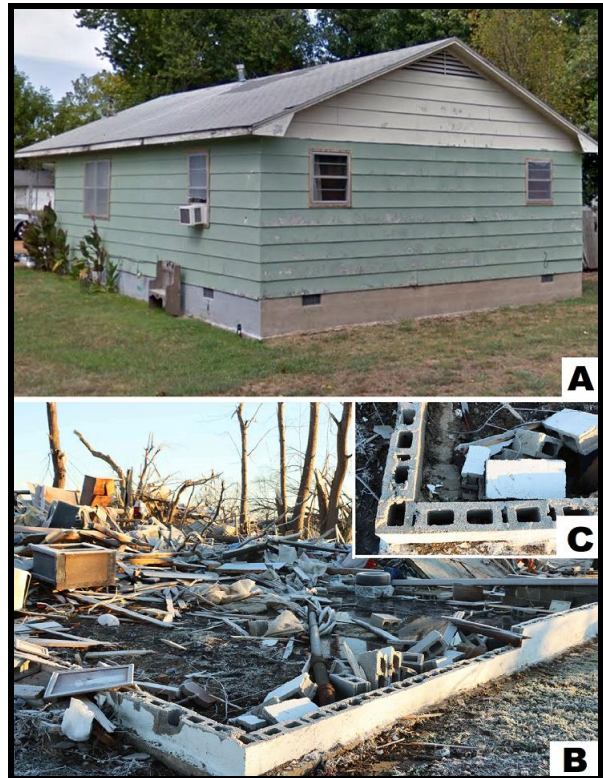
Hundreds of homes were damaged by the tornado. There were basically two types of wood-framed homes: those that were clad with siding and those that clad with brick masonry. The typical home was a one-story, wood-framed structure built on a pier and beam foundation. The foundation was built with concrete masonry units (CMUs). These buildings were essentially not anchored and susceptible to sliding off their foundations as noted with the residence at 314 S. 11<sup>th</sup> Street in Mayfield. Refer to Figure 5.

**Fig.5.** Typical wood-framed home: A) Google Street view before the tornado, B) building view after the tornado, and C) close-up view showing lack of attachment to the foundation.

As noted in the 2006 EF-scale document, unanchored homes swept off their foundations are DoD 5 and have an estimated failure windspeed of 54 m/s (121 mph). Thus, we assigned this failure wind speed to this home. Refer to Table 2.

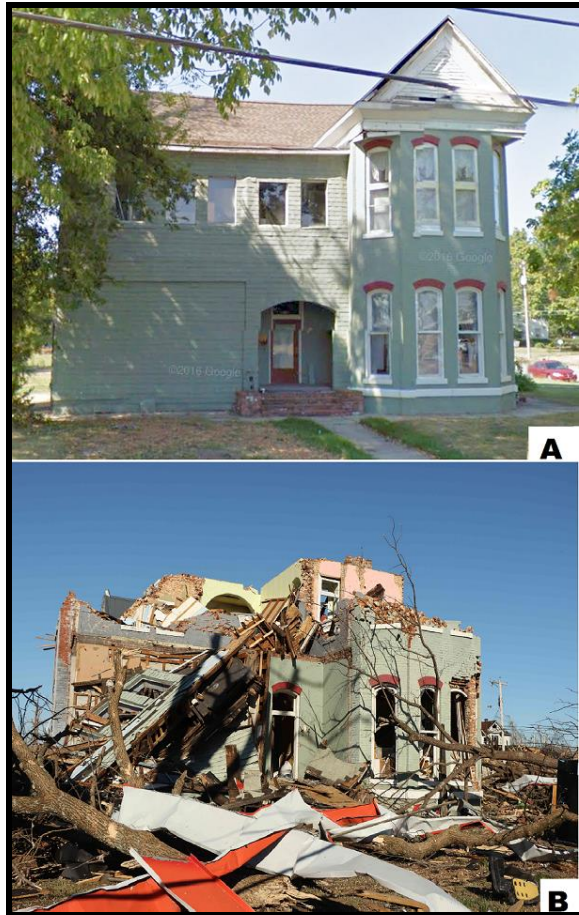
Generally, homes clad with brick masonry were heavier and had more wind resistance. The home at 219 E. North Street in Mayfield was a two-story, wood-framed structure clad with painted brick masonry. This home was built on a brick masonry foundation. Tornadoic winds removed the roof and second story exterior walls leaving interior walls remaining. Damage was equivalent to DoD 8 for the top story with an estimated failure windspeed of 68 m/s (152 mph). Refer to Figure 6 and Table 2.

**Fig. 6.** Two-story wood-framed residence clad with brick masonry: A) Google Street View before the tornado and B) view of house after the tornado.

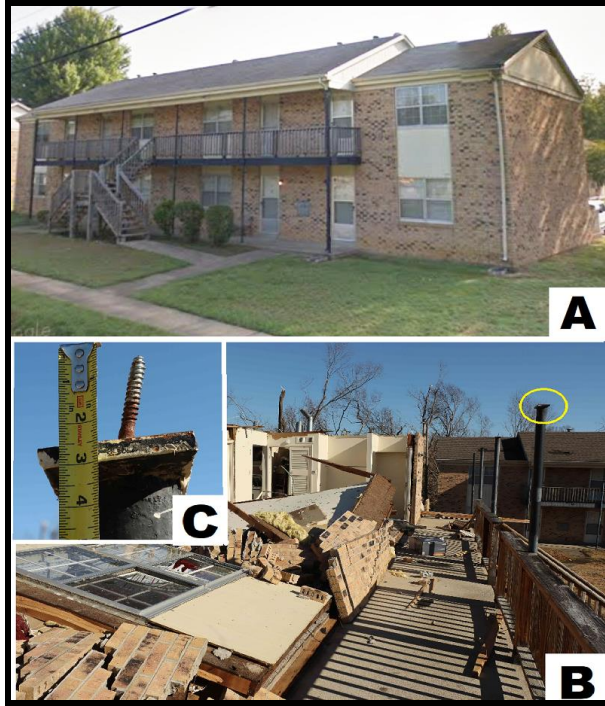
An east-west oriented building sustained the most severe damage. Refer to Figure 7. This building lost its roof which extended over a second-story walkway. Steel posts supported the roof overhang. Each steel post had a welded plate at the top with a hole where a lag screw was installed into the roof structure. Wind became trapped under the walkway roof which added additional uplift to the roof structure. As the beams lifted, screws at the top of each post pulled out of the roof structure leaving the lag screws on top of the posts. This roof overhang faced south and “caught” the strong, south winds, whereas other east-west oriented buildings had overhangs leeward to the wind, so they did not catch the wind.

**Fig. 7.** Two-story apartment building at Mayfield Garden Apartments: A) Google Street View before the tornado, B) loss of roof and overhang after the tornado, and C) close-up view of lag screw left at the top of the steel post along the walkway.

Second story wall bottom plates were straight nailed to the floor. Nails pulled out of the floor as the walls toppled about their bases once the roof was removed. Damage to this apartment building was consistent with DoD 5 in the 2006 EF-scale with estimated failure wind speeds of 71 m/s (158 mph). Refer to Table 3.

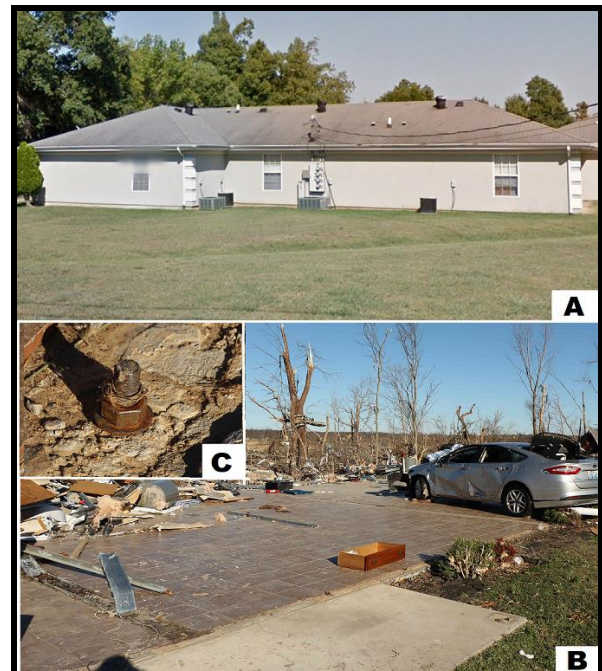
There was roof shingle and decking damage to four of the apartment buildings, but one apartment building was partially removed down to the concrete slab foundation. Close examination revealed that the anchor bolts remained intact around foundation perimeter. Wall bottom plates had pulled through the anchor bolts. The anchor bolts were properly installed with nuts and washers; the nuts were tightened properly.

Building debris was scattered to the north indicating the strongest winds were from the south. This apartment building was oriented east-west, and there was a parking lot to the south. We surmise that the open fetch of the adjacent parking lot likely allowed higher wind speeds while other buildings were blocked by trees or other buildings to the south. Refer to Figure 8.

Damage to this building was consistent with DoD 6 with estimated failure wind speeds around 80 m/s (180 mph). Interestingly, a Ford Fusion car was moved from the parking lot onto the concrete slab where the building had been.

**Fig. 8.** Windhaven Apartment building: A) Google Street View before the tornado, B) destroyed building after the tornado, and C) close-up view of anchor bolt which remained in the concrete slab foundation.

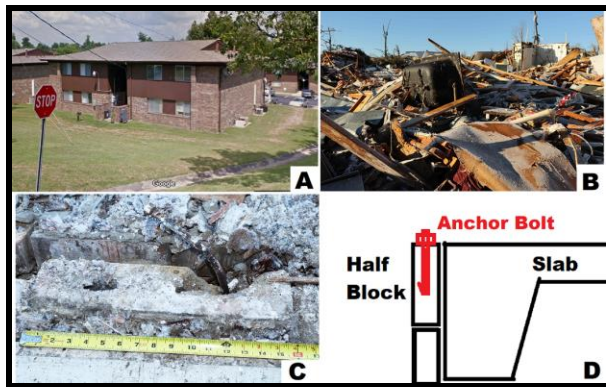
We also examined damage at the Dawson Village Apartments in Dawson Springs, Kentucky where there were 6, two-story, wood-framed structures built on concrete slab foundations. The exterior walls were a combination of painted wood siding and brick masonry. Gable roofs were wood-framed and covered with asphalt shingles. One building had collapsed leaving a pile of debris on the foundation. Some debris also was transported east into the parking lot.

Close examination revealed that the first story wall bottom plates had been bolted to CMU half blocks set around the perimeter of the concrete slab foundation. Wall plate connections failed as these blocks rotated away from the concrete slab foundation. Refer to Figure 9. This type of foundation connection was inherently weak to resist lateral wind loads. As a result, we rated this building at the lower bound of DoD 6 with estimated failure wind speeds of 69 m/s (155 mph).

**Fig. 9.** Wood-framed building at the Dawson Village Apartments: A) Google Street View of the building before the tornado, B) pile of debris on the foundation after the tornado, C) CMU half block with anchor bolt broken out of the block, and D) cross section detail of the foundation.

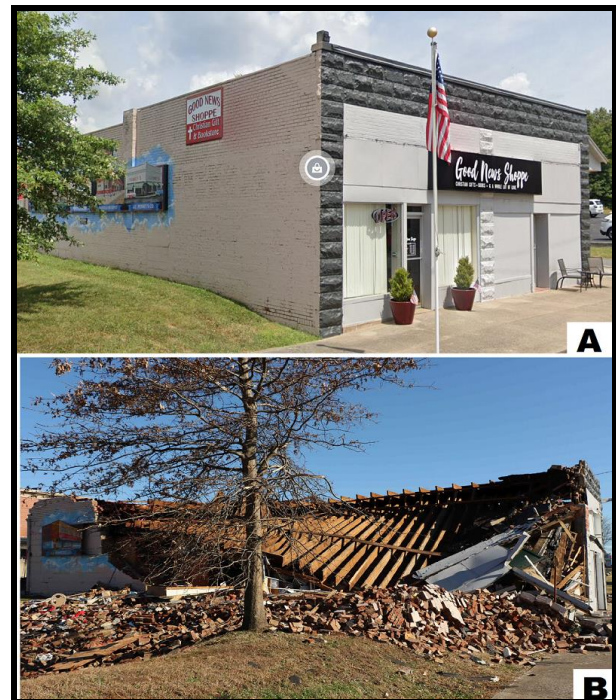
We inspected the Good News Shop, a one-story wood and masonry structure near downtown Mayfield. The west loadbearing masonry wall collapsed resulting in the collapse of the wood roof structure. Damage to this building was equivalent to DoD 8 on the 2006 EF-scale with expected failure wind speeds of 64 m/s (144 mph). This failure wind speed was likely too high as the large maple tree west of the building remained intact indicating failure wind speeds were probably closer to 45 m/s (100 mph). Refer to Figure 10 and Table 4.

**Fig. 10.** The Good News Shop in downtown Mayfield: A) Google Street View of the building before the tornado, and B) collapse of the loadbearing west wall from the tornado.

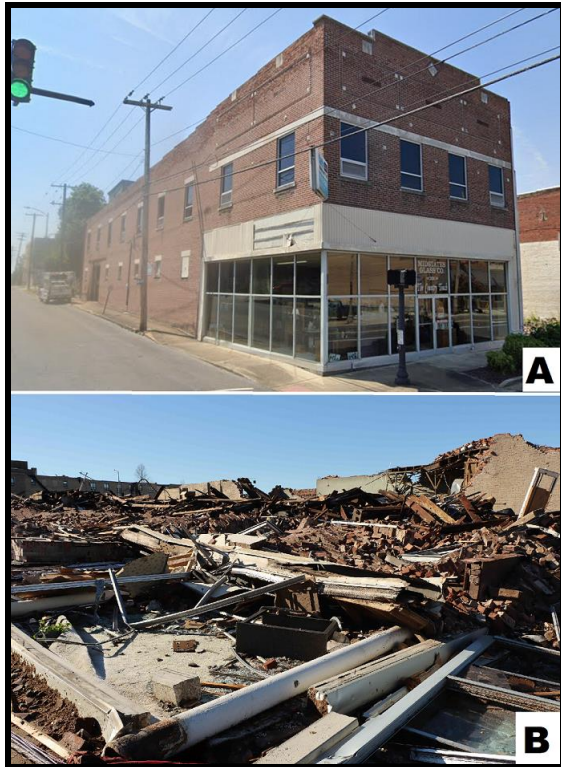
Midstate's Glass Company building was a two-story, rectangular structure oriented north-south located in downtown Mayfield. The building had loadbearing masonry perimeter walls with wood floor and roof joists. Large windows extended across the front of the building on the first story, which faced north. This building completely collapsed during the tornado into a pile of rubble. Damage was equivalent to DoD 9 in the 2006 EF-scale with expected failure wind speeds of 70 m/s (157 mph). Refer to Figure 11 and Table 4.

**Fig. 11.** Midstate's Glass Company building: A) Google Street View before the tornado, and B) complete collapse of building from the tornado.

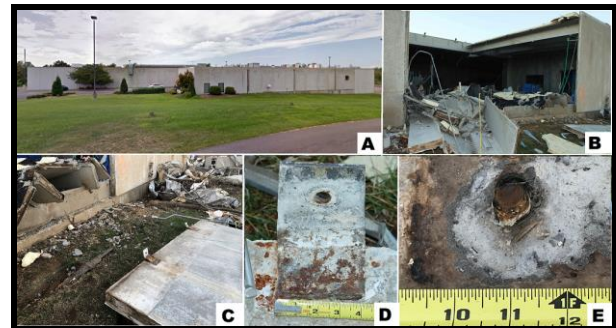
The Pilgrims Pride North plant sustained damage from the tornado. This was a large, isolated retail building (LIRB) located southwest of downtown Mayfield. The building was constructed with precast, concrete wall panels and double tee, concrete roof beams. The tornado passed to the east of the building subjecting it to strong west winds. Two wall panels on the east side of the building fell outward causing the supporting double tee roof beams to collapse.

Close examination revealed each wall panel was secured to the concrete foundation with two anchor bolts. Each wall panel had a pair of L-shaped, steel embeds with a hole to receive the threaded bolt stems to be tightened with nuts and washers. Anchor bolts broke in tension leaving cup-cone fractures on the bolt stems. The L-shaped steel embeds were not bent and remained intact in each wall panel. Refer to Figure 12.

Damage to the building was equivalent to DoD 6 in the 2006 EF-scale with estimated failure wind speeds of 61 m/s (137 mph). Refer to Table 5. However, since only two wall panels had failed, the failure wind speed was likely lower. There were two steel light poles near the building that toppled. This would yield a DoD of 3 in DI 26 with an estimated failure wind speed of 53 m/s (118 mph).

**Fig. 12.** Pilgrims Pride building: A) Google Street View before the tornado, B) loss of two wall panels from the tornado, C) closer view of the base of the toppled wall panel, D) steel bracket embed remained intact on the wall panel, E) broken anchor bolt in the foundation.

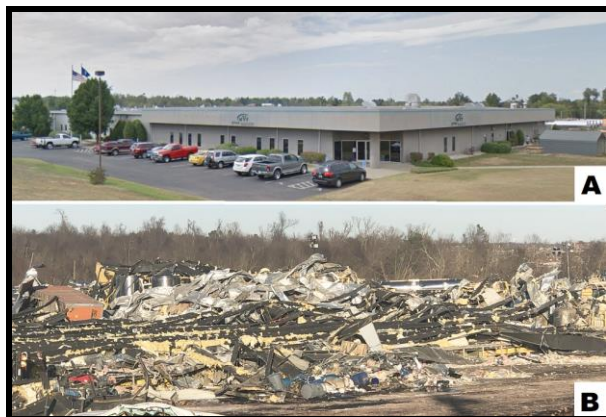
The tornado traveled directly over the building subjecting it to strong east and south winds. The roof was uplifted, and steel columns collapsed in succession, failing where they were bolted to concrete foundation. Anchor bolts broke while column base plates bent, and successive bays fell like dominoes. Refer to Figures 13 and 14.

According to the 2006 EF-scale for DI 21, total destruction of the building would have an estimated failure wind speed of 69 m/s (155 mph). Refer to Table 6.

**Fig 13.** The Candle Factory in Mayfield: A) Google Street View before the tornado, and B) complete collapse of the building by the tornado.

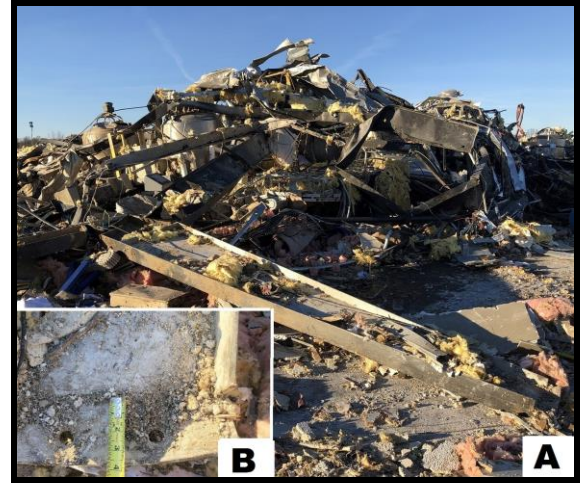
**Fig. 14.** Collapse of the Candle Factory building: A) pile of steel debris on the foundation with support column in foreground, and B) closer view showing bent base plate on column where it had been bolted.

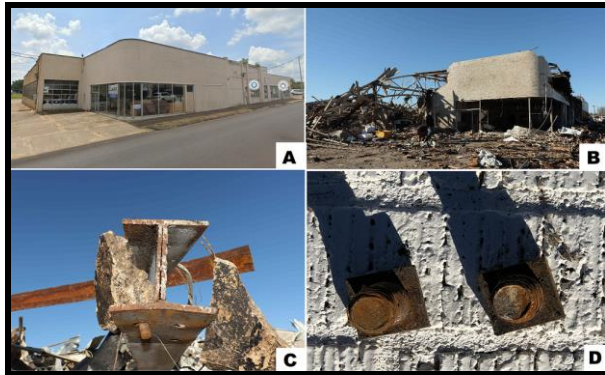
Myers Flooring Store was a warehouse type building in downtown Mayfield. The building was a one- and one-half story steel-framed structure with brick masonry perimeter walls and bowstring-shaped, steel roof trusses. The roof trusses were bolted to steel columns which in turn were bolted to the concrete foundation. Exterior walls were brick masonry. There was a large array of windows on the northeast, east, and south sides of the building along with roll up doors. These windows and doors failed from strong east and south winds resulting in a rapid increase in internal wind pressure which uplifted and collapsed the roof. Most of the debris remained in place on the foundation. Bolted connections were sheared apart between the bowstring roof trusses and tops of the columns as well as where the columns were secured to the foundation. Refer to Figure 15.

According to the 2006 EF-scale DI 23, total destruction of a large portion of a warehouse

building (DoD 7) has an expected failure wind speed of 71m/s (158 mph). Refer to Table 7.

**Fig. 15.** Myers Flooring Store: A) Google Street View before the tornado, B) Collapse of the roof and walls from the tornado, C) Sheared bolted connection where the bowstring truss was attached to the top of the columns, and D) closer view of sheared bolts.

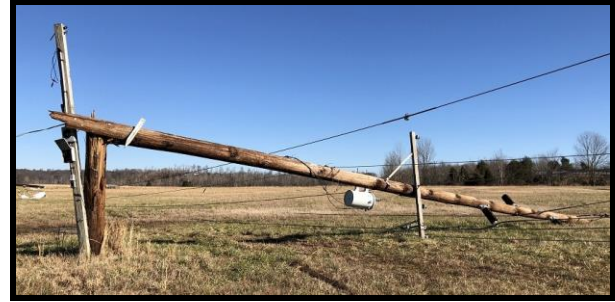
As expected, there was extensive damage to wood utility poles throughout the tornado path. Common failures were snapped poles at or near the ground. Some poles were rotted while others were not rotted. Damage to wood utility poles was consistent with DoD 4 in DI 24 with expected failure wind speeds of 53 m/s (118 mph). Refer to Figure 16 and Table 8.

**Fig. 16.** Broken wood power pole.

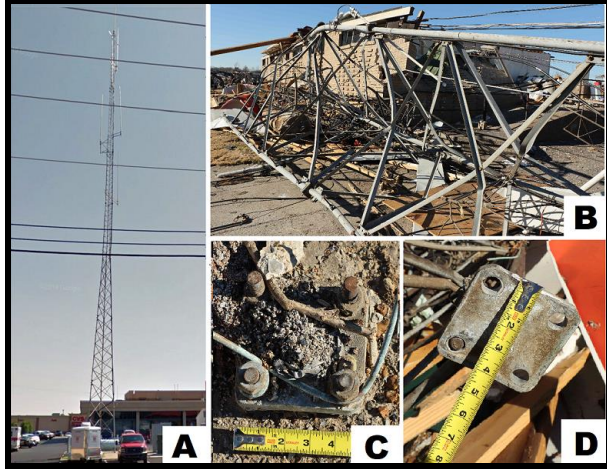
Strong south winds from the tornado toppled the tower to the north partly blocking the street north of the fire station. Close examination of the base of the tower revealed that two legs were torn away leaving base plates anchored to the foundation while the third leg broke the anchor bolts; the base plate was still attached to the leg. Refer to Figure 17.

According to the 2006 EF-scale DI 25, a collapsed tower has an estimated failure wind speed of 59 m/s (133 mph). Refer to Table 9.

**Fig. 17.** Steel trussed communications tower at the Fire Station in Mayfield: A) Google Street image before the tornado, B) toppled tower after the tornado, C) leg tore at base plate, D) broken bolts with attached base plate.

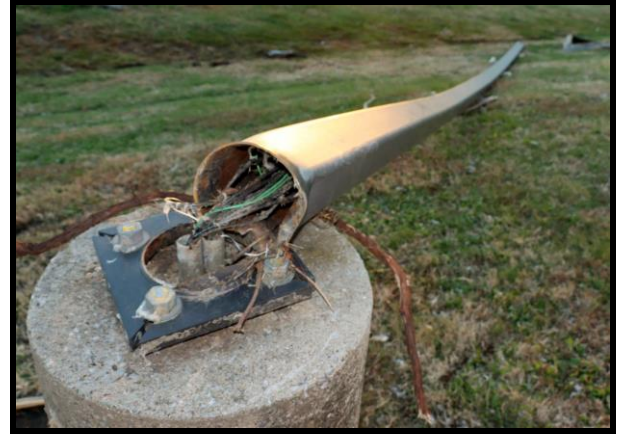
Free-standing, light poles and cantilevered traffic signals were damaged or toppled by the tornado. Those near the Pilgrims Pride facility were round, tapered steel poles that were about 12 m (40 ft) tall and 15 cm (6 in) at the base. Pole bases were welded to a square base plate and attached to concrete piers with four anchor bolts. Refer to Figure 18.

Strong east winds from the tornado toppled the poles to the west and they tore just above the welded joints. According to the 2006 EF-scale, toppled poles are DoD 3 in DI 26 with expected failure wind speeds of 53 m/s (118) mph. Refer to Table 10.

**Fig. 18.** A steel light pole tore at its base near Pilgrim Pride north building.

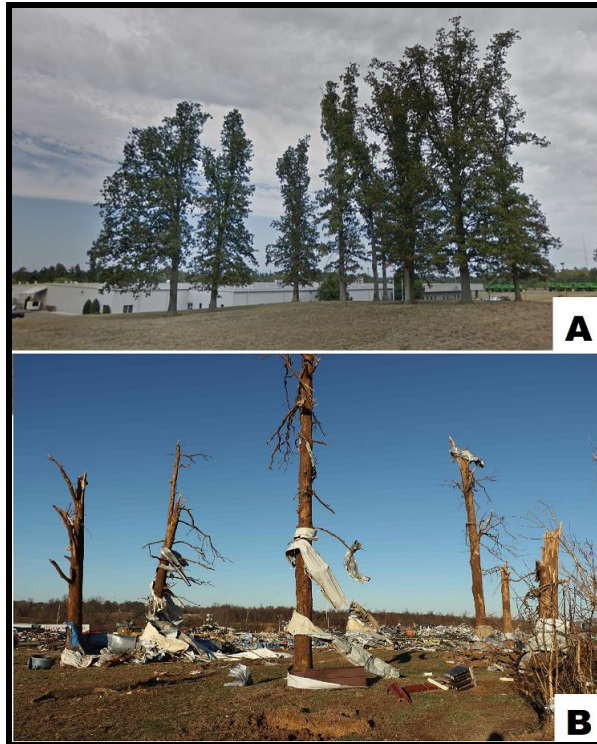
There were many hardwood and softwood trees damaged by the tornado. As an exemplar, we selected a group of hardwood trees in front of the Candle Factory. These trees were up to 15m (49 ft) and 30 cm (12 in) at the base. The large trees were stripped of leaves and branches by flying debris leaving only their main trunks. Damage to these trees was consistent with DoD 5 in DI 27 of the 2006 EF-scale with expected failure wind speeds of 65 m/s (145 mph). It is believed that multiple impacts of sheet metal debris from a nearby building aided in the removal of large tree branches and debarking of the trees. Refer to Figure 19 and Table 11.

**Fig. 19.** Hardwood trees south of the Candle Factory: A) Google Street View before the tornado, and B) view of trees after the tornado.

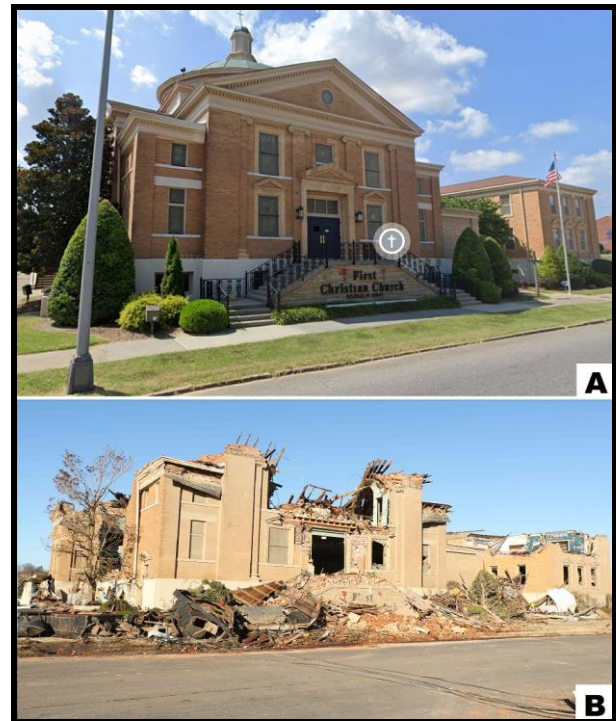
Strong south and west winds passed directly over the church building as the tornado passed causing the domed roof to collapse into the

sanctuary. Much of the second story was removed on the remaining church building, as well as the adjacent office and classroom buildings.

In the 2006 EF-scale, this building would be considered a low-rise building (DI 17) with DoD between 6 and 7. Estimated failure wind speeds to the church building and adjacent buildings would be around 76 m/s (170 mph). We note that winds in the tornado were likely higher. Refer to Figure 20 and Table 12.

**Fig. 20.** First Christian Church in Mayfield: A) Google Street View before the tornado, and B) collapsed domed roof and top story after the tornado.

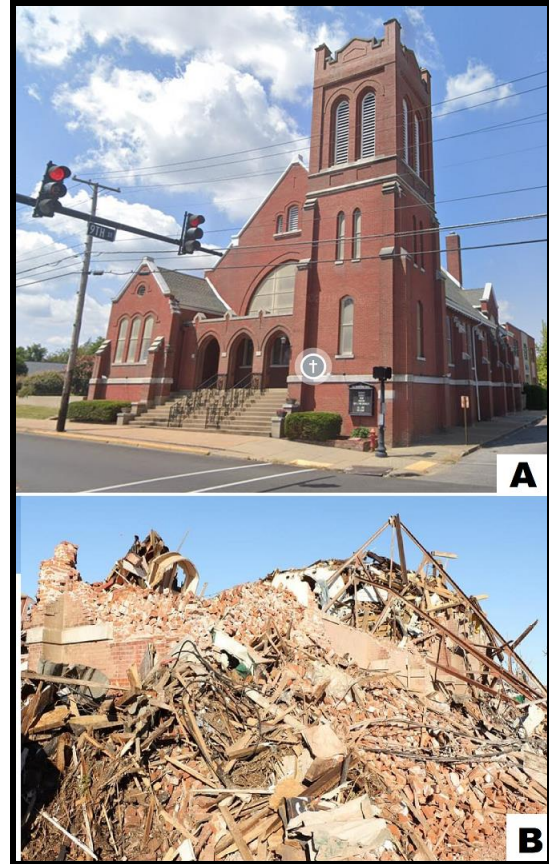
The building was struck with strong south and west winds as the center of the tornado passed causing the sanctuary to collapse to the north and east. Three of the six A-shaped steel roof trusses fell onto north 9<sup>th</sup> Street along with the east masonry wall. Debris remained in close proximity to the site. The bell tower also collapsed. The two-story building to the north of the sanctuary lost its top floor and the metal building also collapsed. Refer to Figure 21.

The current consensus of opinion by the ASCE/SEI/AMS committee is that a religious building with all walls collapsed with pile of debris on the foundation would have an estimated failure windspeed of at least 76 m/s (170 mph). The two-story building north of the sanctuary was considered a low-rise building and the damage, between DoD 6 and 7 in DI 17 in the 2006 EF-scale, would have similar failure windspeeds. Destruction of the metal building would have an estimated failure wind speed of 69 m/s (155 mph).

**Fig. 21.** First Presbyterian Church building in Mayfield: A) Google Street View before the tornado, and B) destroyed building after the tornado.

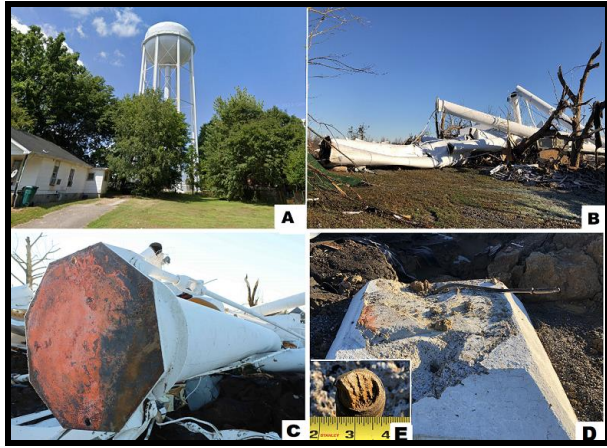
The current consensus of opinion among the ASCE/SEI/AMS committee is that toppled water

towers would have an estimated failure wind speed of around 58 m/s (130 mph).

**Fig. 22.** Mayfield water tower: A) Google Street View before the tornado, and B) collapsed water tower after the tornado, C) hexagonal steel bottom plate of leg, D) broken anchor bolts and concrete pier cap, and E) cup-cone fracture of anchor bolt.
