Timothy P. Marshall, P.E.
Haag Engineering Co.

1. INTRODUCTION

The purpose of this paper is to discuss the characteristics of building damage associated with storm surges. As water rises, a combination of hydrostatic and/or hydrodynamic forces develop on inundated buildings. Wood-framed structures float in water, and movement of water can undermine and dismantle buildings from below. Recognizing how storm surge damages buildings can help damage investigators better separate wind and water damages.

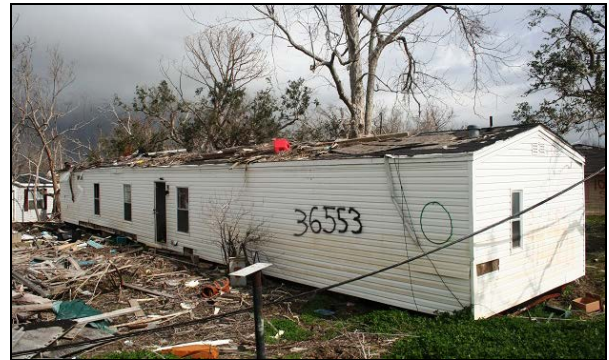
Manufactured homes often are situated in flood-prone areas. Moving water with debris can push homes off their piers and transport them downstream. Manufactured homes will float but eventually break apart as they strike the shore or other floating debris. FEMA (2009a) details how to prevent manufactured homes from being damaged by floodwaters. They indicate that it only takes 10 to 12 cm (4 to 5 in.) of water above the floor to float an unsecured manufactured home off its foundation (Fig. 2).

Figure 2. This manufactured home was moved off its foundation by moving water (not wind) and was stopped by a tree in Venice, LA. Note flotsam and floating debris on the roof as well as the absence of wind-displaced siding.

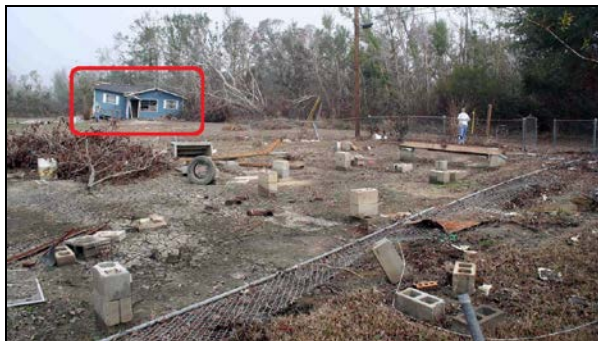
Figure 3. This wood-framed house (red outline) floated landward from its stacked CMU foundation (foreground) where it was stopped by trees in Pass Christian, MS. The home was not picked up and transported by a tornado as some have argued.

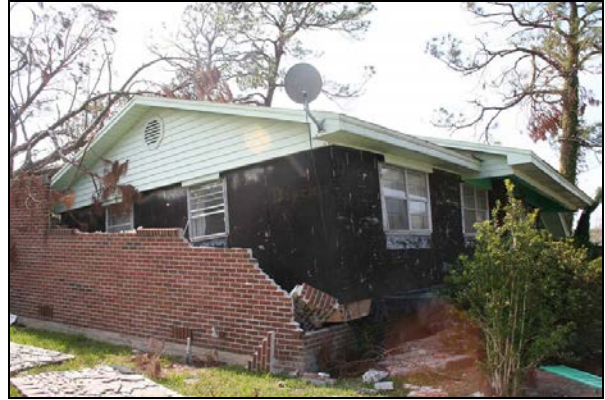
Perimeter masonry veneer also can limit building movement. Wood-frames can rise and fall within the confines of the masonry veneer, especially if the masonry is not well attached to the frame. Such buildings rarely return to their original position, leaving distorted flooring and broken piping. Some have argued that aerodynamic wind forces lifted the buildings. However, careful examination of the crawl space can reveal if the building floated. Look for various debris (i.e. flotsam, insulation, branches, etc.) trapped between the tops of the piers and the flooring indicating the building floated during the flood (Fig. 4).

Figure 4. This wood-framed home in Pass Christian, MS floated within the broken brick veneer shell but did not come back to the same position. This condition was not caused by wind. Note wind did not damage the gable siding or satellite dish.

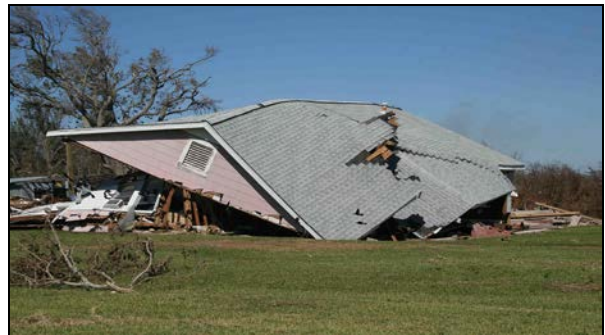
Buildings that are exposed to significant wave action and repeating impacts of floating debris can lose load bearing walls collapsing all or part of the roof. The greatest building damage occurs on the side facing the water. FEMA (1989) points out that such buildings appear “pitched down” toward the water (Fig. 5), a tell-tale sign that water did the damage, not wind. Some have argued that a “downburst” wind crushed the buildings. However, the strongest axis of building construction is downward. The direction of force can be determined by studying failed wall stud connections. Water forces occur at low elevations perpendicular to the downward force direction.

Figure 5. This wood-framed house was undercut by moving water and debris in Bay St. Louis, MS. The house has the typical “pitched-down” appearance toward the water. Note the absence of wind damage to the roof shingles.

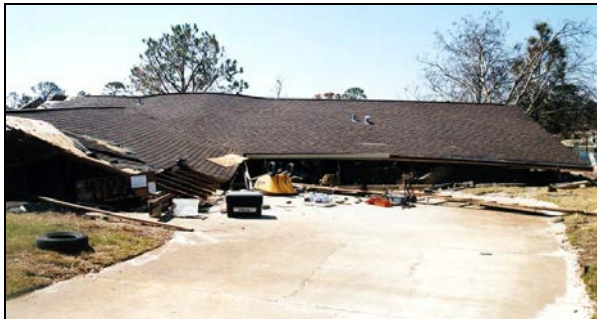
Figure 6. Walls collapsed when this house became submerged in Pensacola, FL leaving the roof upright on the foundation.

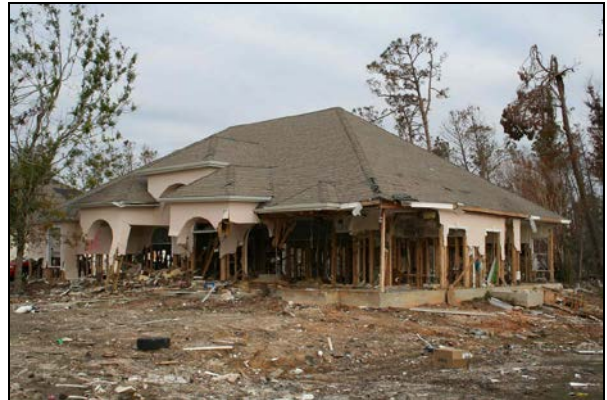
Figure 8. Moving water gutted this wood-framed house on a slab foundation in Long Beach, MS. There was minimal wind-caused damage to the roof shingles.

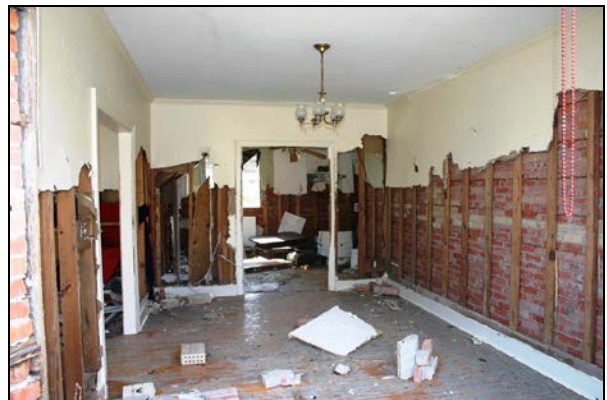
Figure 9. Wave action and floating debris removed the gypsum board sheathing inside this home, not wind. Note the chandelier remained undamaged.

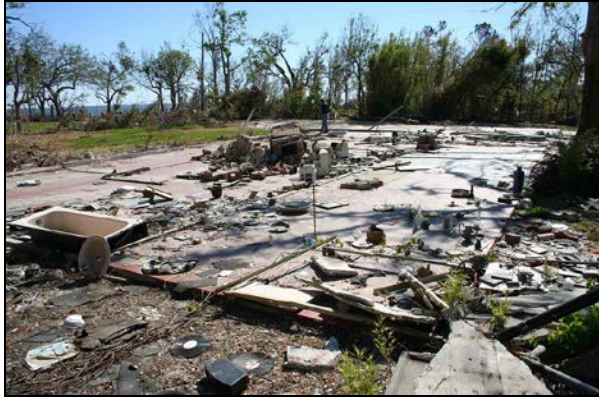
Even when buildings are reduced to concrete slabs, evidence still remains about what caused the destruction. Indications that moving water destroyed the buildings involve finding roof structures remaining upright on the ground with roof shingles still intact. Look for items remaining on the slab, such as bent plumbing, nails, or bolts. These items may give an indication of the direction and magnitude of the low-level forces applied to the base of the building. Also look for unbroken debris deposited nearby, such as glass doors, windows, mirrors, dishes, and lights. The author even has found ceiling fans with the intact blades and unbroken glass globes lying on the ground. The absence of damage to such brittle items resulted when the building was dismantled slowly by wave action and these items fell into the water. Once submerged, such items remained protected (Fig 10).

Figure 10. Storm surge removed the entire building from the property, leaving only heavy items. Unbroken glass items remained on the slab indicating the building was dismantled slowly.

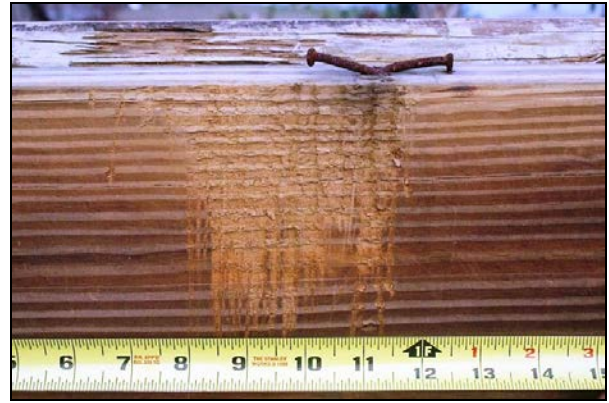
Figure 11. Scrape marks on the side of a floor girder that recorded the bobbing up and down motion of a floor joist that had been toenailed to the top of the girder.

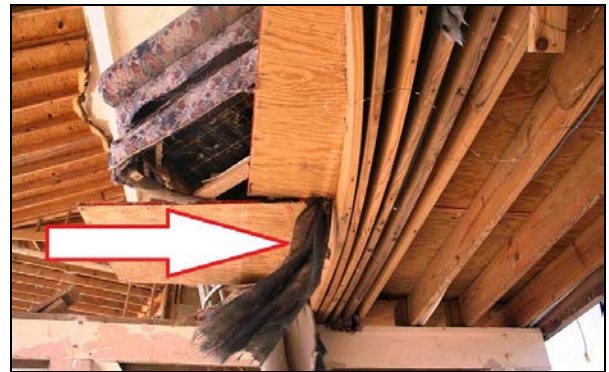
Figure 12. Progressive stacking of floor joists towards the landward side of the building due to the force of moving water and wave action (arrow).

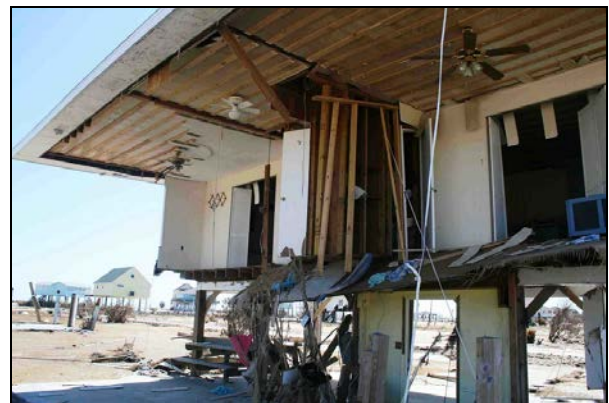
of the floor or roof can be left hanging precariously while items such as ceiling fans and wall hangings remain untouched (Fig. 13). Eventually, all that remains are the pilings and perhaps a few floor girders.

Figure 13. Wave action undermined and removed the floor structure on this elevated wood-framed house on the Bolivar peninsula. Note ceiling fans remained intact.

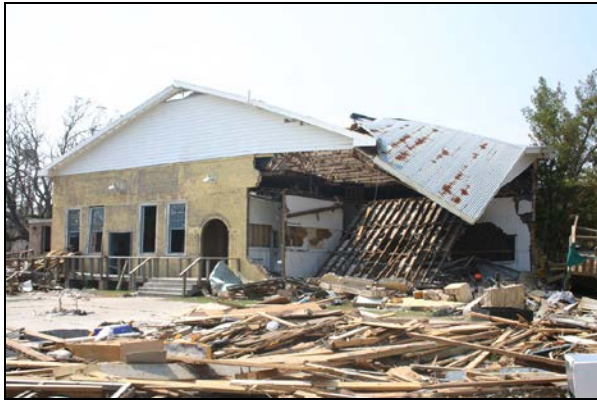
Masonry buildings are vulnerable to damage by moving water as they have little lateral strength. These buildings typically are constructed with brick, hollow clay block, or concrete masonry units (CMUs). Obviously, walls most susceptible to damage would be those perpendicular or broadside to the water flow direction. Collapse of loadbearing masonry walls can lead to partial or total collapse of the roof (Fig. 14). In contrast, wind tends to lift, flip, or remove roof coverings and/or roof structures.

Figure 14. Partial collapse of masonry walls due to moving water and repeated impacts of floating debris in Waveland, MS. There was a 3m water line above the floor inside this building.

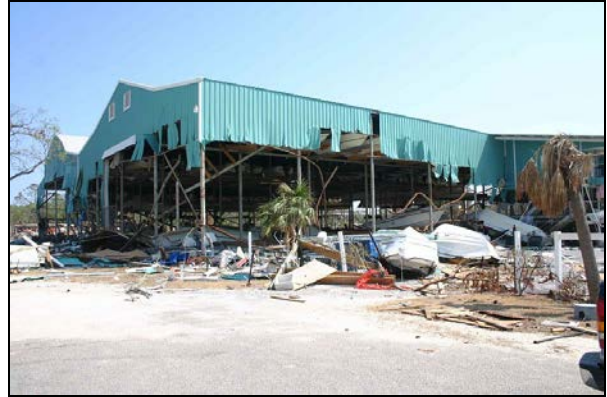
Lateral forces from moving water and repeated impacts of floating debris eventually buckles and removes the panels and girts in the lowest portions of the walls (Fig. 15). Again, water damage is greatest near the bases of buildings. By contrast, wind damage would be concentrated at roof level. Large canopies and doors also would susceptible to wind damage.

Figure 15. Removal of metal wall cladding and girts due to moving water and repeated impacts of floating debris. This building was in Pass Christian, MS.

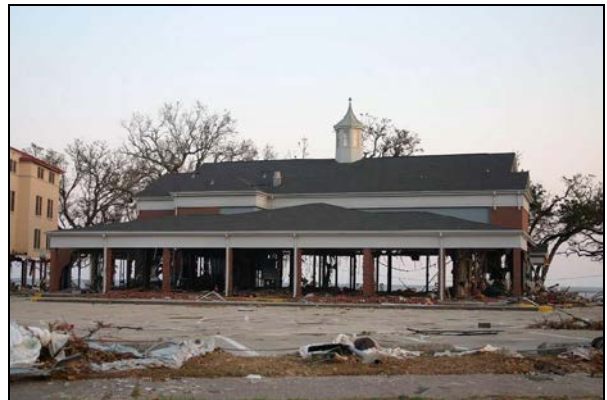
Steel-framed structures have bolted or welded beams and column assemblies. Walls can be clad with a variety of surfaces to include brick, stone, stucco, etc. Lateral forces from moving water and floating debris impacts literally can gut such buildings, removing partition walls and contents (Fig. 16). Although some people have argued that buildings explode due to low barometric pressure during a hurricane or a tornado, such buildings are not sealed tightly enough to result in significant differential pressure effects.

Figure 16. The first story of this steel-framed building was gutted by storm surge in Gulfport, MS. There was no wind damage to the roof covering including the cupola.

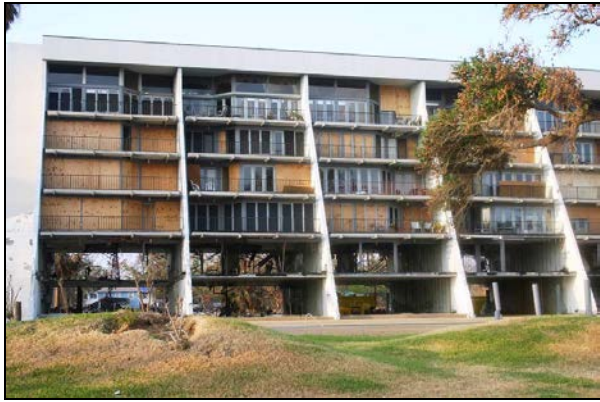
Figure 17. Moving water removed the interior partitions and contents in the lowest stories of this building in Biloxi, MS.

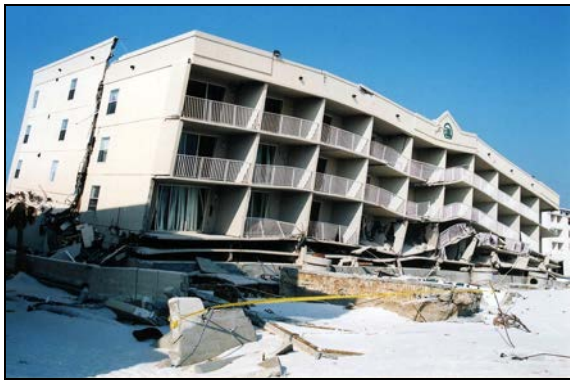
In rare instances, catastrophic structural failures can occur with concrete-framed buildings when loadbearing walls or foundations are compromised (Fig. 18).

Figure 18. Catastrophic collapse of what was a five-story concrete-framed building in Orange Beach, AL. Waves removed the load bearing walls.
