828 Damage Survey and Analysis of the 20 May 2013 Newcastle-Moore EF-5 Tornado

Kiel Ortega^{1,2}, Donald Burgess^{1,2}, Gabriel Garfield^{1,3}, Christopher Karstens^{1,2}, James LaDue⁴, Timothy Marshall⁵, Tiffany Meyer^{1,4}, Brandon Smith^{1,2}, Richard Smith³, Doug Speheger³ and Greg Stumpf^{1,6}

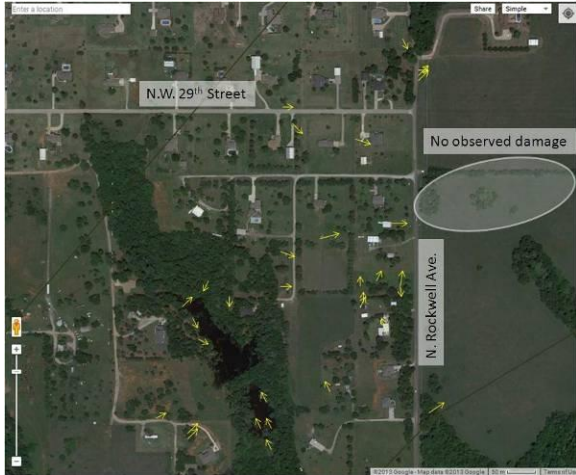
Figure 3: Debris trajectory analysis near N. Rockwell Ave. and N.W. 28th Street in Newcastle. The closest co-located WSR-88D radar volume scan is from KCRI around 1954 UTC.

High-resolution satellite imagery made a tree fall analysis possible. The analysis was completed by one of the authors (Speheger) and revealed an intermittently confluent damage pattern, suggestive of a weak vortex (e.g., Karstens et al. 2013), starting approximately 0.9 km northwest of Highway 76 and N.W. 16th St. There was also a 1.1 km break in consistent damage between Castle Creek Dr. and Kirkham Dr. along N.W. 24th St, even though the location has large areas of trees and several structures located along the path. Another confluent damage pattern was apparent just southwest of the official start location (Fig. 3), with one small shed completely destroyed. However, the path then entered two open fields. The tree line between the fields was observed to not have any damage (Fig. 3).

The KCRI volume collected around 1954 UTC (not shown) yields a much more favorable subjective interrogation, while the percentage pixels exceeding the T1 thresholds increases to 75%. However, the radar data is in contrast to the damage, and lack thereof, found in the area (Fig. 3).

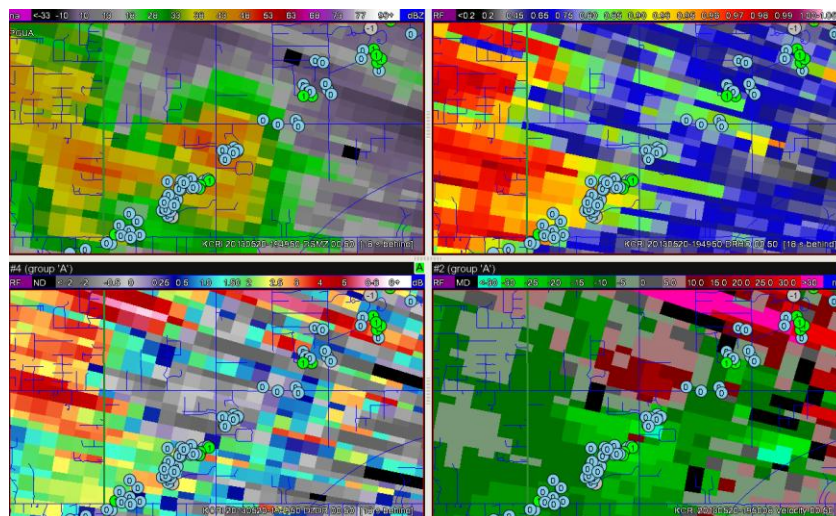
The first volume in which the peak reflectivity within the tip of the hook echo exceeds 43 dBZ was recorded around 1950 UTC by KCRI (Fig. 4). While 50% of the pixels satisfied the reflectivity exceeding 43 dBZ and correlation coefficient less than 0.82, a subjective interrogation of the polarimetric and velocity fields yields a lacking texture, especially within the correlation coefficient field, in identifying tornadic debris.

Figure 4: 0.5° tilt from KCRI around 1950 UTC. Top-left: reflectivity; top-right: correlation coefficient; bottom-left: differential reflectivity; bottom-right: Doppler velocity. All panels have roads (blue), county lines (green) and the damage points overlaid.

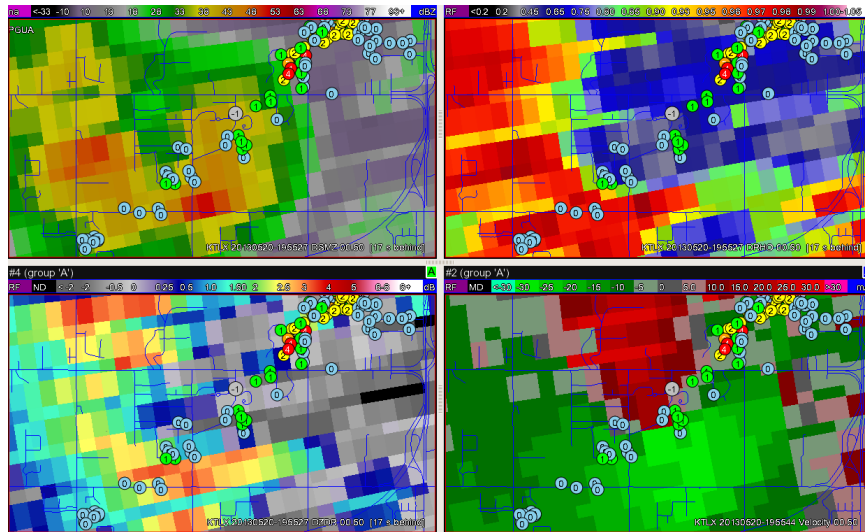
Figure 5: As in Fig. 4, except for the 0.5° tilt from KTLX at 1956 UTC.

though there were more pixels within the vortex. The two volumes also reveal similar results through subjective interrogation as the volumes from KCRI (Fig. 5; 1951 UTC not shown).

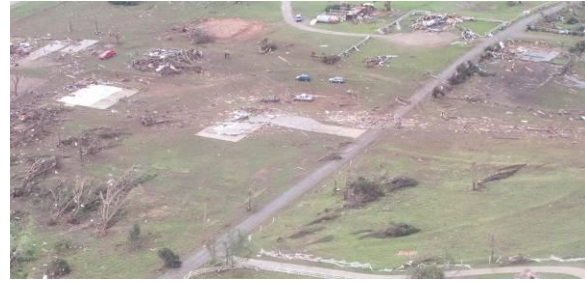
One home along S. Virginia Ave. (2013 UTC) had potential EF5 appearance (swept foundation), however the ground survey found that the base plates were secured using cut concrete nails (Fig. 6). Cut nails have much less pull-out resistance compared to bolts that have properly tightened nuts with washers. This is because the washers help distribute the load on the bottom wall plates over the area of the washers. Bolts also help resist lateral forces which could slide a home off the foundation.

Figure 6: Aerial image of swept foundation. Ground surveys found that the home was only secured to the foundation using cut nails, resulting in EF4 rating.

The surveyors considered any single family home in which the foundation was swept clean for assigning an EF5 rating. The first of such homes was located on S. Virginia Ave. south of S.W. 149th (Fig. 6). While the slab was swept clean and the debris strewn downwind for some

distance, ground surveyors found that the base plates were only secured using concrete nails. Given this exceptionally weak foundation connection, the final rating for the home was EF4. Many homes within the tornado path had weak foundation connections precluding them from possible EF5 assignment (Fig. 10).

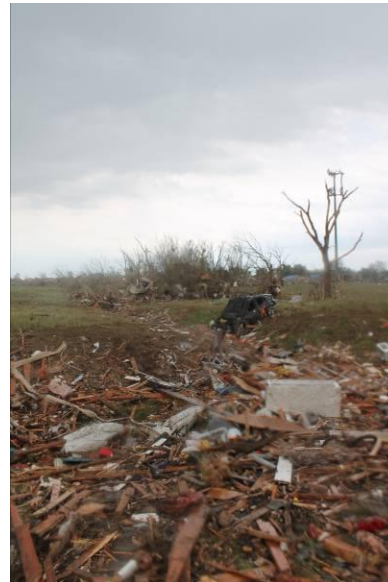
Figure 7: Picture looking down the tornado path from a home swept from its foundation. A denuded tree and lofted vehicle are visible. Another vehicle was lofted past the trees in the background.

rating of some more isolated, higher-end DODs. The EF5-rated residence on Hunters Glen Ct. is an example where context increased confidence in determining the final rating (Fig. 7; LaDue 2011). First, two vehicles from the location were lofted. Second, a tree east of the home was denuded. Third, debris from the home was not found in any large portion and the debris was windrowed towards the east.

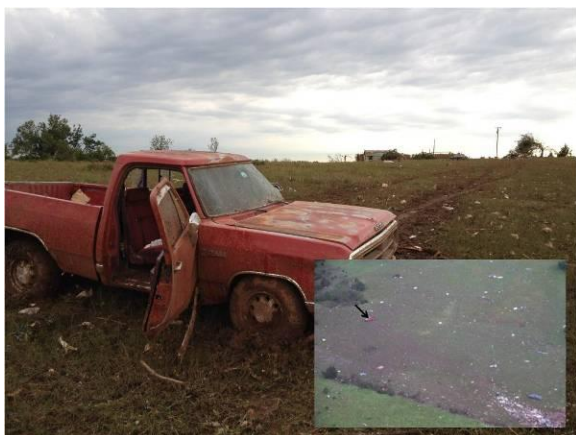
Figure 8: Truck which was displaced by the tornado, however it was not lofted nor tumbled, but slid through a muddy field.

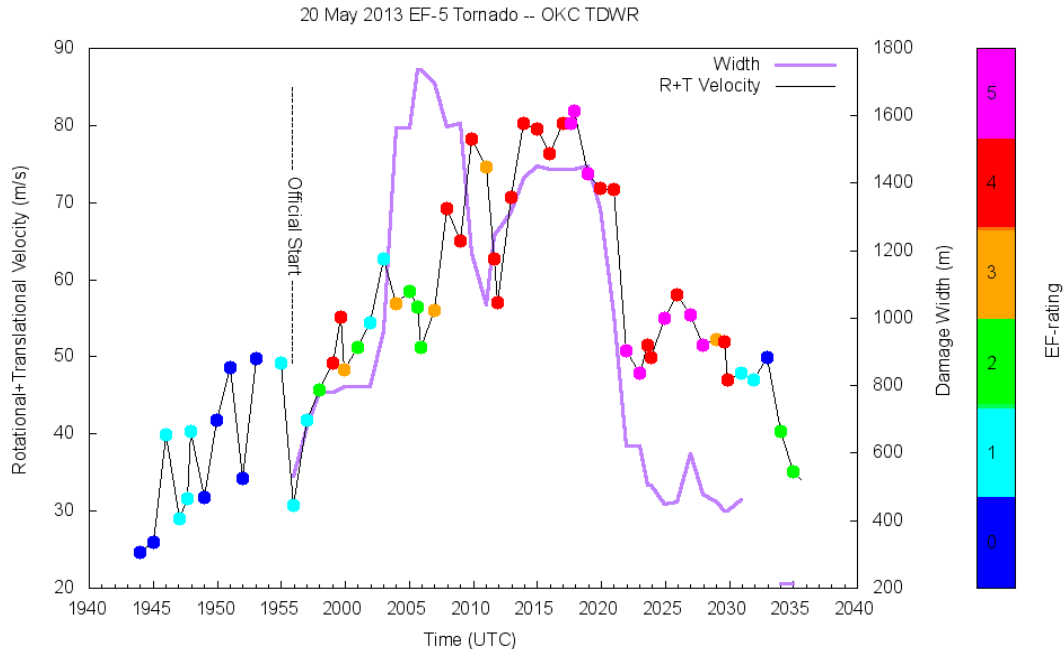
Figure 9: Rotational velocity from TOKC Doppler velocity data with maximum damage and damage width from ground survey information.

Plotted in Figure 9 are the velocity data compared with the damage width and damage

ratings from the ground surveys. Several interesting things are seen in the plot. The first is the presence of EF0- and EF1-ivalent (29+, 38.5+ m/s, respectively) winds prior to the official start of the tornado; then the decrease in winds to near minimum EF0-ivalent at the official start of the tornado. The first EF4 damage was correlated with very modest TOKC velocities (45-50 m/s) compared to EF-scale estimated minimum wind of 74 m/s for EF4 (McDonald et al. 2006). The maximum width of the tornado occurs approximately at 2005 UTC, yet the velocities were fairly moderate (50-55 m/s). While those wind speeds correlate well to the observed damage, it's difficult to make a definite comparison given the lack of substantial DIs between 2001 and 2008 UTC. The peak winds measured by TOKC (81.9 m/s) are co-located with found EF5 level damage at the ground and occur when the tornado is at its closest approach to TOKC (5.1 km; beamwidth of ~115 m). However, the TOKC winds (81.9 m/s) are well short of the 90 m/s wind speed estimate for EF5 damage to occur. Finally, the decrease in tornado width, starting at approximately 2021 UTC, greatly affected the ability of the radar to collect the maximum wind speeds within the

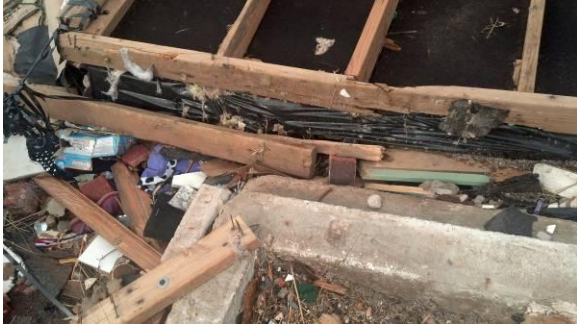
Figure 10: A close up of a home's base-plate-to-foundation connection. Shot pins were used to secure the base plate to the connection, with bolts not even being used in the corners.

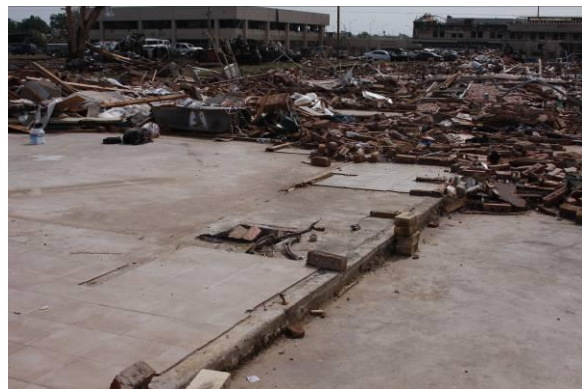
Figure 11: One of 4 homes assigned an EF5 rating near Moore Medical Center. All four homes were swept from their foundations, with removal of base plates and bent anchor bolts. The resident of this home was injured sheltering from the tornado in the bathtub.

connection to the foundation. As is often the case with EF4+ damage in urban areas, determining the wall-rafter connection (and other connections) was not always possible⁷, because the evidence for making such a determination could not be located. In the absence of additional load path information, the construction quality for these structures was deemed compliant with the local building codes. Nevertheless, these structures were considered candidates for the expected value wind speeds associated with residential structures (DI FR12), or 200 mph, resulting in the assigned EF5 ratings.

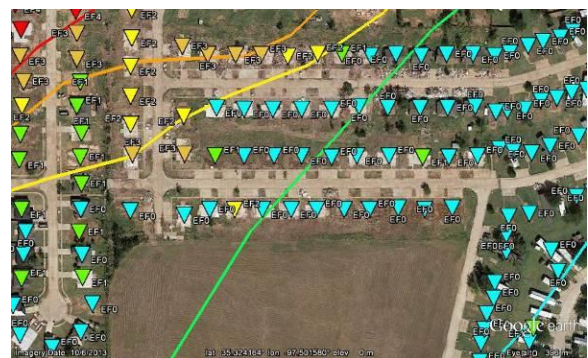
Another possibility is that due to the enormous amount of debris in the air, debris damage was identified in the ground-based and aerial images and marked as wind damage. The magnitude of debris impacts on the periphery of the tornado track is no more apparent than along S.W. 12th, 13th and 14th Sts. between Macalpine St. and S. Janeway Ave. While many of the homes were rated EF0, the severity of damage impacts, which included sizeable holes in roof structures, with all southward facing windows broken, led to most of these EF0 rated duplexes to be demolished (Fig. 12).

Figure 12: Google Earth image showing several EF0 or EF1 rated duplexes which were subsequently demolished due to debris impacts.
