HURRICANE IVAN DAMAGE SURVEY

Timothy P. Marshall*
Haag Engineering Co.
Dallas, Texas

1. INTRODUCTION

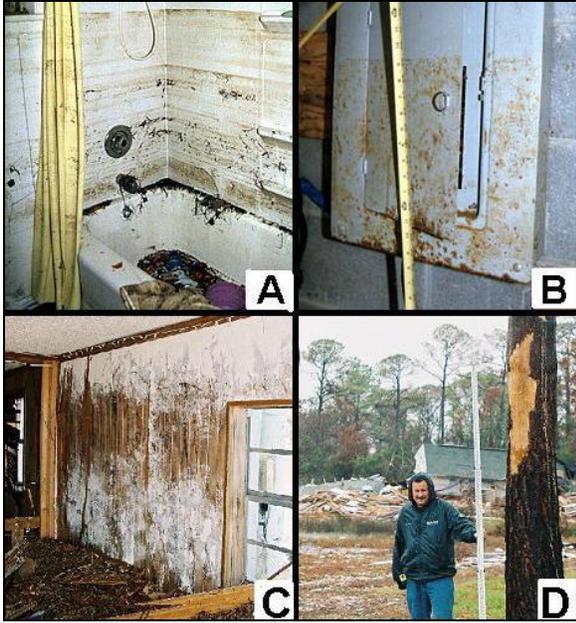
The author measured the height of the storm surge using a surveyor’s level and rod. Still water lines in buildings provided the best estimate of the storm surge level. The line was formed by dirt and debris in the water that was deposited on wall surfaces. Generally, the still water level was found in a room that was not breached by wave action. Occasionally, a line of grime was found deposited on glass items or rust on metal items due to contact with salt water. Sometimes scrape marks were noted in wall surfaces from impacts by floating furniture (Fig. 4).

Figure 4. Indications of the height of water: a) dirt line in bathroom, b) rust line on metal fuse box, c) scrape marks on paneling, and d) scrape marks on trees.

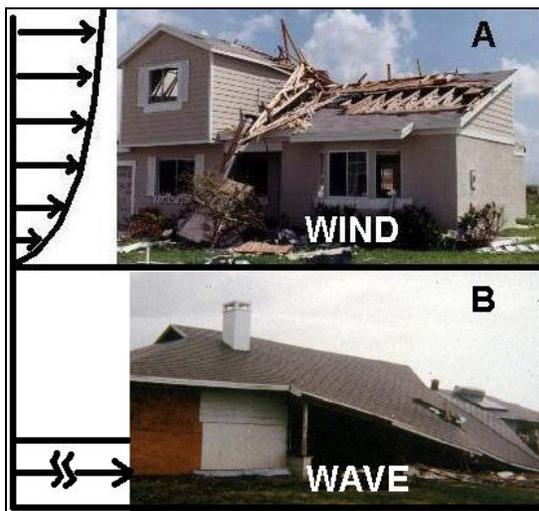
One issue in assessing hurricane damage is whether wind or wave action or a combination of both damaged a building. This issue arises since there are separate insurance policies for wind and wave damage. Not every building owner has both insurance policies. Therefore, an accurate determination of the causes and extent of building damage must be made. Wind and wave forces attack a building differently. Wind forces are greatest at roof level whereas wave forces attack the base of the building (Fig. 9).

Figure 9. Examples of wind (a) and wave (b) damage to housing. Relative forces are illustrated on left with height above the ground.

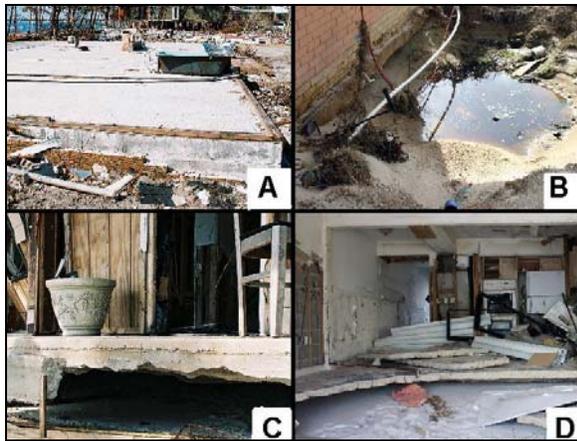
Storm surge destroyed many buildings on slab foundations (Fig. 10). Typically, the building frame was removed from the slab along with most of the contents and finish items. Occasionally, bolted wood plates remained. The force of moving water sometimes removed the carpeting and hardwood flooring. In some cases, sand was scoured adjacent or beneath the slab. The most extensive damage involved collapsing and breaking up of the concrete slab.

Figure 10. Examples of storm surge damage to buildings on concrete slab foundations from Hurricane Ivan: a) cleaning, b) scouring, c) undermining, and d) collapsing.

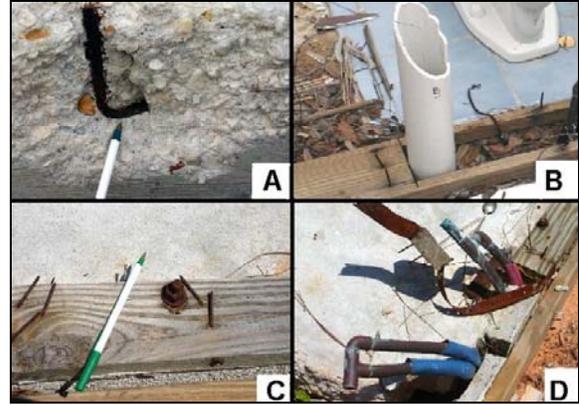
Buildings that were completely destroyed still left evidence as to the direction and magnitude of the applied forces (Fig. 11). Anchor bolts were bent along the direction of the applied force and in some instances, broke out of the leeward side of the concrete slab. Nails that secured the wall studs to the wall bottom plates also were bent along the direction of the applied force. Copper piping was quite malleable and easily bent. Brittle materials such as PVC and cast iron piping frequently were broken out on the opposite side of the applied force.

Figure 11. Indicators of direction and magnitude of the applied force: a) bolt broken out on the leeward side of the slab, b) broken PVC piping from an applied force from left-to-right, c) bent nails on wood bottom plate, and d) bent copper plumbing from a force from right-to-left.

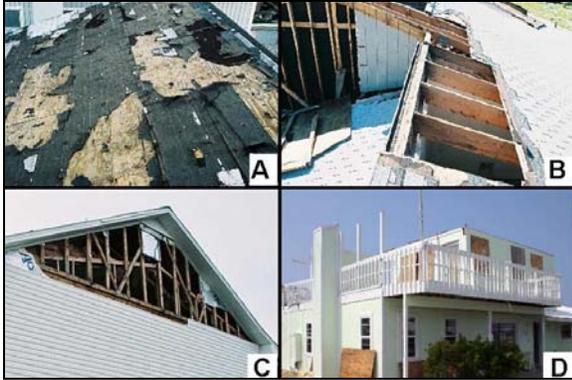
Wind damage to buildings on concrete slab foundations was limited mostly to cladding items such as roof shingles, brick masonry, vinyl siding, or windows (Fig. 12). However, in rare instances, portions of the roof deck were removed and gable ends were either pushed inward or outward. Roof structures were usually strapped to the wall top plates, and therefore, few roofs were removed. The most significant damage to homes from wind occurred indirectly from trees falling on them. Trees penetrated roofs and walls causing localized structural damage as well as rainwater entry. Concrete slab foundations were not damaged by wind.

Figure 12. Examples of wind damage to buildings on concrete slab foundations after Hurricane Ivan: a) displaced roof covering, b) uplift of roof decking, c) removal of gable end/siding, and d) complete roof failure.

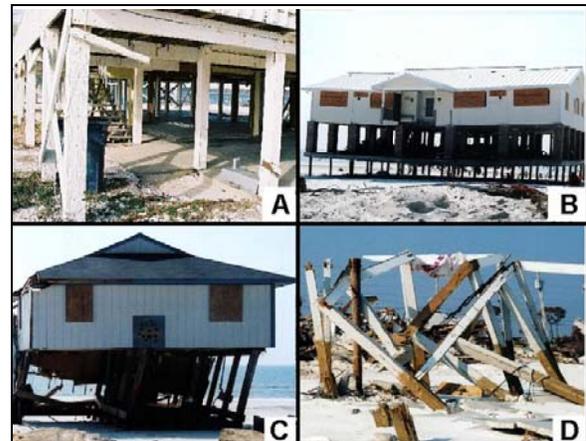
Storm surge damage to buildings elevated on timber pilings varied considerably from none to complete destruction depending on the height of the building above the water, depth of the pilings, and exposure to wave action. Not surprisingly, buildings adjacent to the coast suffered the greatest structural damage from the storm surge. Minor damage involved removal of cross bracing between the pilings. Moderate damage involved eroding sand around the bases of the pilings and rotating the pilings. Concrete slabs around the pilings were left elevated or collapsed when sand was removed. Severe damage involved broken and crushed pilings causing partial or complete collapse of the building. Pilings were some times abraded or scarred by floating debris (Fig. 14).

Figure 14. Damage to pilings from wave action: a) breaking of cross bracing, b) erosion of sand around the pilings, c) rotation of pilings, and d) breaking of pilings.

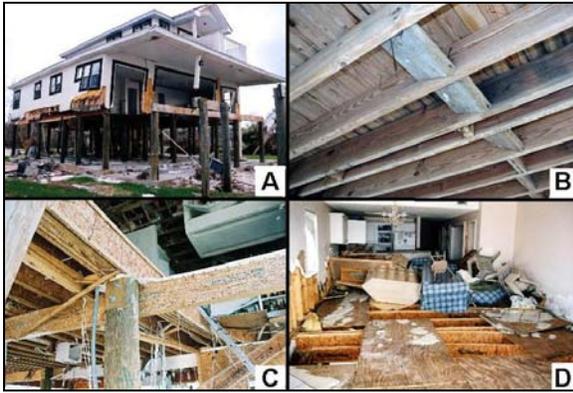
Floor systems exposed to wave action experienced lateral forces from the moving water as well as uplift forces from rolling waves. Minor damage to floor systems involved the bowing of floor girders and/or rotation or removal of blocking between the floor joists.

In some instances, the plywood subfloor was uplifted causing nails to back out of the wood. Moderate damage involved breakage of some of the floor girders and removal of joists along the side of the building that faced the water. Occasionally, bolts that secured the girders were bent landward and/or upward in the direction of the applied force. Some times, lateral wave forces broke the floor joists or pushed them together, stacking them toward the landward side of the building. Uplift forces from rolling waves lifted the joists out of their hangers. Loss of floor support led to progressive collapse of the building with the worst damage occurring on the side of the building that faced the water. The effect of wave action on buildings elevated on pilings was to dismantle them from below (Fig. 15).

Figure 15. Damage to floor systems from wave action: a) loss of floor girders, b) rotation of blocking, c) stacking of floor joists, and d) uplift of the plywood subfloor.

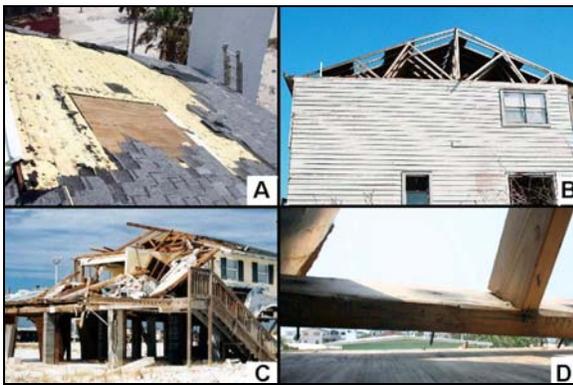
Wind damage to buildings elevated on pilings usually began at roof level with the loss of roof shingles, chimney caps, or antennas. In some instances, portions of the roof deck were removed along windward roof corners and eaves. Wind damage progressed downward, in contrast to wave damage. In rare instances, wind pushed the tops of frame walls inward or outward causing the walls to rotate about their bases. Failure occurred when straight-nailed wall bottom plates simply pulled out of the subfloor. A hinge formed at the base of the wall. Lack of proper strapping and bracing contributed to such wall failures. Floor systems were left unaffected (Fig. 16).

Figure 16. Examples of wind damage to buildings elevated on timber pilings: a) removal of roof covering, b) gable end and roof deck failure, c) windward wall failure, and d) nailed wall bottom plate pulled out of the floor.
