Timothy P. Marshall* and Stuart Robinson

1. INTRODUCTION

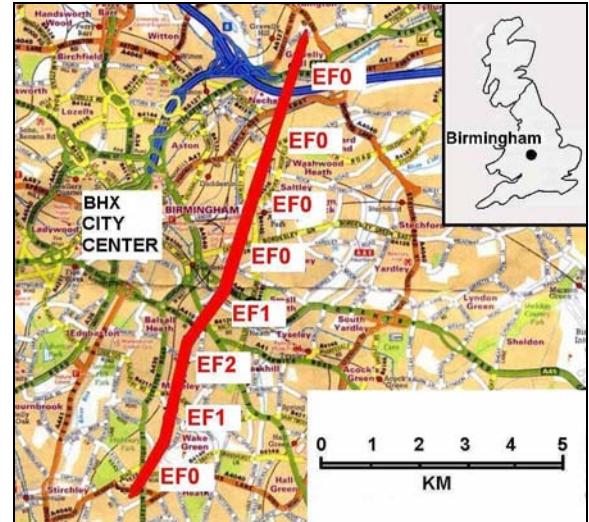
The authors found the damage path extended about 11 km long and varied between 100 and 300m wide. The tornado tracked consistently along a heading 20 degrees east of north, and lasted about 20 minutes (Fig. 7). Tornado damage consisted primarily of displaced roof tiles and downed trees. However, some roofs were completely displaced and vehicles flipped or rolled in the worst damaged areas.

Figure 7. Damage path of the Birmingham U.K. tornado along with EF scale rating.

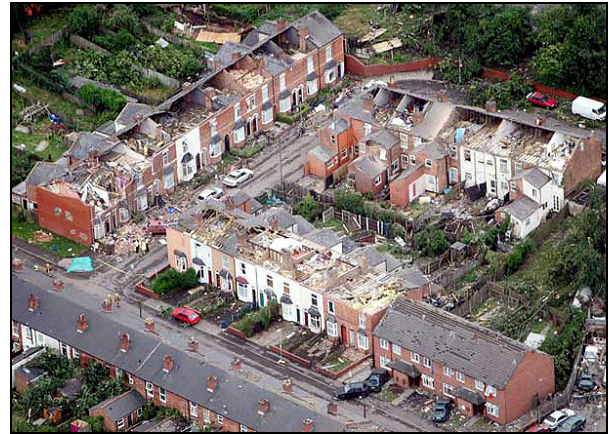
The damage path paralleled Ladypool Road, a densely populated area consisting mostly of two and three-story buildings with businesses on the first story. The most intense damage occurred in the Sparkbrook suburb where dozens of roofs were removed. Three residential buildings, each one block long, lost their roofs along Birchwood and Alder Roads (Fig. 8). Small trucks were tipped over and small cars were flipped or rolled (Fig. 9). The tornado reached its maximum intensity in this area, and was rated EF-2 on the Enhanced Fujita scale (see McDonald 2004) or T-4 on the TORRO scale that is used in Britain (see Meaden 1982). Maximum three-second winds that caused the damage were estimated to be between 50 and 60 ms^{-1} .

Figure 8. Among the most intense tornado damage observed were displaced roofs in the Sparkbrook subdivision only a few kilometers southeast of the Birmingham city center. Photograph courtesy of Adrian Pearman/Caters.

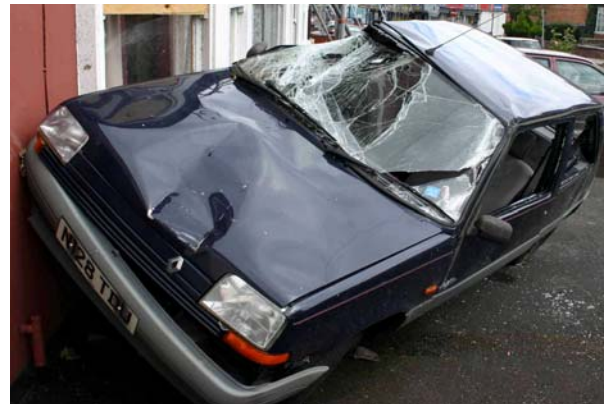
Figure 9. Car rolled over brick retaining wall causing dent in hood and came to rest against a building.

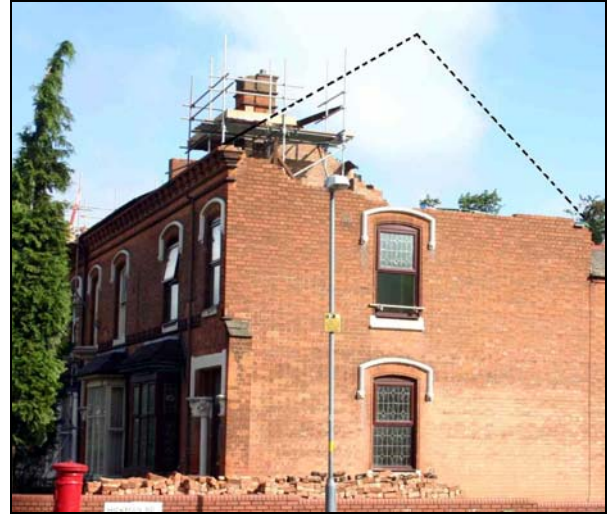
Figure 11. Collapsed brick masonry gable end. Dashed line indicates original roof profile.

The vast majority of roof structures were built to take the weight of the heavy roof down through the brick masonry walls. In general, there was little in the way of lateral support for gable masonry or resistance of the roof structure to wind uplift. As a result, wind toppled loadbearing gables causing roofs to collapse. Also, the tops of some brick masonry chimneys had fallen into the buildings penetrating the floors ending up on the first stories. Falling masonry was definitely a hazard to people and it was amazing that more people were not injured.

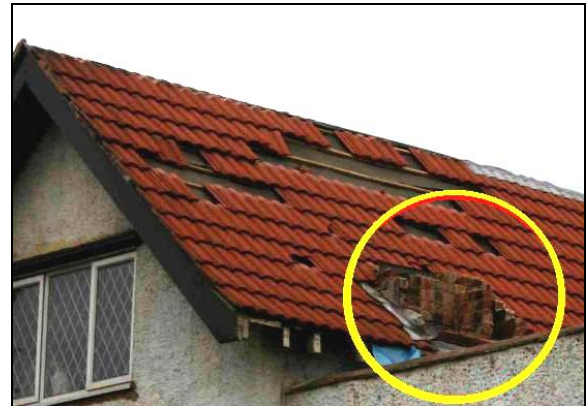
Figure 12. Loss of brick masonry chimney (circled) along with roof tiles.

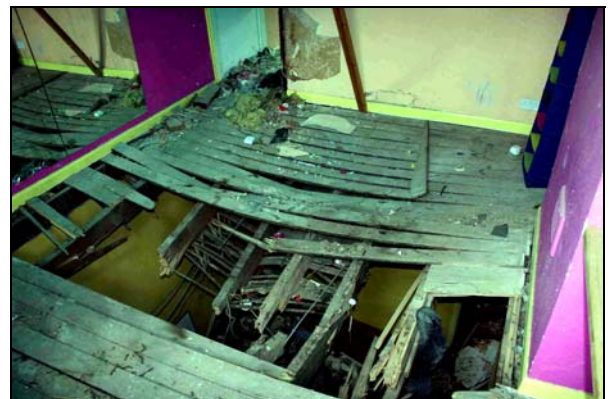
Figure 13. Chimney collapsed through upper floors ending on the first story.

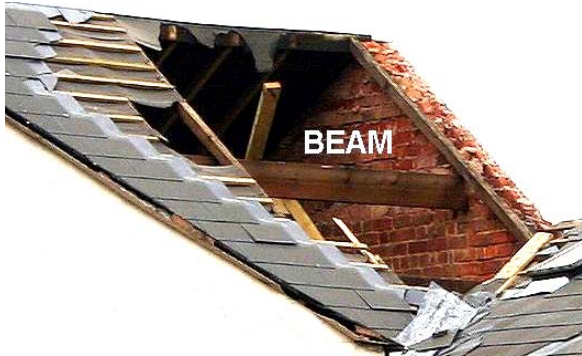
Close examination of the wall top plates revealed considerable corrosion of the nailed connections. In some instances, the nails broke or crumbled whereas in other instances the rafters pulled out of the wall top plates leaving the nails intact. Many of the buildings damaged by the tornado were old, some built more than one hundred years ago. However, some of the newer built buildings were built better with metal clips securing the rafters to the wall top plates.

Figure 14. Rafters were uplifted from the roof beams.

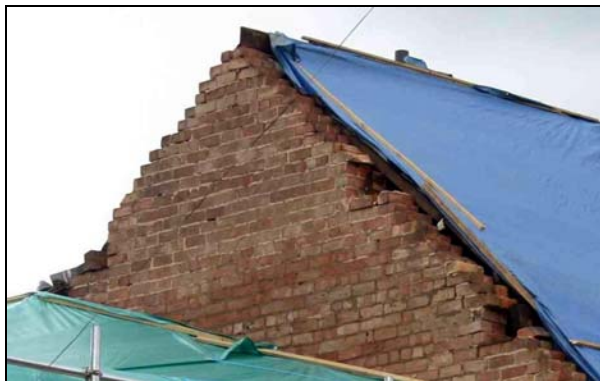
Roof structures were wood-framed. Generally, rafters and joists were nailed to wall top plates and the plates were anchored to the tops of the masonry walls. Rafters were nailed every three to four meters to wooden cross beams or purlins. The beams were then slotted into and supported by the brick masonry gable ends. Such construction worked well for carrying the heavy weight of the roof covering to the walls, however, these roof structures were susceptible to being uplifted by the wind. In some instances, the rafters pulled apart from the beams while in other instances, the beams were uplifted from the gable end masonry (Figs. 14 and 15). Only a few courses of brick had been placed over the slotted purlins, but this did little in the way of resisting wind uplift forces.

Figure 15. Roof beams were uplifted from slots or pockets in the gable masonry.

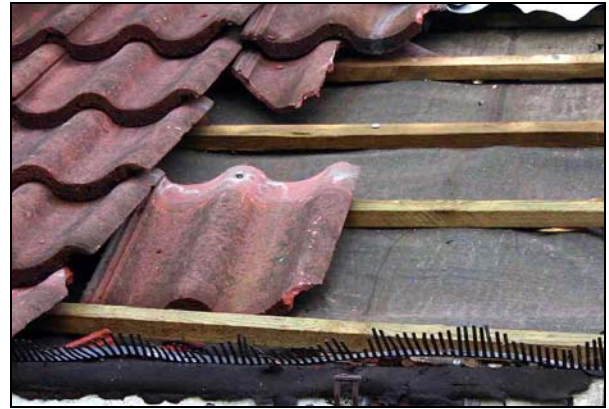
Figure 16. Only the tops of double S-shaped concrete tiles were nailed to wood battens. Thus, the bottoms of the tiles could be lifted relatively easily by wind prying the tiles from the battens.

Another problem was that the tops of roofing slates or tiles were nailed or hung on battens making them relatively easy to be uplifted by the wind. Some slates/tiles weighed 5 kg and became airborne impacting buildings and vehicles downwind. Patterns were noted in the locations of displaced roofing indicating the direction of the wind. Slates/tiles were most susceptible to being displaced at windward corners, eaves, and rakes as well as in areas where the wind accelerated around chimneys.

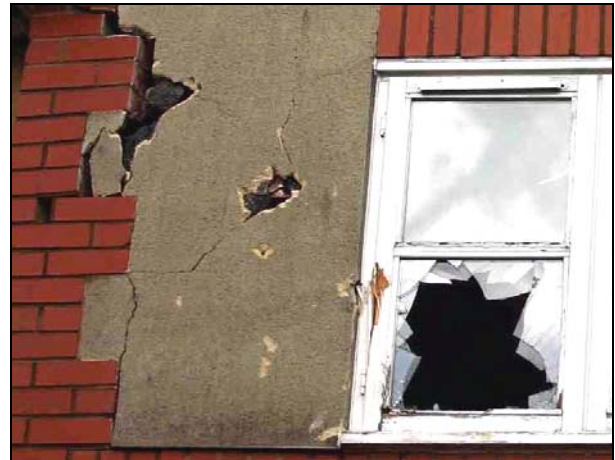
Figure 17. Impact marks on south side of residence from flying roof debris.

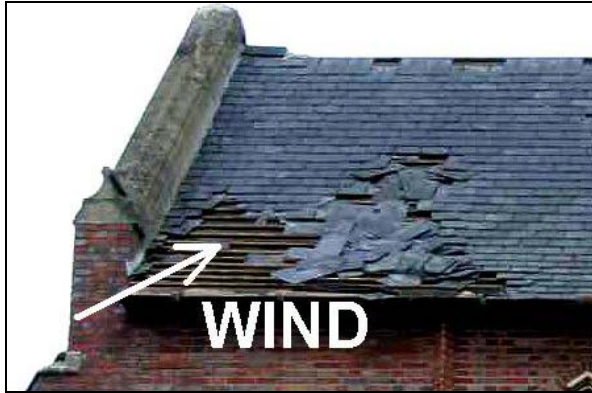
The most susceptible areas for removal of the roof coverings were along windward eaves, corners, rakes, and around chimneys where wind accelerated creating larger uplift forces (Figs. 18 through 20). Thus, it was possible to determine the wind direction from looking at the pattern of displaced roofing.

Figure 18. Slates removed from windward corner.

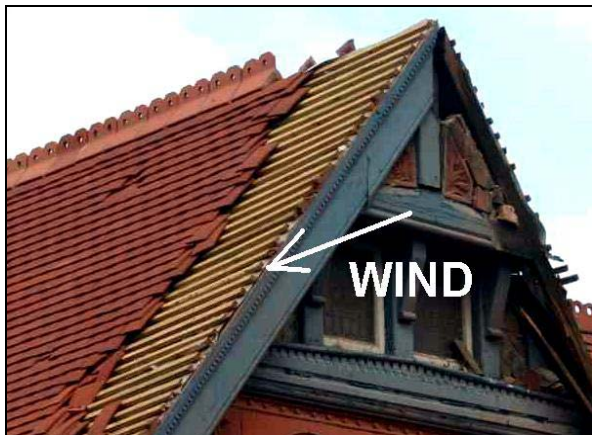
Figure 19. Clay tiles removed from windward rake.

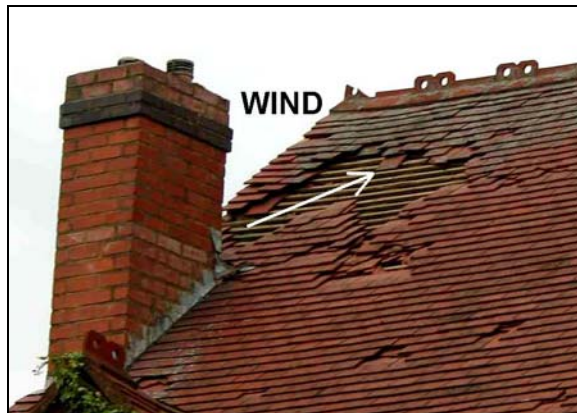
Figure 20. Clay tiles displaced due to acceleration of wind around chimney.
