8B.3

Damage survey of the Greensburg, KS tornado

Timothy P. Marshall*
Haag Engineering Co.
Dallas, TX

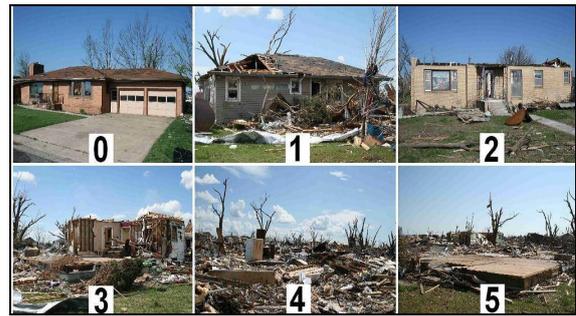
EF-scale numbers were assigned to 662 homes based on increasing severity of the damage (Fig. 3). Degrees of damage (DOD) descriptions were followed in accordance with those developed by the Wind Science and Engineering Center (2006). Homes were rated EF-0 if they had some damage to their roof coverings and/or lost some of their vinyl or metal siding (DOD=2). A rating of EF-1 was assigned to those homes that lost most of their roof covering and/or had minor structural damage to the roof such as displaced gable ends or loss of some roof decking (DOD=4). Homes were rated EF-2 if they had lost most of their roof structure but the walls remained standing (DOD=6). A rating of EF-3 was given to homes that lost most of their walls (DOD=8). An EF-4 rating was given to those homes that had all walls down and a pile of debris remaining on their foundation (DOD=9). EF-5 ratings were given to anchored homes that were swept clean from their foundations (DOD=10).

Figure 3. Examples of EF-scale damage ratings to homes in Greensburg, KS.

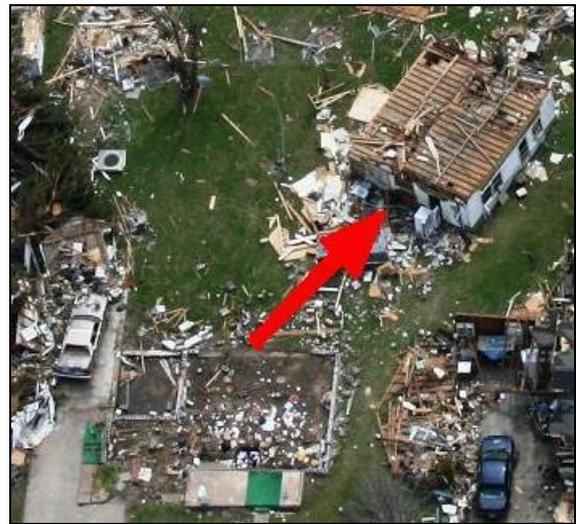
We encountered 53 homes that slid off their block foundations (Fig. 4). These homes were rated EF-2 or assigned an EF number of the adjacent home that did not slide off its foundation. In addition, about one dozen homes were not rated as homeowners already had cleared the debris from their foundations.

Figure 4. Example showing a home that was "swept clean" from its foundation that was rated EF-2 based the removal of its roof. Note vehicle remained within the destroyed garage.

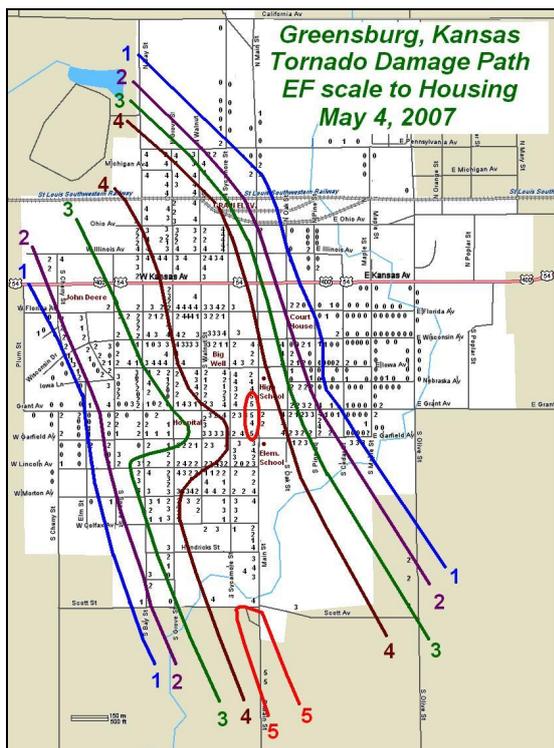
The results of our house to house survey are presented in Table 1 and plotted in Figure 5. EF-0 damage occurred to 194 homes. These homes were located on the periphery of the damage track, along the east and west edges of town. EF-1 damage occurred to 74 homes, while 177 homes had EF-2 damage. It was found that homes were more apt to lose their entire roof rather than a portion of the roof by a factor of more than 2 to 1. We found approximately the same number of EF-3 and EF-4 damaged homes. Only seven homes were found with EF-5 damage.

Figure 5. Plot of EF-scale damage to housing, with contours. Considerable smoothing had to be done to draw the contours given the large variability in housing performance.

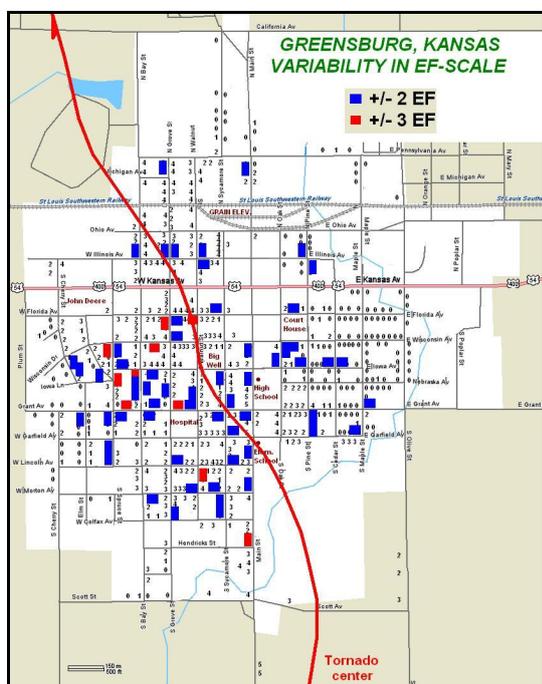
As expected, the degree of damage to homes was more severe on the east side of the tornado track than on the west side. However, the variability in EF-scale ratings was greater on the west side of the tornado track (Fig. 6).

Figure 6. Variability in EF-scale ratings. Blue boxes indicated a difference of two in adjacent homes and red boxes indicate a difference of three.

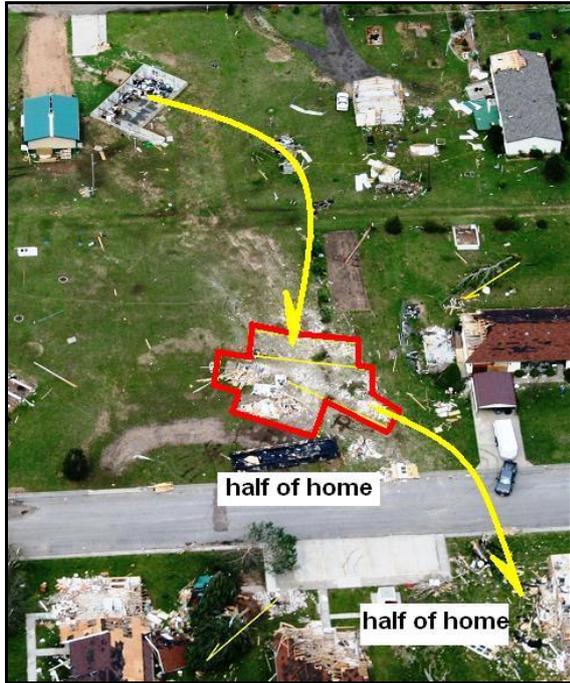
In general, the manufactured homes performed poorly in the tornado winds regardless of the size of the home. Refer to Table 2. Unanchored manufactured homes were common and these homes rolled, vaulted, or were lofted. A total of 28 manufactured homes, or 72 percent, were destroyed and as such, provided no occupant protection. By comparison, only 17 percent of “permanent” homes had been damaged in Greensburg to the point where they provided no occupant protection. Many of the destroyed manufactured homes were adjacent to “permanent” homes that only experienced EF-0 to EF-2 damage (Fig. 7). In certain instances, the steel frames from the manufactured homes were lofted downwind and struck other buildings. This finding underscores the importance that manufactured homes are not safe havens in tornadoes.

Figure 7. Lofting of unanchored, double wide manufactured home in area where residences experienced only EF-0 to EF-2 damage.

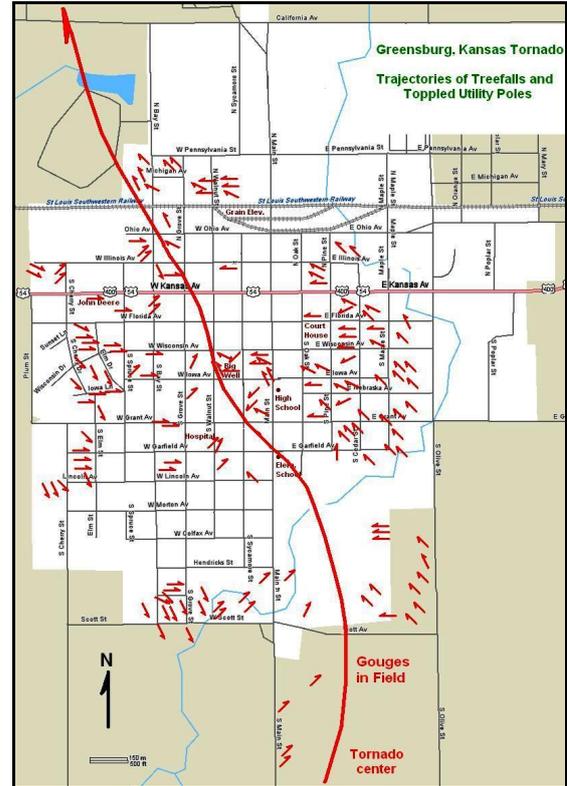
We plotted damage vectors of 155 downed trees and utility poles which revealed the broad cyclonic wind flow of the tornado (Fig. 8). A sharp convergence line was found oriented southeast-to-northwest extending through the middle of town. Most trees and utility poles were toppled to the west or northwest east of the convergence line whereas most trees and utility poles were toppled to the east and southeast west of the convergence line. Trees with large branches broken were rated EF-0 (DOD=2), trees uprooted or snapped were rated EF-1 (DOD 3 and 4), and trees that were debarked with only stubs of the trunks remaining were rated EF-2 (DOD=5). Many trees near the center convergence line were debarked and lost their largest branches leaving trunk stubs.

Figure 8. A plot of damage vectors of 155 downed trees and utility poles.

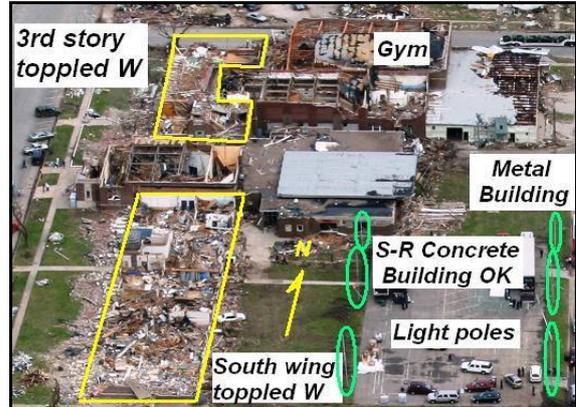
Greensburg High School consisted of several interconnecting buildings (Fig. 9). Walls were three wythes thick of unreinforced masonry. The main building was three stories with a one-story south wing. Roof structures were wood or steel. A steel-reinforced concrete structure and metal building extended from east side of the High School.

The High School was located about one block east of the convergence line and experienced the strongest winds from the south through east. Walls in the top story of the main building and south wing were broadsided by the strongest winds and collapsed to the west. The heavy masonry walls on the east side of the school fell inward into the classrooms whereas the west walls fell outward. Close examination revealed the walls failed about hinge lines that occurred at the level of the window sills (Figs. 10 and 11). The lack of columns with vertical steel reinforcement between the windows resulted in walls that lacked sufficient strength to resist lateral wind loads. Still, the degree of damage to the High School yielded an EF-4 rating.

Figure 9. Aerial view of the Greensburg High School looking north. Unreinforced masonry walls collapsed (yellow outlines) to the west whereas the steel reinforced concrete building remained intact.

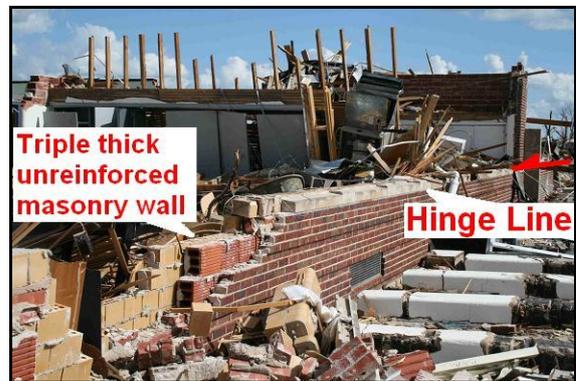
Figure 10. West wall of south wing fell outward rotating about the base of the windows. Red arrow indicates hinge line.

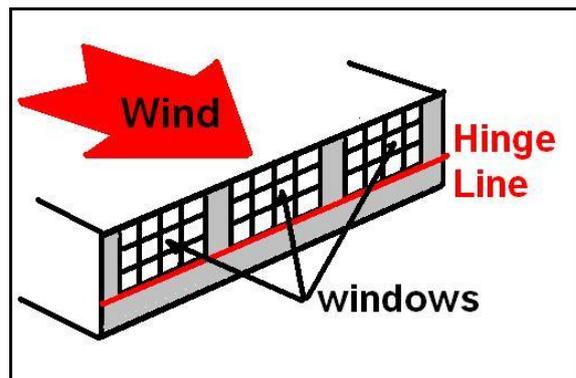
Figure 11. Illustration of how unreinforced masonry walls failed on schools. Walls rotated about hinge lines at the bases of the windows.

Specific study of the damage to the High School and Elementary School revealed weak points in the construction of unreinforced masonry walls. In particular, hinge lines formed at the bases of windows causing the walls to topple. Damage to these schools was characteristic of an EF-4 rating. Even the better built hospital sustained significant damage as roof components were not anchored. There was good correlation between the calculated wind load to lift the concrete roof beam and the EF rating.

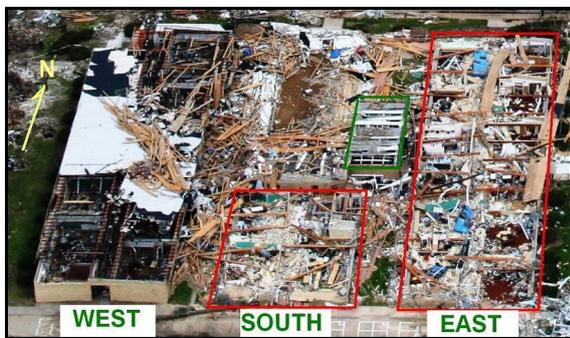
Delmer Day Elementary School consisted of four, single-story interconnected structures that were oriented north-south (Fig. 12). Walls were two wythes thick of unreinforced masonry. The east and south portion of the building had a wood framed roof structure consisting of glulam beams. The beams were attached to the top of the masonry walls with J-bolts. The north and west portions of the building had steel-framed roof structure. Open web steel joists were welded to a steel angle that was secured to a wooden top plate anchored to the tops of the masonry walls with J-bolts.

The school was located just east of the convergence line and experienced the strongest winds from the south through east. Just as with the High School, the east and west walls were broadsided by the strongest winds and collapsed to the west in the east and south buildings. The masonry walls on the east side of the school fell inward into the classrooms whereas the west walls fell outward. Close examination revealed the walls failed about hinge lines that occurred at the level of the window sills just like the High School (Fig. 13). The lack of columns with vertical steel reinforcement between the windows resulted in walls that lacked sufficient strength to resist lateral wind loads. Still, the degree of damage to the Elementary school yielded an EF-4 rating.

Figure 12. Aerial view of the Delmer Day Elementary School looking north. Unreinforced masonry walls (red outlines) collapsed to the west.

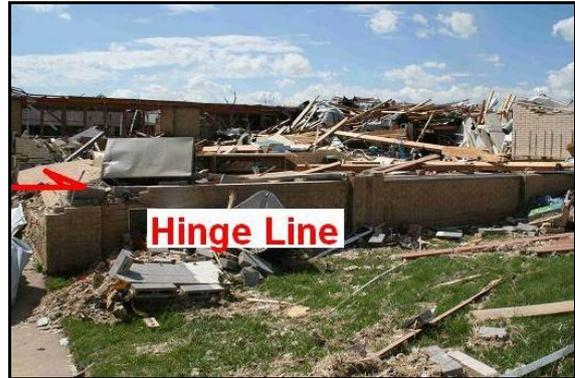
Figure 13. East wall of the South building toppled inward rotating about the base of the windows. Red arrow indicates hinge line.

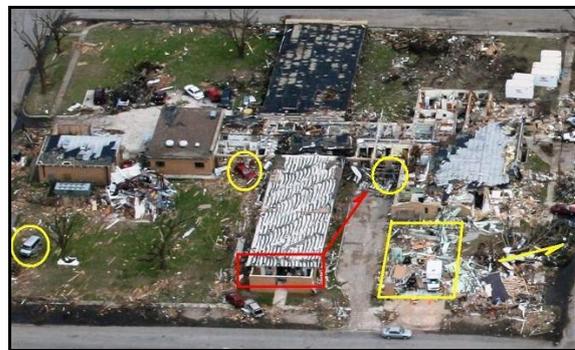
The Kiowa County Memorial Hospital consisted of four interconnected structures and a detached garage (Fig. 14). Walls were two wythes thick of masonry with vertical steel reinforcement at the wall corners. North, south, and west wings (including the detached garage) had steel-reinforced concrete bond beams located at the tops of the walls. Steel-reinforced concrete tee beams spanned these structures but were not anchored to the bond beams (Fig. 15). The remaining center and east wings had wood-framed roof structures.

Figure 14. Aerial view of the Kiowa County Memorial Hospital looking north. Moved cars are circled. A displaced concrete tee beam (red outline) and collapsed garage (yellow outline) are noted.

The hospital was located about one block to the west of the convergence line and experienced the strongest winds from the west-southwest. Several vehicles in the parking lot were moved to the north. One of the concrete tee beams at the south end of the south wing was uplifted and deposited on a vehicle to the northeast. According to FEMA (2007), the beam weighed approximately 4500 kg. They calculated a wind velocity of 66 ms^{-1} to lift the beam. By comparison, the expected value for wind to uplift such a beam is 64 ms^{-1} according to the EF-scale. Damage to the hospital was indicative of an EF-3 rating.

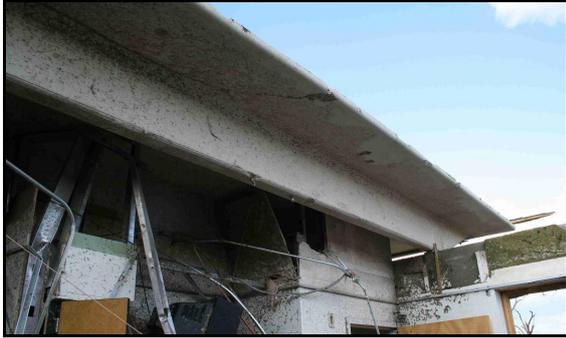
Figure 15. Wind removed a 4500 kg steel-reinforced concrete roof beam on the hospital.
