**ELIE, MANITOBA, CANADA, JUNE 22, 2007:
CANADA'S FIRST F5 TORNADO**

Patrick J. McCarthy*, D. Carlsen, and J. Slipec
Prairie and Arctic Storm Prediction Centre
Meteorological Service of Canada
Environment Canada

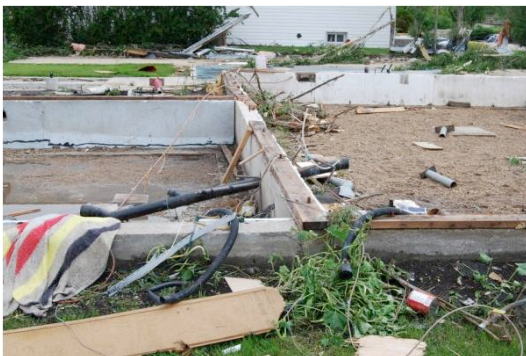
The easternmost destroyed house (#1), was completely swept away, including the floor joists (figure 1). Other than a few small building fragments, there was no debris anywhere on the property. The home immediately to its east suffered damage consistent with F1 intensity, while the home immediately to the west (house #2) was completely destroyed. House #1 had no basement.

Figure 1. Foundation of House #1.

Some parts of the sill plate remained attached to the foundation (figures 1 and 2). The sill plate was bolted to the foundation

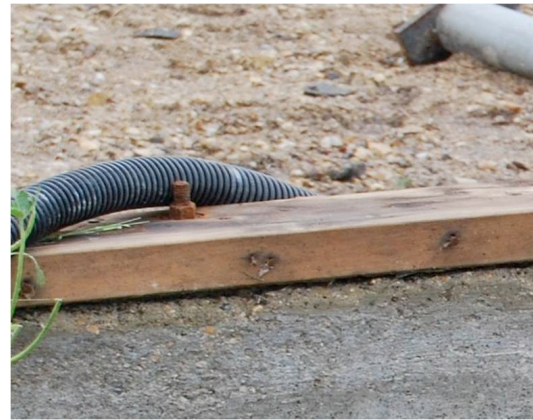
with slightly larger than standard J-bolt-type anchors. Large heavy washers were also used. The sill plates were 2x6 and markings on the top of these plates suggested the home was of 2x6 construction. This form of construction is typical in Manitoba, due to the need for extra insulation for the cold prairie winters. However, 2x6 construction was less common 30 years ago.

Figure 2. Sill plate with anchor bolt still attached to the foundation on House #1.

There was no evidence of any rotting of house #1's remaining sill plates. Some of the plates appeared to have shattered under great stress. Where sill plates were missing, a few bolts had been sheared off while others were bent towards the north or northwest. Some bolts remained vertical. Many of the washers on the remaining sill plates were freshly recessed, suggesting that the sill plate was being pulled upward. All of this evidence pointed to the walls of the home being well attached to the sill plate. Preliminary assessment was strong F4 damage, though there was some discussion of a possible F5 rating. Fortunately no one was in the home at the time of the tornado as the level of destruction appeared not to be survivable.

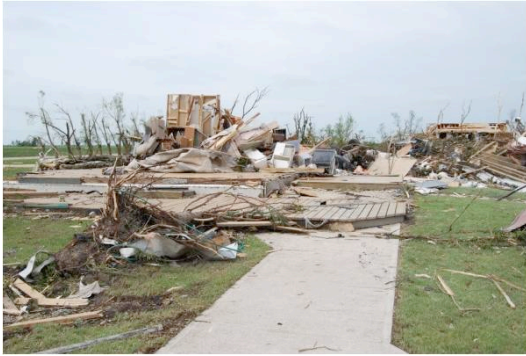
House #2 (figure 3), immediately to west of house #1, was almost completely obliterated. Only a small piece of an outside wall attached to a fireplace hearth remained standing. The main floor joists, which had been set in the foundation during construction, remained intact. Some debris remained nearby and on the main floor against the wall fragment. The home appeared to have 2x4 wall construction. Preliminary assessment of the home was

strong F3 to weak F4. No one was in the home at the time of the tornado.

Figure 3. Remnants of House #2.

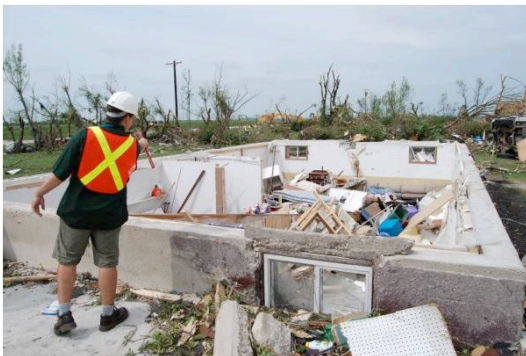
The next home to the west (house #3) was completely gone with only the open basement remaining (figure 4). There were no notable pieces of the home on the property.

There were no sill plates remaining on the poured concrete foundation, nor was there evidence that anchor bolts were used. However, the main cross beam supporting the floor joists appeared to have been attached the basement walls.

The attached garage sill plates had been bolted to the garage concrete floor. Some of the pressure treated sill plates remained. These plates also showed evidence of the washers having become freshly recessed. Preliminary assessment of this home's damage was weak F4. People in this home at the time of the tornado took shelter in the basement and survived without serious injury.

Figure 4. Foundation of House #3.

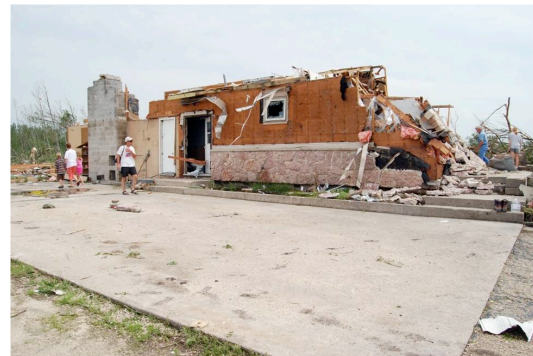
House #4 (figure 5) just to the west of house #3, was the south-westernmost building in the town of Elie. At the time of the investigation, it was believed that this was the first of the four destroyed homes to be struck by the tornado.

This house still had some exterior walls and a portion of the roof intact. The floor joists had been set into the concrete foundation during construction. The joists were attached to the rim joints which were in turn bolted to the exterior of the foundation. The flooring and walls were attached to this structure. The exterior sheathing was plywood. This extremely well built home was given a preliminary damage rating of Strong F2 to possibly weak F3.

Figure 5. Remains of House #4.

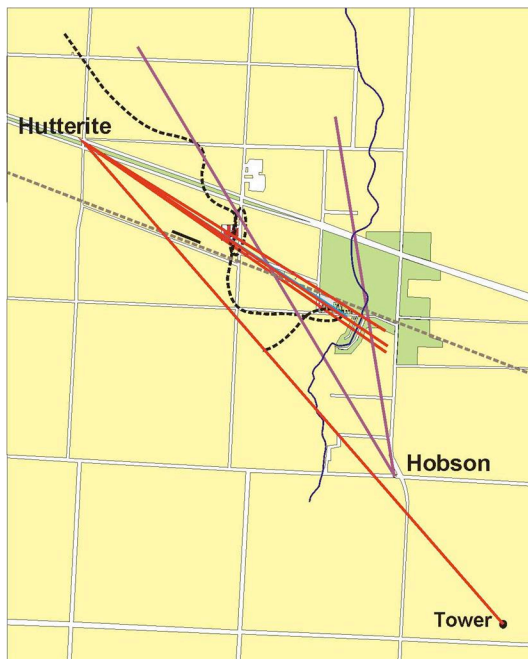
Using the GPS landmarks, sight-lines were projected from the videographers' positions (figure 6) through the tornado's near-surface mid-point on a detailed digital map of the area. Once common positions were determined, the two videos were synchronized to the time. Since one of the two videos was not continuous, the videos had to be resynchronized when necessary. To confirm the synchronization was accurate, notable flying debris or specific events were tracked.

Figure 6. Example of video triangulation work. "Hutterite" and "Hobson" refer to videographer locations. The town of Elie is the green shaded area. "Tower" refers to a transmission tower landmark. The curving black dashed line represents the entire tornado track. The lines represent the some of the sight-lines used for the triangulation.

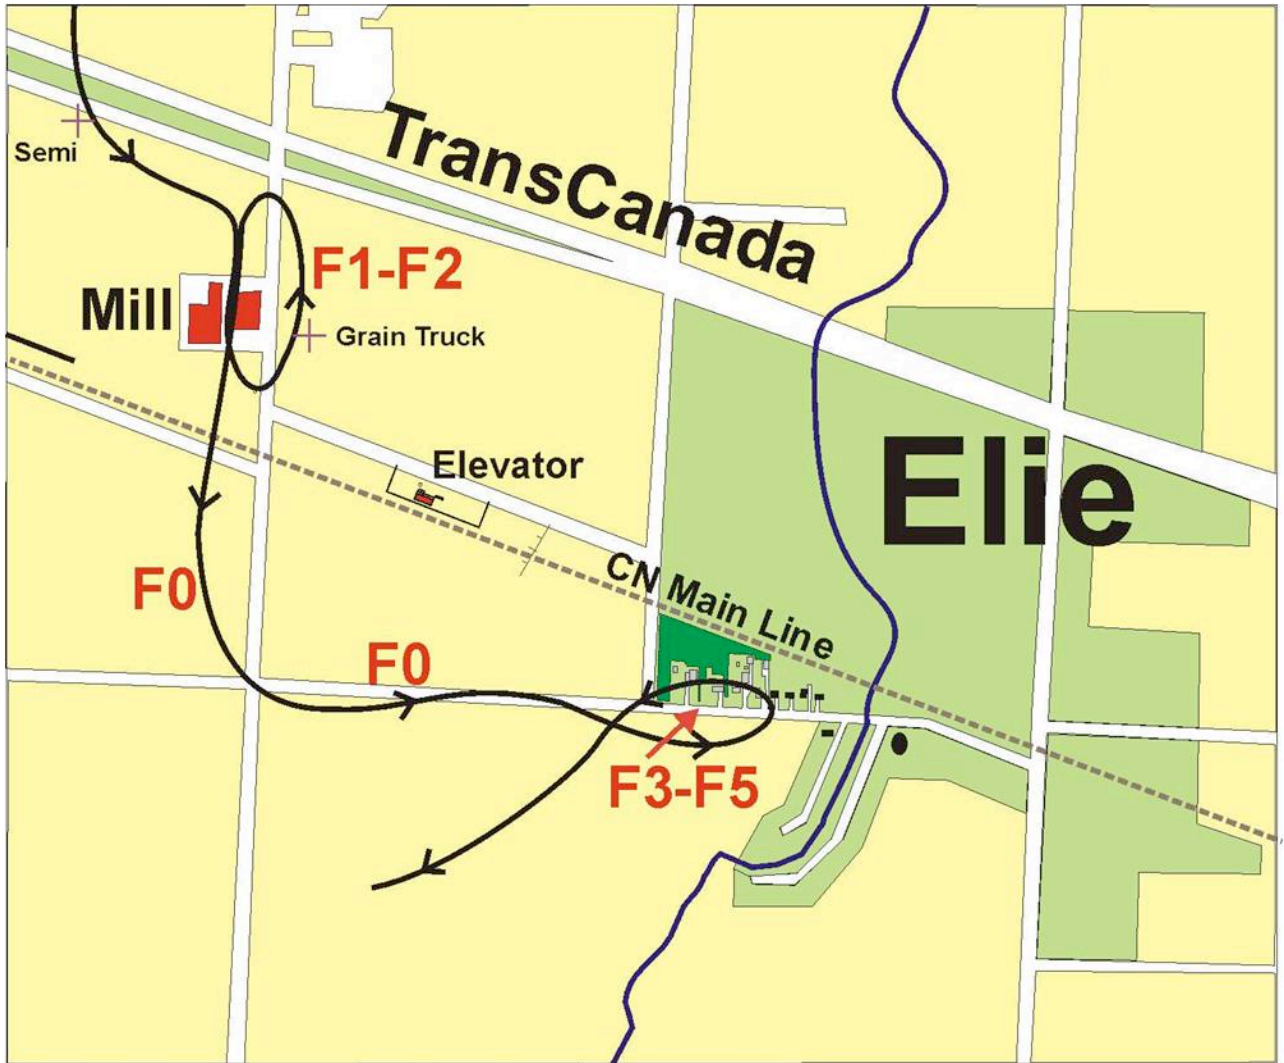
The collected information painted a much clearer picture of the tornado's path (figure 5). Rather than traveling about four kilometers, the tornado had meandered for about 6 km; twice performing a full loop. One of the videos revealed that the tornado has struck the flour mill twice! The tornado

struck the mill from the north than looped east then back north through an adjacent field. The tornado strengthened and turned back south over the mill. A large grain truck parked at the mill had tumbled through the nearby field with the tornado.

Figure 5. Detailed map of tornado track.
