ANALYSIS OF CAUSES OF ICING CONDITIONS WHICH CONTRIBUTED TO THE CRASH OF CONTINENTAL FLIGHT 3407

P3.3

Frederick R. Mosher*, Debbie Schaum, Chris Herbster, Tom Guinn

Embry-Riddle Aeronautical University, Daytona Beach, FL

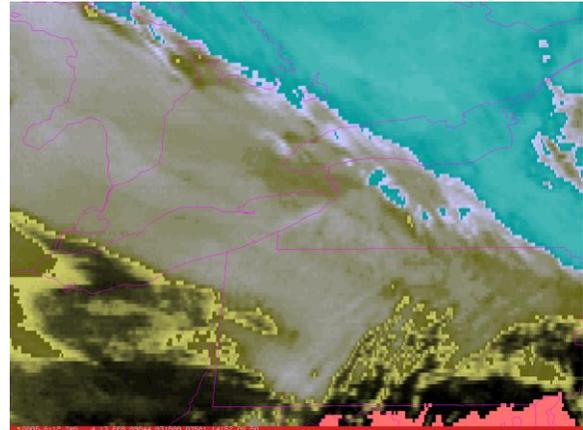
Figure 1 shows the IR satellite image for New England while Figure 2 shows a blowup of the western New York region with enhancements showing the 0 to -10 range (yellows), -10 to -20, and colder than -20 (blues). The cloud top temperatures in western New York are -15 °C.

Figure 2 . Enhanced IR image of western New York at 3:15Z with 0 to -10 being the yellows, -10 to -20 being the browns, and colder than -20 °C being the blues.

In the Ohio valley there was a zonal jet core at 250 mb. The western New York area was in the left front quadrant of the jet, which generally is an area of upper level divergence and upward vertical motion. However the influence of the jet appears to be primarily limited to the upper level clouds, such as the higher clouds in northern and central New York shown in fig. 2.

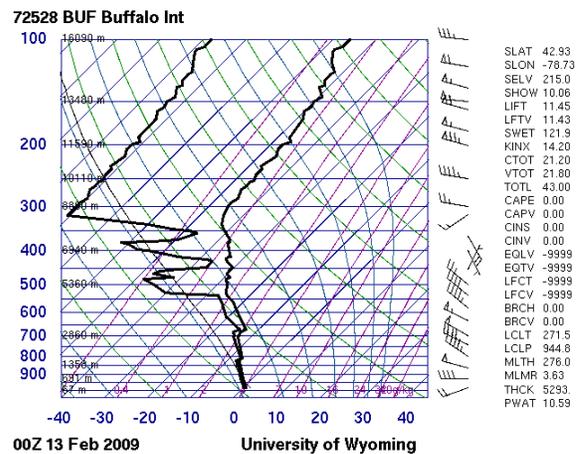
The OZ sounding from Buffalo is shown in figure 3. The digital listing of the sounding shows that the -15°C cloud top height was at approximately 11,000 ft. The 03Z surface observation from Buffalo showed an overcast cloud base of approximately 2,100 ft.

Figure 3. SkewT diagram of the OZ sounding from Buffalo.

temperature profile to be absolutely stable (air temperature decreasing with height more slowly than the moist adiabatic lapse rate). Hence upright convection does not appear to be a cause of the vertical motions.

The Buffalo 0Z sounding shown in figure 3 shows the winds at the surface from the west southwest at 20 knots veering to the west northwest at 50 knots at 850 mb. This veering wind profile is associated with warm advection and lifting. The prefrontal conditions represented by this sounding would have sufficient vertical motions to cause the stratus cloud mass covering western New York, the light precipitation, and the light aircraft icing conditions, but not necessarily the severe icing conditions encountered by Flight 3407.

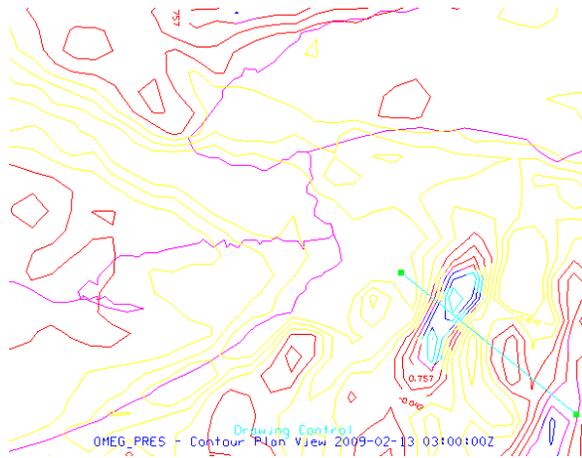
Figure 4. Vertical motion at 850 mb (approximately 4,500 ft.) at 3Z from the WRF model simulation. Straight line is path of Flight 3407.

The enhanced upward vertical motion in western New York was over enhanced terrain. The enhanced vertical motion was persistent in this area during the entire 3 hours of the model simulation. This was also the only area of enhanced vertical motions in western New York which would explain why other aircraft did not encounter the severe icing. If the upward vertical motion in a cloud is faster than the downward fall speed of the droplets, the cloud droplets will be swept upward toward the cloud top where the upward motion stops. This will

cause an accumulation zone of liquid water near the cloud top, which can increase the liquid water content of the cloud. This accumulation zone of liquid water appears to be responsible for the rapid buildup of ice as Flight 3407 descended into the cloud.

An area for future development would be to incorporate the high resolution vertical motion information currently available in numerical models into icing diagnostic and forecast products.
