HURRICANE IKE DAMAGE SURVEY

Timothy P. Marshall*
Haag Engineering Co.
Irving, Texas

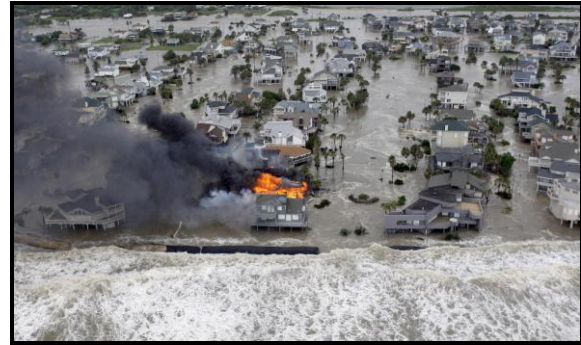
The author witnessed the storm surge firsthand. Water levels increased gradually throughout the day before the hurricane. Low-lying areas of Galveston Island became submerged 12 to 16 hours prior to the eye making landfall (Fig. 1). Waves superimposed on top of the storm surge undermined building foundations and dismantled building supports. Eventually, many buildings collapsed into the water and broke apart with debris being transported inland. In contrast, buildings immediately behind the seawall survived the hurricane since they were protected from the storm surge and wave action.

Figure 1. Residence on fire as the storm surge inundates Galveston Island well in advance of the hurricane. AP Photo/David J. Phillip.

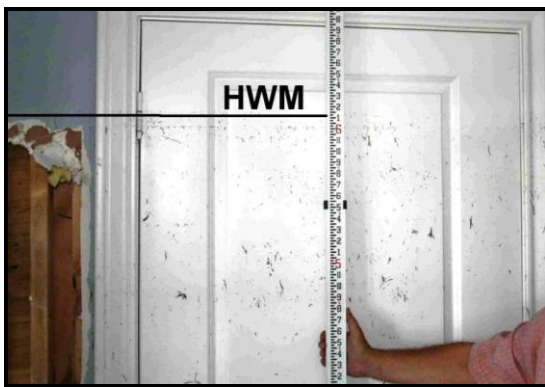
The author measured high water marks on the interiors of buildings using a surveyor's level and rod. Generally, water lines were found in rooms that were not breached by wave action. Water lines were composed of dirt and debris deposited when the water level stabilized, much like how dirt rings form in bathtubs (Fig. 3). Water lines were referenced to known benchmarks or topographic features such as road intersections.

High water marks ranged from 3.1 m to 3.7 m on Galveston Island. Around Galveston Bay, high water marks ranged from 3.7 m on the west side of the bay to 4.4 m on the east side of the bay. On the Bolivar Peninsula, high water marks ranged from 3.7 m at the south end to 5.5 m at the north end near the town of High Island. All water marks were adjusted to mean sea level. These high water marks compared well to those measured by the Federal Emergency Management Agency (FEMA 2009).

Figure 3. Example of a high water mark on the interior of a building.

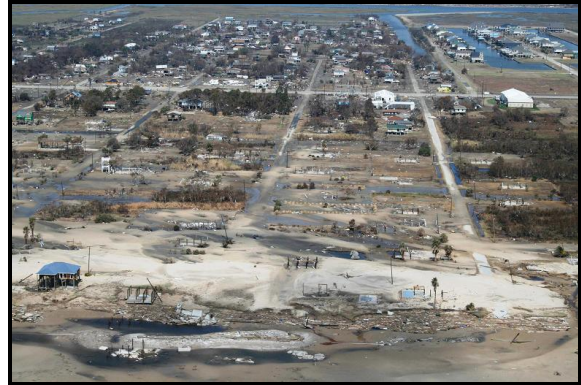
The most common building type on the Bolivar Peninsula and west Galveston Island were wood-framed residences elevated on timber pilings. Typically, elevated floor platforms ranged from two to four meters above grade or four to six meters above mean sea level. Many homes experienced both storm surge and wave action. Homes at the lowest elevations and closest to shore were most likely damaged or destroyed by storm surge and wave action (Figs. 4 through 6).

Figure 4. Wave action destroyed buildings near the beach (bottom of image) whereas buildings farther inland (top of image) remained intact.

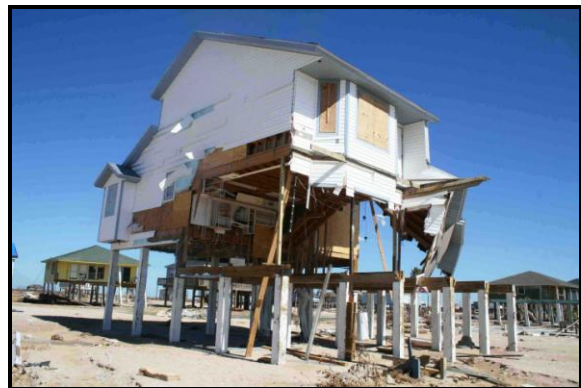
Figure 5. This home lost most of its first elevated floor and several walls due to wave action but, remarkably, did not collapse. By contrast, houses farther inland (in background) were not damaged since wave action was less severe.

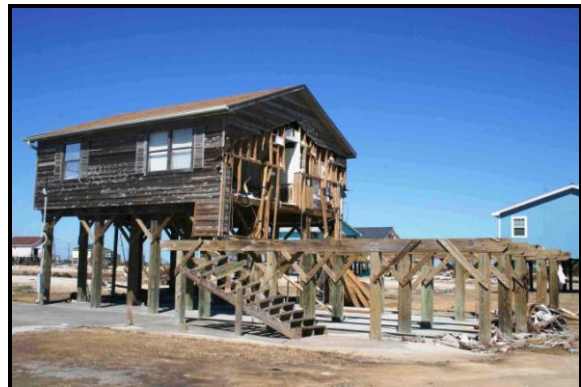
Figure 6. Storm surge removed the lower portion of this home leaving the upper portion intact. Generally, buildings at low elevations were susceptible to being damaged or destroyed by storm surge and wave action.

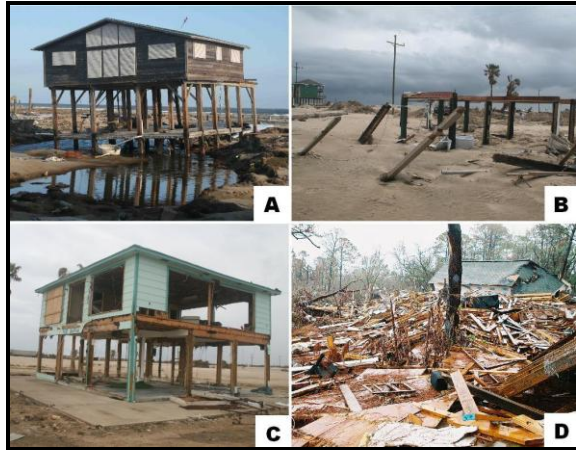
The author identified four zones of wave damage to buildings: 1) scour, 2) deposition, 3) clean, and 4) debris (Fig. 7). The scour zone was located adjacent to the beach. Sand washed away around pilings and undermined concrete slabs on grade. Roads and sewer systems also were washed away.

Immediately behind the scour zone was a deposition zone where the storm surge deposited sand on roads, lawns, and beneath elevated homes. In some instances, the sand accumulated several feet deep. Farther inland was a clean zone where fast moving water removed walls and contents from the first story leaving clean slabs. Even farther inland was a debris zone where flotsam, vehicles, building contents, wood debris, etc. from destroyed houses and trees had accumulated in large mats.

Figure 7. Examples of the four wave zones identified by the author in the survey: a) scour, b) deposition, c) clean, and d) debris.

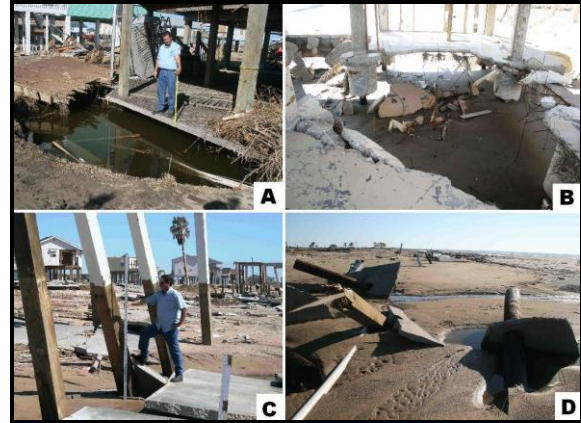
Within the scour zone, the author identified increasing degrees of damage to building foundations (Fig. 8). First, wave action removed sand from around the bases of pilings and from beneath concrete slabs on grade. This action left concrete slabs partially or completely suspended in the air between the pilings. As wave action increased, concrete slabs broke apart. Eventually, enough sand was removed around the bases of the pilings to cause them to lean or topple. In some instances, pilings had shallow depth making it easier for wave action to undermine them.

Figure 8. Increasing degrees of damage to foundations of elevated wood-framed residences in the scour zone: a) partial scouring of sand beneath slab on grade, b) complete scouring of sand and collapse of slab on grade, c) removal of slab on grade and leaning of the pilings, and d) total loss of piling support.

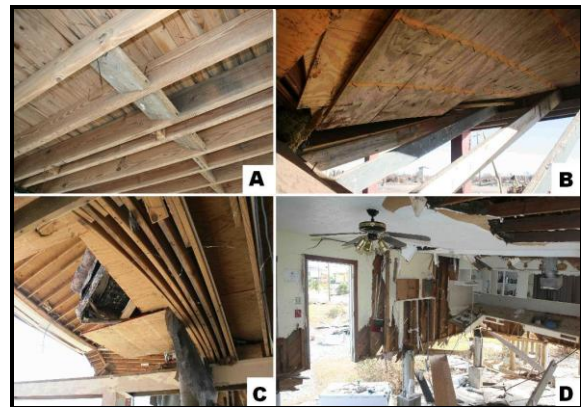
Degrees of damage to elevated floors increased in all wave zones when waves reached floor level. Initially, wave action rotated or removed blocking between the floor joists. Then, waves uplifted and dismantled floor sheathing as fasteners were incrementally withdrawn from the sheathing. Higher waves uplifted and removed floor joists or pushed them laterally stacking them along the landward sides of the homes. Eventually, enough floor structure was removed resulting in the collapse of the home or leaving the home perched precariously on top of its pilings (Fig. 9). Some houses that fell into the water had floated inland and came to rest on sand hills beside the Intracoastal

Figure 9. Increasing degrees of damage to flooring on elevated wood-framed residences: a) rotation of blocking, b) uplift of flooring, c) landward stacking of floor joists, and d) complete loss of the floor structure.

Waterway. In each instance, the destruction of flooring began on the seaward sides of buildings where wave impact forces were greatest.

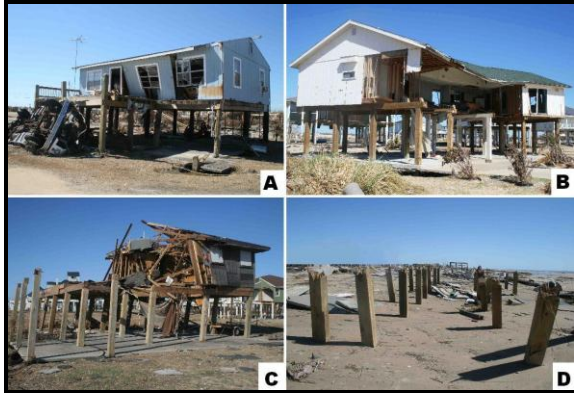
Floors that were removed by wave action left walls hanging from their top plates. In some instances, waves pushed the bases of seaward walls inward and landward walls outward, creating hinge lines at the tops of the walls (Fig. 10).

Figure 10. Increasing degrees of damage to elevated wood-framed residences in Hurricane Ike: a) damage to a seaward wall, b) loss of seaward walls and part of the floor, c) partial collapse of a house, and d) completely destroyed house with only timber piles remaining.

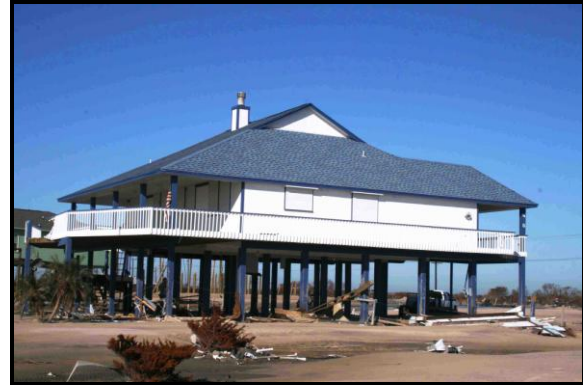
The author observed a number of homes that survived Hurricane Ike on the Bolivar Peninsula and west Galveston Island. Such homes were inland from the scour zone and had elevated floors more than 6 m above mean sea level (Fig. 11). Well built-homes had hurricane straps at vital connections, solid wall sheathing, and hip type roofs covered with metal or laminated type asphalt shingles. Several homes had window and door shutters.

Figure 11. A well-built house that survived Hurricane Ike was elevated above the level of the storm surge and wave action. Also, the home was located inland, with no scouring around the pilings.

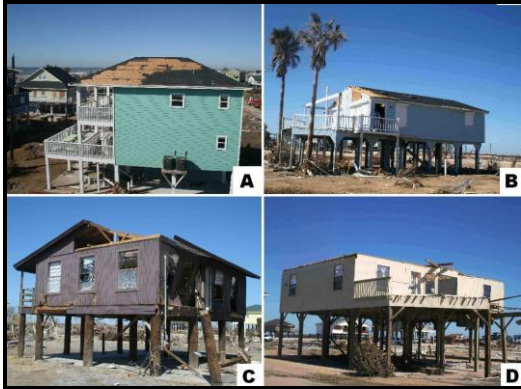
Wind damage to residential buildings was limited mostly to cladding items such as roof shingles, vinyl or hardboard siding and to unprotected windows. In rare instances, portions of roof decks were removed and gable ends were pushed either inward or outward. Roof structures usually were strapped to the wall top plates, and therefore, few roof structures blew off (Fig. 12). The author observed one residence in Webster, TX that had lost its roof revealing rafters and roof joists eaten by termites.

Figure 12. Increasing degrees of wind damage to elevated wood-framed residences in Hurricane Ike: a) loss of roof shingles, b) loss of a porch covering, c) partial loss of the roof structure, and d) total loss of the roof structure.
