Rodney J Potts \*

Bureau of Meteorology Research Centre, Melbourne, Australia

## 3. CASE 1. PERTH AIRPORT, 2 SEPTEMBER 1999, B747

#### 4. CASE 2. BRISBANE AIRPORT 18 JANUARY 2001

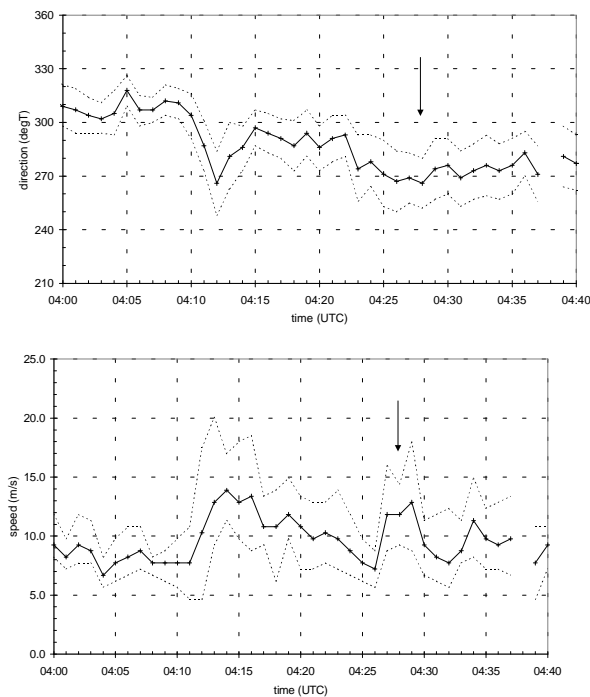
records wind data from an anemometer located on the airport but approximately 1200 m west of the Runway 24 threshold. The wind direction and speed are sampled at 1 second intervals and 1-minute means are calculated and recorded. Fig 1 shows the 1-minute mean wind direction and speed for the period of interest with the dashed lines showing the range. The arrow indicates the time at which the aircraft landed. At 0412 UTC, as the line of showers moved across the airport, the wind direction backed more westerly and the wind speed increased sharply. The speed then eased gradually and by 0426 UTC the mean wind was a westerly of  $7 \text{ ms}^{-1}$  with gusts to  $9 \text{ ms}^{-1}$ . A heavy shower (radar reflectivity 34 dBZ) then moved across the airport and the mean wind speed increased sharply to  $12 \text{ ms}^{-1}$  with gusts to  $18 \text{ ms}^{-1}$ . This lasted until approximately 0430 UTC. The wind direction remained steady at around 270 degrees during the period.

Fig.1 One-minute-mean wind direction (a) and wind speed (b) for Perth Airport for period 0400-0440 UTC, 2 September 1999. Dashed lines show minimum and maximum values observed for each minute.

Based on the speed of the cells from the radar the sharp increase in wind speed would take around a minute to move from the BoM anemometer site

to the threshold of Runway 24 and the aircraft would have encountered this change in the final stage of its approach, shortly before 0428 UTC when the aircraft had landed. Immediately prior to touchdown the aircraft experienced a sharp roll to the right of around 8 degrees followed by a similar sharp roll to the left, the latter causing the outer left engine pod to strike the ground. The response is consistent with a sudden increase in crosswind component from the right, and likely presence of turbulence that would have been associated with the change as it moved across the airport. Unfortunately the flight data recorder information from the aircraft did not include wind so the surface based observations cannot be substantiated.

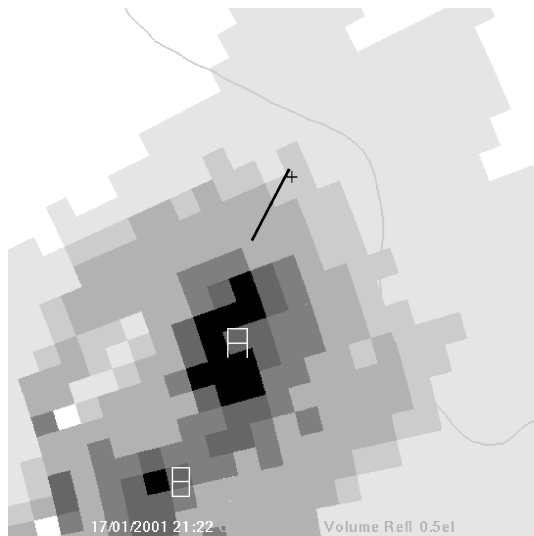
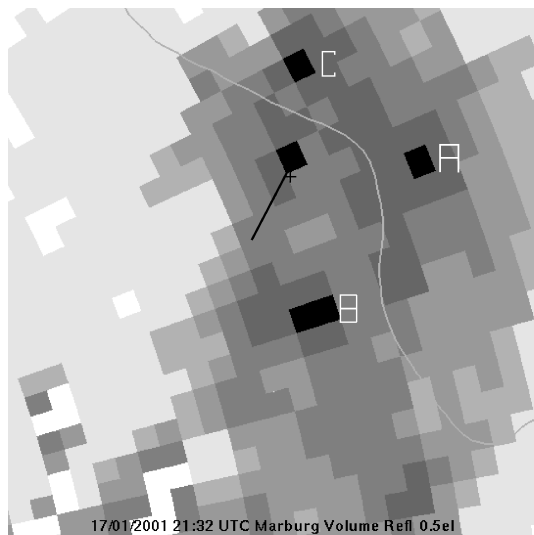
Weather radar data for 17/2122 UTC and 17/2132 UTC showed an intense multicellular storm near Brisbane Airport which was moving northeast at a speed of approximately  $17 \text{ ms}^{-1}$ . The two main reflectivity cells in this storm are shown in Fig 2 at A and B, together with the location of Rwy 01/19. Maximum radar reflectivities to 61 dBZ were observed in these cells. By 2132 UTC new core development was evident at the surface on the northern flank of the leading cell and this is shown at C in Fig 2b. Cells A and B passed just south of Rwy 19 and the new cell development would have occurred over the runway in the period 2122-2132 UTC. An examination of the volumetric radar data for 2122 UTC showed evidence of this with a reflectivity core developing at upper altitudes on the north flank of cell A. By 2142 UTC the storm

Fig 2. Brisbane weather radar data for elevation angle 0.5 deg and times (a) 2122 UTC and (b) 2132 UTC, 17 January 2001. Solid black line shows location of Runway 01/19 and + symbol shows location of BoM anemometer.

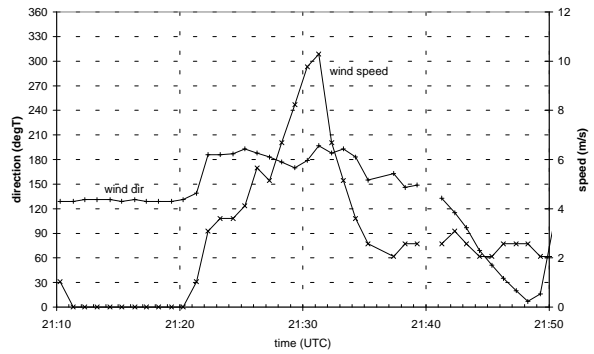
The Bureau of Meteorology anemometer on Brisbane Airport is located close to the threshold of Rwy 19 (Fig.2) and Fig 3 shows the variation in direction and speed of the 1-minute-mean winds at this location. This shows a weak southeasterly drift up to 2121 UTC when the wind direction shifted to 180 deg and the speed increased. This increase occurred in two stages, firstly to  $4 \text{ ms}^{-1}$  and then from 2126 UTC it increased further to around  $10 \text{ ms}^{-1}$  with gusts to  $13 \text{ ms}^{-1}$ . The temperature dropped by  $1.5 \text{ deg C}$  in this second

Fig 3. One-minute-mean wind direction and wind speed for BoM anemometer at Brisbane Airport.

stage after previously remaining constant. The increase in the wind is consistent with the initial passage of a gust front from the main storm and then the development of a strong outflow associated with the new cell development. Subsequent to this the speed decreased rapidly to around  $2 \text{ ms}^{-1}$  by 2136 UTC while the direction remained a southerly.
