6.5 DAMAGE SURVEY AND RADAR ANALYSIS OF THE FORT WORTH AND ARLINGTON, TX TORNADOES ON 28 MARCH 2000

Timothy P. Marshall*
Haag Engineering Co.
Dallas, Texas

Michael Foster
National Weather Service
Norman, Oklahoma

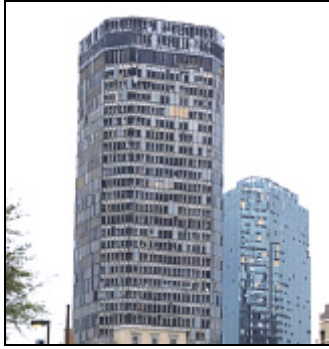
The circulation continued eastward striking the 35 story, glass faced Bank One Tower (Fig. 5). Most of the 3,000 windows shattered leaving the building open like a large doll house. Glass damage also was observed at the nearby Tandy Center and UPR Building due to flying debris. A third fatality occurred in north Fort Worth during the storm when a teenager was struck in the head by a baseball-size hailstone while trying to move his newly purchased car into the garage to avoid the hailstorm. The last U.S. hail fatality was recorded on July 30, 1979 in Fort Collins, CO.

Figure 5. West façade of the Bank One Tower (left) and the UPR building (right) showing extensive loss of window glass.

A tornado struck downtown Fort Worth on 28 March 2000 causing extensive damage to homes and high rise buildings. This case study illustrates once again that downtown regions are just as likely to be struck by tornadoes as less populated areas. Even more critical was the pervasive use of glass in the downtown Fort Worth that increased the risk of injury or death. In addition, such buildings sustained considerably greater damage when opened by the wind. Impact resistant glass should be installed on buildings prone to flying debris.

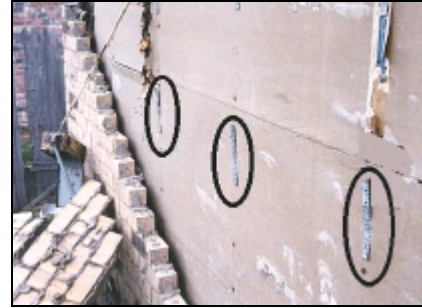
Figure 7. Brick ties (circled) were not bent into mortar joint, so the brick wall was not attached to the house.

The tornado crossed Matlock Road and entered another subdivision comprised of larger one- and two-story homes. The damage path then started to curve to the northeast with the worst damage being on Chasemore Lane. Brick masonry walls fell from many homes since they had not been attached to the framing with corrugated metal ties. In many instances, the ties were attached to the framing but were never bent into the mortar joints (Fig. 7). Overall, about 200 homes sustained F1 or greater damage.

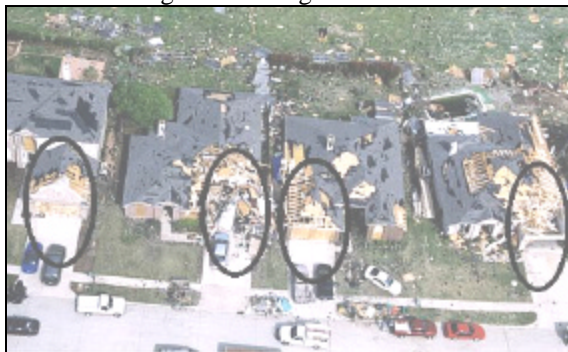
The Arlington tornado damage path was 8 km long and up to 200 m wide. The first damage occurred in a residential area along Embercrest Drive about one mile south of I-20, just east of Collins Blvd. Homes were one-story, wooden-framed structures built on concrete slab foundations and had attached two-car garages. Damage up to F-3 occurred when the garage doors failed leading to uplift of the roofs or pushing out of exterior walls. Homes with attached garages facing the wind sustained far greater damage than homes with attached garages facing away from the wind (Fig. 6).

Figure 6. Garage failures (circled) on homes that faced the wind.
