P9.3

HAIL DAMAGE TO BUILT-UP ROOFING

Timothy P. Marshall* and Scott J. Morrison
Haag Engineering Co.
Dallas, Texas

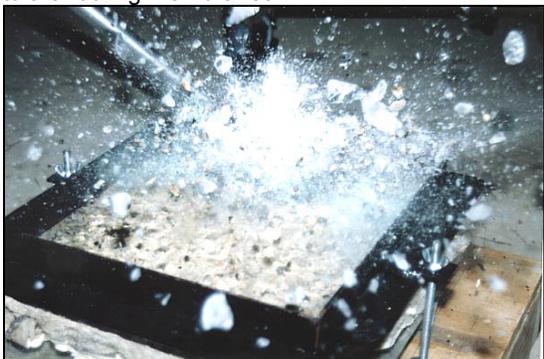
A total of 94 impacts were made against the built-up roof samples of which 18 samples had the loose and embedded gravel removed prior to testing. Typically, the ice ball broke apart or shattered upon impact and removed the loose gravel, forming a divot

(crater) in the roof surface (Figures 5 and 6). Larger and faster ice balls created larger and deeper divots in the loose gravel. The largest ice ball impacts removed pieces of the asphalt flood coat, leaving the exposed asphalt surface fragmented and shiny. There were no instances where gravel had been driven downward into the roofing membranes.

Figure 5. Ice ball breaks apart on impact removing some of the surface gravel and flood coat.

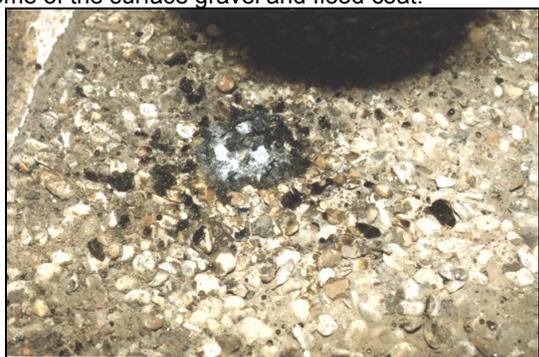
Figure 6. Roof surface after ice ball impact. Some of the gravel and asphalt flood coat had been removed. However, gravel was not driven into the plies.

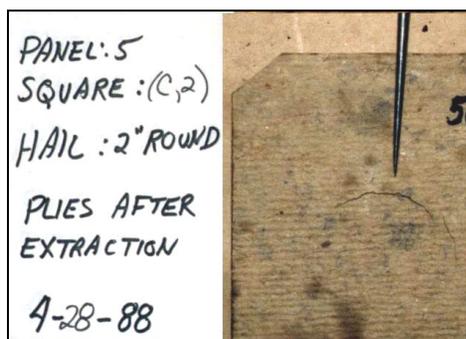
The impacted roof samples were examined visually before they were subjected to an asphalt solvent. The roofing reinforcements then were extracted, dried, and examined for cuts, tears, dents, or any other evidence of hailstone impact. Fractures in the roof reinforcements appeared star- or crescent-shaped (Figure 7).

Figure 7. Crescent-shaped fracture in organic reinforcement after desaturation.

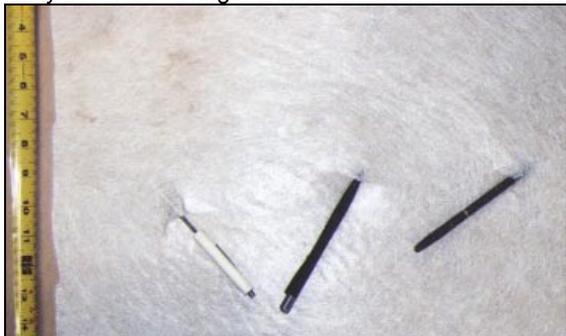
No damage occurred to the built-up roof samples whether ballasted or unballasted when impacted with 1.5 in. (2.4 cm) diameter ice balls. However, some spalling of the asphalt flood coat occurred with 2.0 in. (5.1 cm) diameter ice ball impacts against the ballasted samples, but no damage was found to the glass-fiber reinforcements. Glass-fiber reinforcements were fractured when unballasted samples were struck with 2.0 in. (5.1 cm) diameter ice balls (Figure 8). The

fractures appeared star-shaped and occurred in all layers beneath the center of the impact. The underlying glass-fiber insulation board also was dented beneath the impact points. Occasionally, gravel-sized indentations were found in the upper plies but this was not coincident with any impacted areas. Such anomalies were created when the gravel was pressed into the plies before the asphalt had cooled. This likely occurred during the initial installation of the roof.

Figure 8. Star-shaped fractures in the glass-fiber reinforcements after asphalt removal.

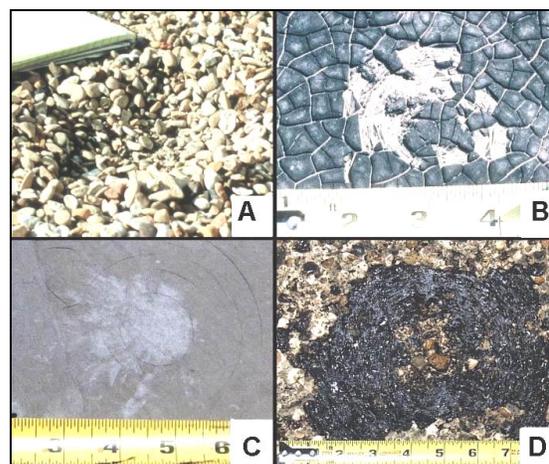
Hail damage to a built-up roof takes on many forms depending on the age and condition of the roof surface. Concentric fractures can occur in the asphalt flood coat around the impact points on newer built-up roofs whereas, the asphalt flood coat can be spalled or fractured on older and more brittle roofs. With

ballasted roofs, hail can remove some of the loose gravel forming a crater or divot in the roof surface. The larger, harder, and faster the hailstone, the deeper and wider the crater or divot. Large hailstones can leave a "doughnut-shaped" fracture pattern in the roof surface where gravel and/or flood coat remains at the center of the impact. Only the largest and hardest hailstones can remove enough of the ballast to break apart the asphalt flood coat and penetrate the roofing reinforcements (Figures 9 and 10).

Figure 9. Hail impacts on built-up roofs: a) divot in loose gravel (no damage), b) spalling of the asphalt flood coat, c) concentric fractures in coating associated with a spatter mark, and d) "doughnut-shaped" area of spalled asphalt flood coat with large impact.

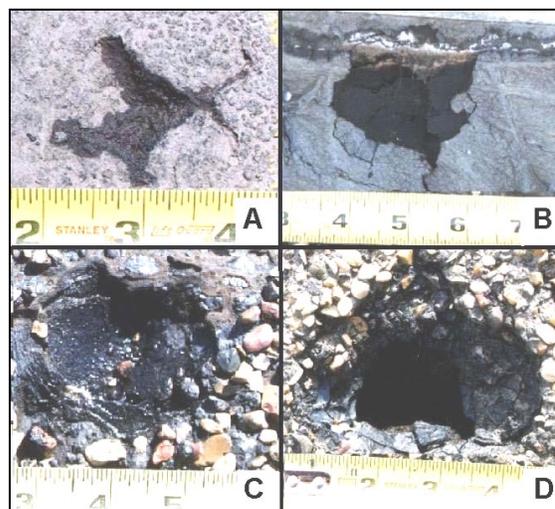
Figure 10. Hail damage forms on built-up roofs: a) star-shaped fracture in bare area, b) punctured flashing, c) punctured blister, and d) puncture in field of roof that went through the wood roof deck.

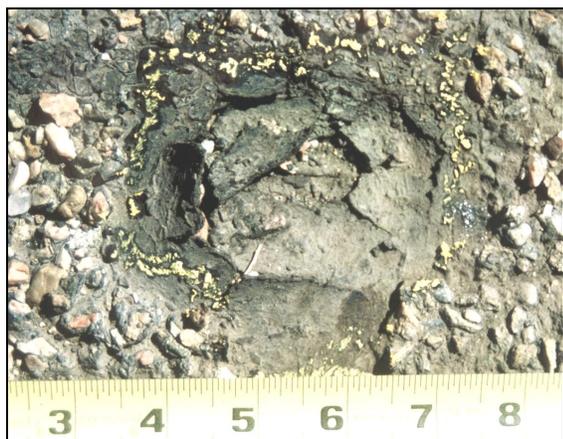
Exposed asphalt oxidizes as it ages turning from black to grey in about one year. Some times loose gravel can cover hail damaged areas and a broom is needed to sweep aside the loose gravel. Hail damage

to a roof can still be found years after the event (Figure 11).

Figure 11. Five-year-old hail damage to a built-up roof.

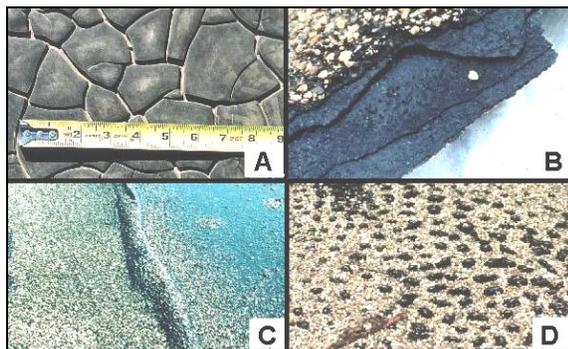
There are a number of anomalies on built-up roofs that can be mistaken for hail-caused damage such as alligating, interply voids, membrane blisters, and asphalt bubbles (Figure 12). Alligating occurs as oils within the asphalt separate leaving a harder material that cracks when it shrinks. Interply voids result when not enough asphalt is applied between membrane plies. Membrane blisters develop when air and water vapor are expanded within interply voids. Bubbles form in the asphalt when it is boiled and cools rapidly as it is applied to the roof surface.

Figure 12. Built-up roof deficiencies not caused by hail: a) alligating, b) gaps between plies, c) membrane blister, and d) asphalt bubbles.
