A New Ground Deicing Hazard Associated with Freezing Drizzle Ingestion by Jet Engines during Taxi

Roy Rasmussen* and Chuck Wade
National Center for Atmospheric Research (NCAR)
Al Ramsay
Science Applications Corporation
David Fleming, Tom Lisi and R.K. Moore
United Airlines
Morris Kjolleberg and Karl Morten Rosenlund
Braathens Airlines

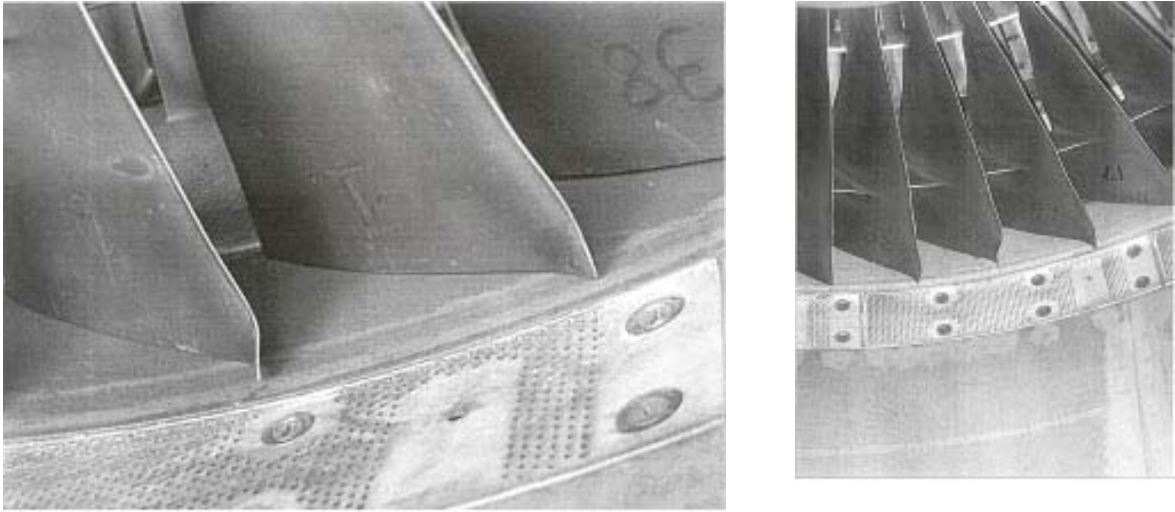
On Oct. 31, 2002, twelve United Airlines 737 aircraft incurred jet engine damage after experiencing a winter storm at Denver, Colorado. The damage was primarily bent fan blade tips, and was consistent with ice being ingested into the engines at normal flight engine speeds (figure 1, photo of bent fan blades) . Total damage was reported by United Airlines as being over \$2 million dollars, with one engine requiring replacement. The damage was noted after the aircraft landed at their destination airports. The aircraft that incurred damage departed Denver between 5:00 and 8:00 p.m. Mountain Standard Time (MST). The weather observer at Denver reported mist and light snow during this time period, and also unseasonably cold temperatures (-8 C). While in-bound to Denver these aircraft encountered light to moderate icing aloft as given by Pilot Reports. After landing the aircraft were deiced at the gate to remove ice build up that occurred via in-flight ice accretion. This deicing included the removal of any ice from the jet engine fan blades. Once deiced and loaded, the aircraft taxied to deicing pad B (located just west of Concourse B at Denver International Airport), and were further examined for ice accumulation due to the reported snow conditions. During this period ground personnel reported the presence of freezing drizzle despite the METAR report of mist and light snow. Denver is a category A airport and therefore had an observer present that augmented the METAR in this case to report snow and mist.

the weather conditions associated with these cases, and comes to the conclusion that the actual weather condition during the time period when the engine damage occurred in both cases was most likely heavy freezing drizzle rather than light snow and mist as reported in the Oct. 31, 2002 Denver case or light freezing drizzle as reported during the Oct. 31, 2003 Denver and February 2002 Oslo, Norway cases. If the flight crew had been aware of the heavy freezing drizzle conditions, standard engine run-up procedures would have been implemented to shed any potential ice accumulation. Since the official weather observations did not indicate heavy freezing drizzle, this procedure was not implemented, and the ice that accumulated during taxi from the gate and during the taxi to takeoff was likely shed during the takeoff rotation, causing the damage reported to the aircraft.

Figure 1 Jet engine damage due to freezing drizzle.

The main solution to this problem is the accurate and timely reporting of the correct precipitation type and intensity based on liquid equivalent rate. A real-time version of the Ramsay algorithm described above has been implemented on the Weather Support to Deicing Decision Making (WSDDM) real-time winter weather nowcasting system (Rasmussen et al. 2001). This system provides real-time weather updates at airport locations experiencing winter weather conditions, including a one hour snowfall rate forecast. A new graphic has been added to the system (figure 8) which gives a graphical depiction of the current precipitation type and rate from the Ramsay algorithm. This graphic is updated every minute, and thus provide an accurate estimate of the actual precipitation type (rain, freezing rain, snow, freezing drizzle) and precipitation intensity based on a mass rate of accumulation instead of visibility.

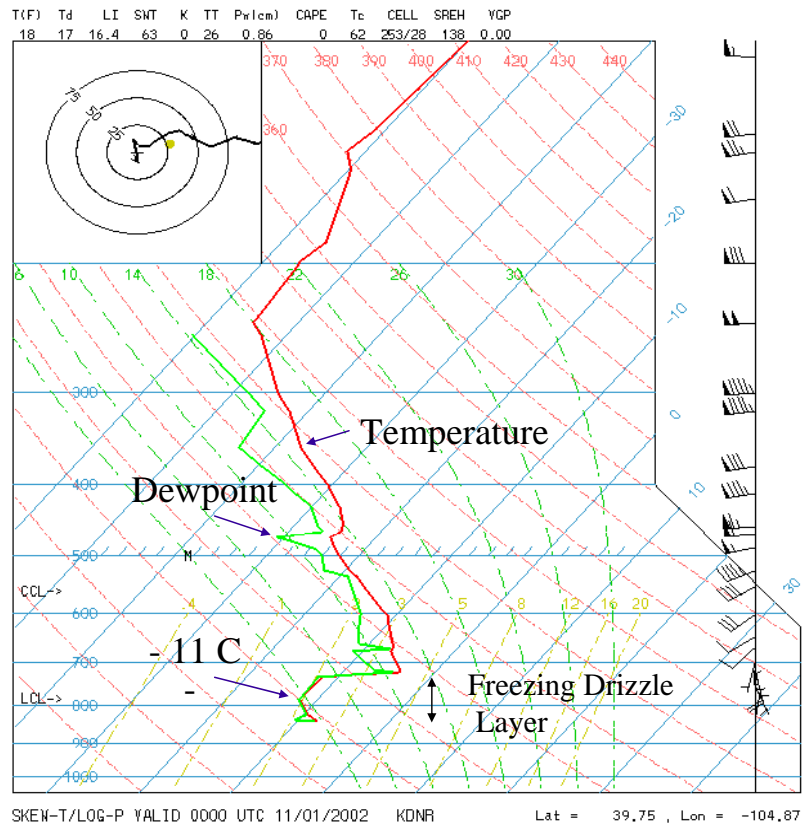
The 00 UTC Denver sounding shows that the cold air is about 1 km deep and saturated, indicating the presence of a shallow cloud as discussed above (Fig. 2). A strong inversion existed at the top of the cold air at 720 hPa, with the coldest temperature in the cloud layer being -11 C. This type of sounding is typical of freezing drizzle conditions produced by frontal overrunning (Rasmussen et al. 1995). Key to the formation of drizzle is the relatively warm cloud temperatures present. Above the inversion the air is just below saturation, and at certain locations likely ice saturated. These pockets of ice saturation likely produced the observed light snow conditions.

Figure 2 Denver sounding from 00 UTC Nov. 1, 2002

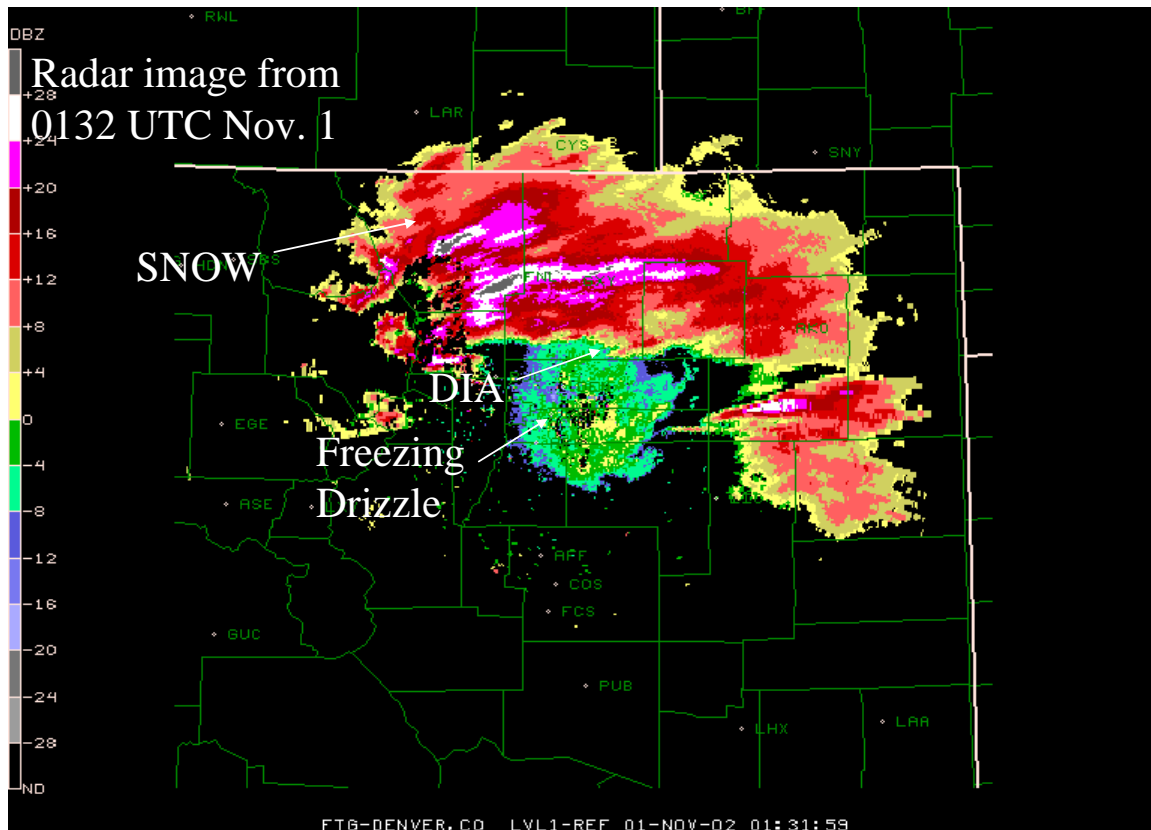
than 200 microns in diameter). Snow, on the other hand, typically can have much larger radar reflectivity values (typical maximum values are 25 to 30 dBZ), due to the presence of snowflake sizes up to a cm in diameter. The radar reflectivity from 0.5 degree lowest level scan from the NexRad Denver radar during the engine damage period is shown in figure 3. Two distinct features are evident in the image. Near Denver International airport, there is a circular reflectivity pattern that is between -10 and 0 dBZ in intensity with a fairly uniform horizontal pattern. To the north of Denver, the reflectivity is significantly higher in intensity (up to 25 dBZ), and banded in nature. The circular echo over DIA is consistent with either freezing drizzle or light snow (Ikeda and Rasmussen 2003). The echo to the north of DIA is consistent with snow bands. The METAR reports at LIMON (to the southeast of DIA) and Arapahoe (to the southwest of DIA) both indicate the presence of freezing drizzle (Limon actually is reporting freezing rain, which can occur when the intensity of freezing drizzle is high) beneath the uniform radar reflectivity pattern. Thus, the reported weather conditions beneath the uniform echo is freezing drizzle (or freezing rain) other than DIA.

Figure 3 NexRad radar reflectivity from the 0.5 degree scan from 0130 UTC on Nov. 1, 2002

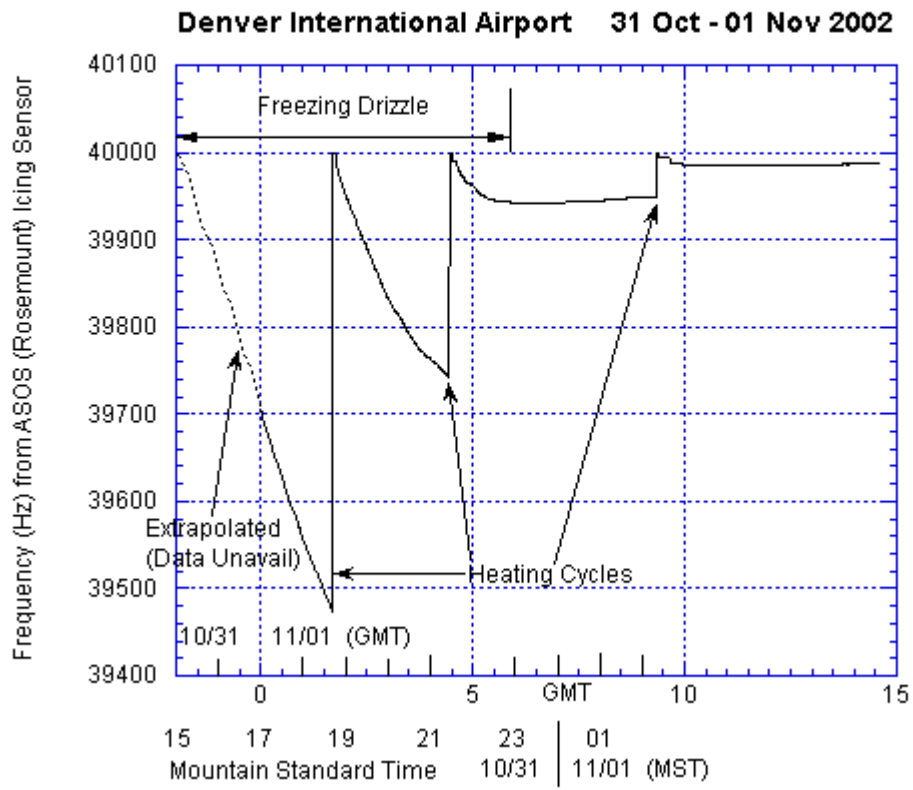
the use of the one minute raw ASOS data. Fortunately, NCAR was archiving the one minute ASOS data from this case as part of its ongoing research and development regarding ground deicing issues under funding from the FAA Aviation Weather Research Program (AWRP). The raw output from the freezing rain sensor is a vibration frequency of the sensing rod. When no ice accretes on the rod the vibration frequency of the rod is approximately 40,000 Hz. When ice accretes on the rod, the frequency drops in proportion to the thickness of the ice accretion. This information is used by the current ASOS system to indicate the presence of freezing rain. Table 2 also gives an extension of the freezing rain algorithm by Ramsey (NWS 1999 report) to detect freezing drizzle using the one minute data from the freezing rain sensor and other relevant information from the ASOS system. Freezing drizzle is reported if: 1) the frequency is less than 39,967 Hz and the accretion rate on the sensor produces a frequency drop greater than 6 Hz in 15 minutes, 2) the LEDWI present weather sensor reports "no precipitation", 3) the ambient temperature is less than or equal to 0 C, and 4) sky cover is overcast. All of these criteria are met during the engine damage period. Ramsey (1999) has also developed a method to determine freezing drizzle intensity using the rate of frequency drop from the freezing rain sensor (Table 3). The frequency drop during the engine damage period was 37 Hz per 15 minutes (figure 5), indicating that the drizzle intensity was > 0.02 in/hr, or heavy drizzle intensity. Figure 6 compares the Ramsey drizzle algorithm to the LEDWI precipitation type and intensity algorithm that is currently used on ASOS. The thick bars are the Ramsay algorithm and the thin bars are from the LEDWI. Both the LEDWI and the Ramsay algorithm reported no precipitation from 1500 – 2000 UTC, Nov. 1. Note that the ASOS algorithm using LEDWI and the freezing rain sensor is only designed to report rain, freezing rain, or snow precipitation types and their intensity, and therefore does not automatically report freezing drizzle. This figure indicates that the Ramsay algorithm would have reported heavy freezing drizzle during the engine damage period instead of the light snow reported by the observer. The LEDWI instrument reported ?0 or ?1, which indicates that the sensor detected precipitation, but did not have sufficient signal to determine the type or intensity.

Figure 5 Time series of freezing rain sensor frequency from Oct. 31, 2200 UTC to Nov. 1, 1500 UTC.

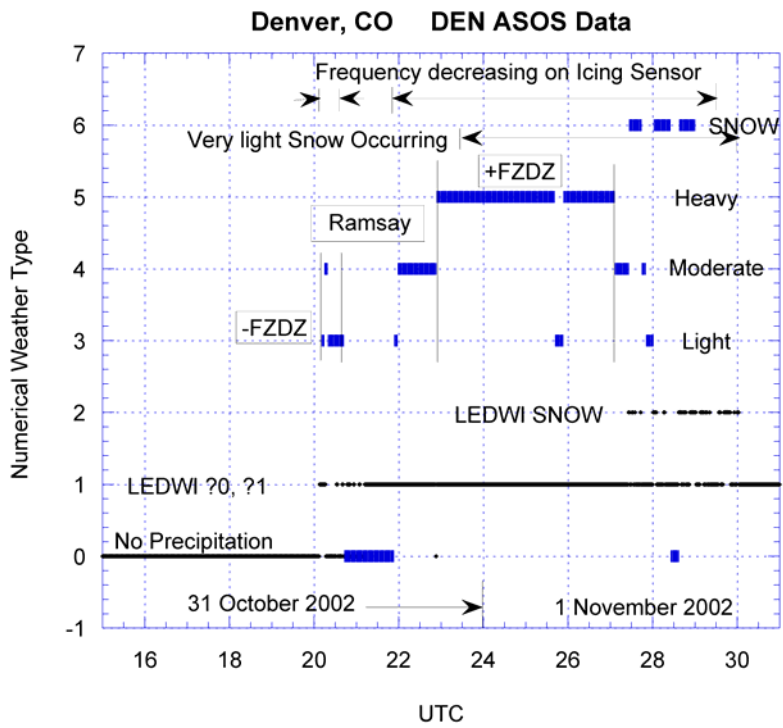
Note that drizzle intensity by a manual observer is determined by visibility. If visibility were used to determine drizzle intensity in this case, only light drizzle would have been reported as compared to the heavy drizzle intensity derived from the freezing rain sensor using Al Ramsay's algorithm. Thus, the determination of drizzle intensity from visibility suffers from the same ambiguity that the determination of snow intensity using visibility does (Ramsey 1999, Rasmussen et al. 1999).

Figure 6. Time series of drizzle intensity from the freezing rain sensor, the LEDWI, and the manual observer from Oct. 31, 2002 1500 UTC to Nov. 1, 2002 0700 UTC.

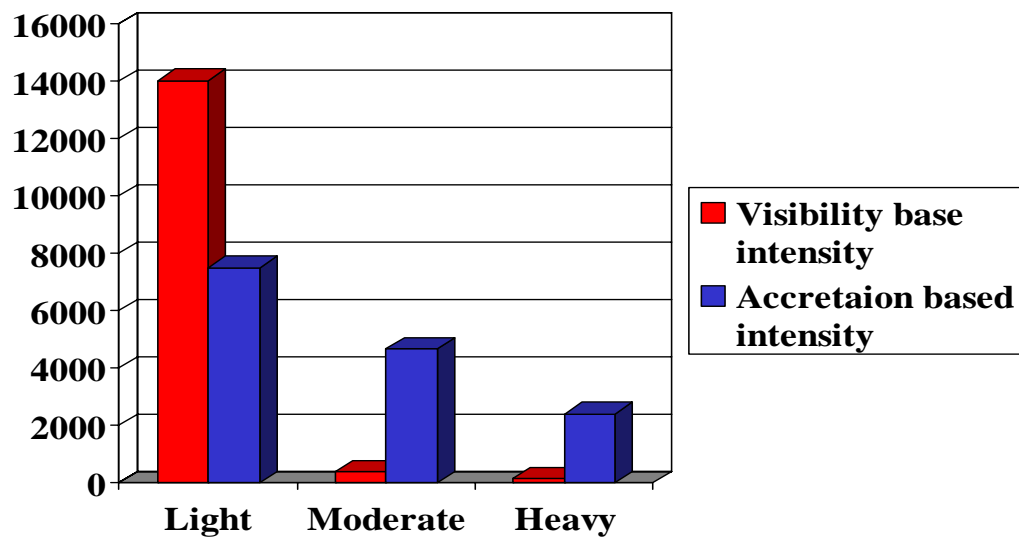
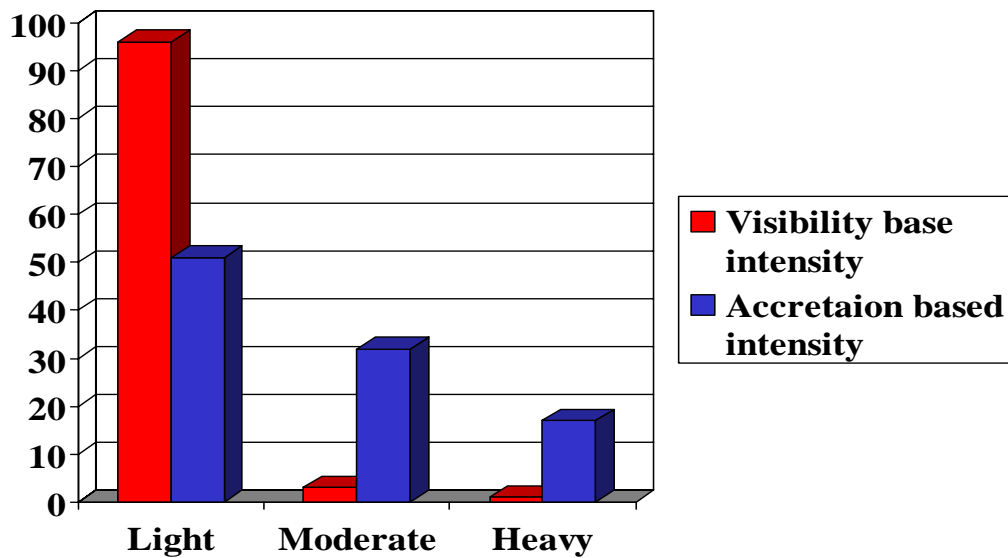
A similar incident of jet engine damage occurred in Oslo, Norway Gardemoen airport on Feb. 7, 2003 between 1614 – 1816 UTC. During this time light freezing drizzle was reported with an ambient temperature near -7 C. However, evidence from roadways and the tarmac reported by SAS and Braathens staff were that heavy freezing drizzle was actually occurring. We suspect that this was a case of high visibility and high drizzle intensity, which Ramsey (1999) has shown occurs nearly 50% of the time. Figure 7 is derived from the Ramsey study and show the percent of time that drizzle intensity is correctly reported by visibility as opposed to using the algorithm shown in Tables 2 and 3. As shown, nearly all drizzle intensity reports by visibility (96%) fall into the light category as in this event, while in reality only 54% should be in this category with the remaining 46% in the moderate to heavy category.

Figure 7 Frequency of freezing drizzle intensity from Ramsay 1999
