## A Preliminary Study of the 16 June 2014 Tornadoes in Northeast Nebraska

## Brian E. Smith and Daniel Nietfeld – NOAA/NWS Omaha/Valley, NE

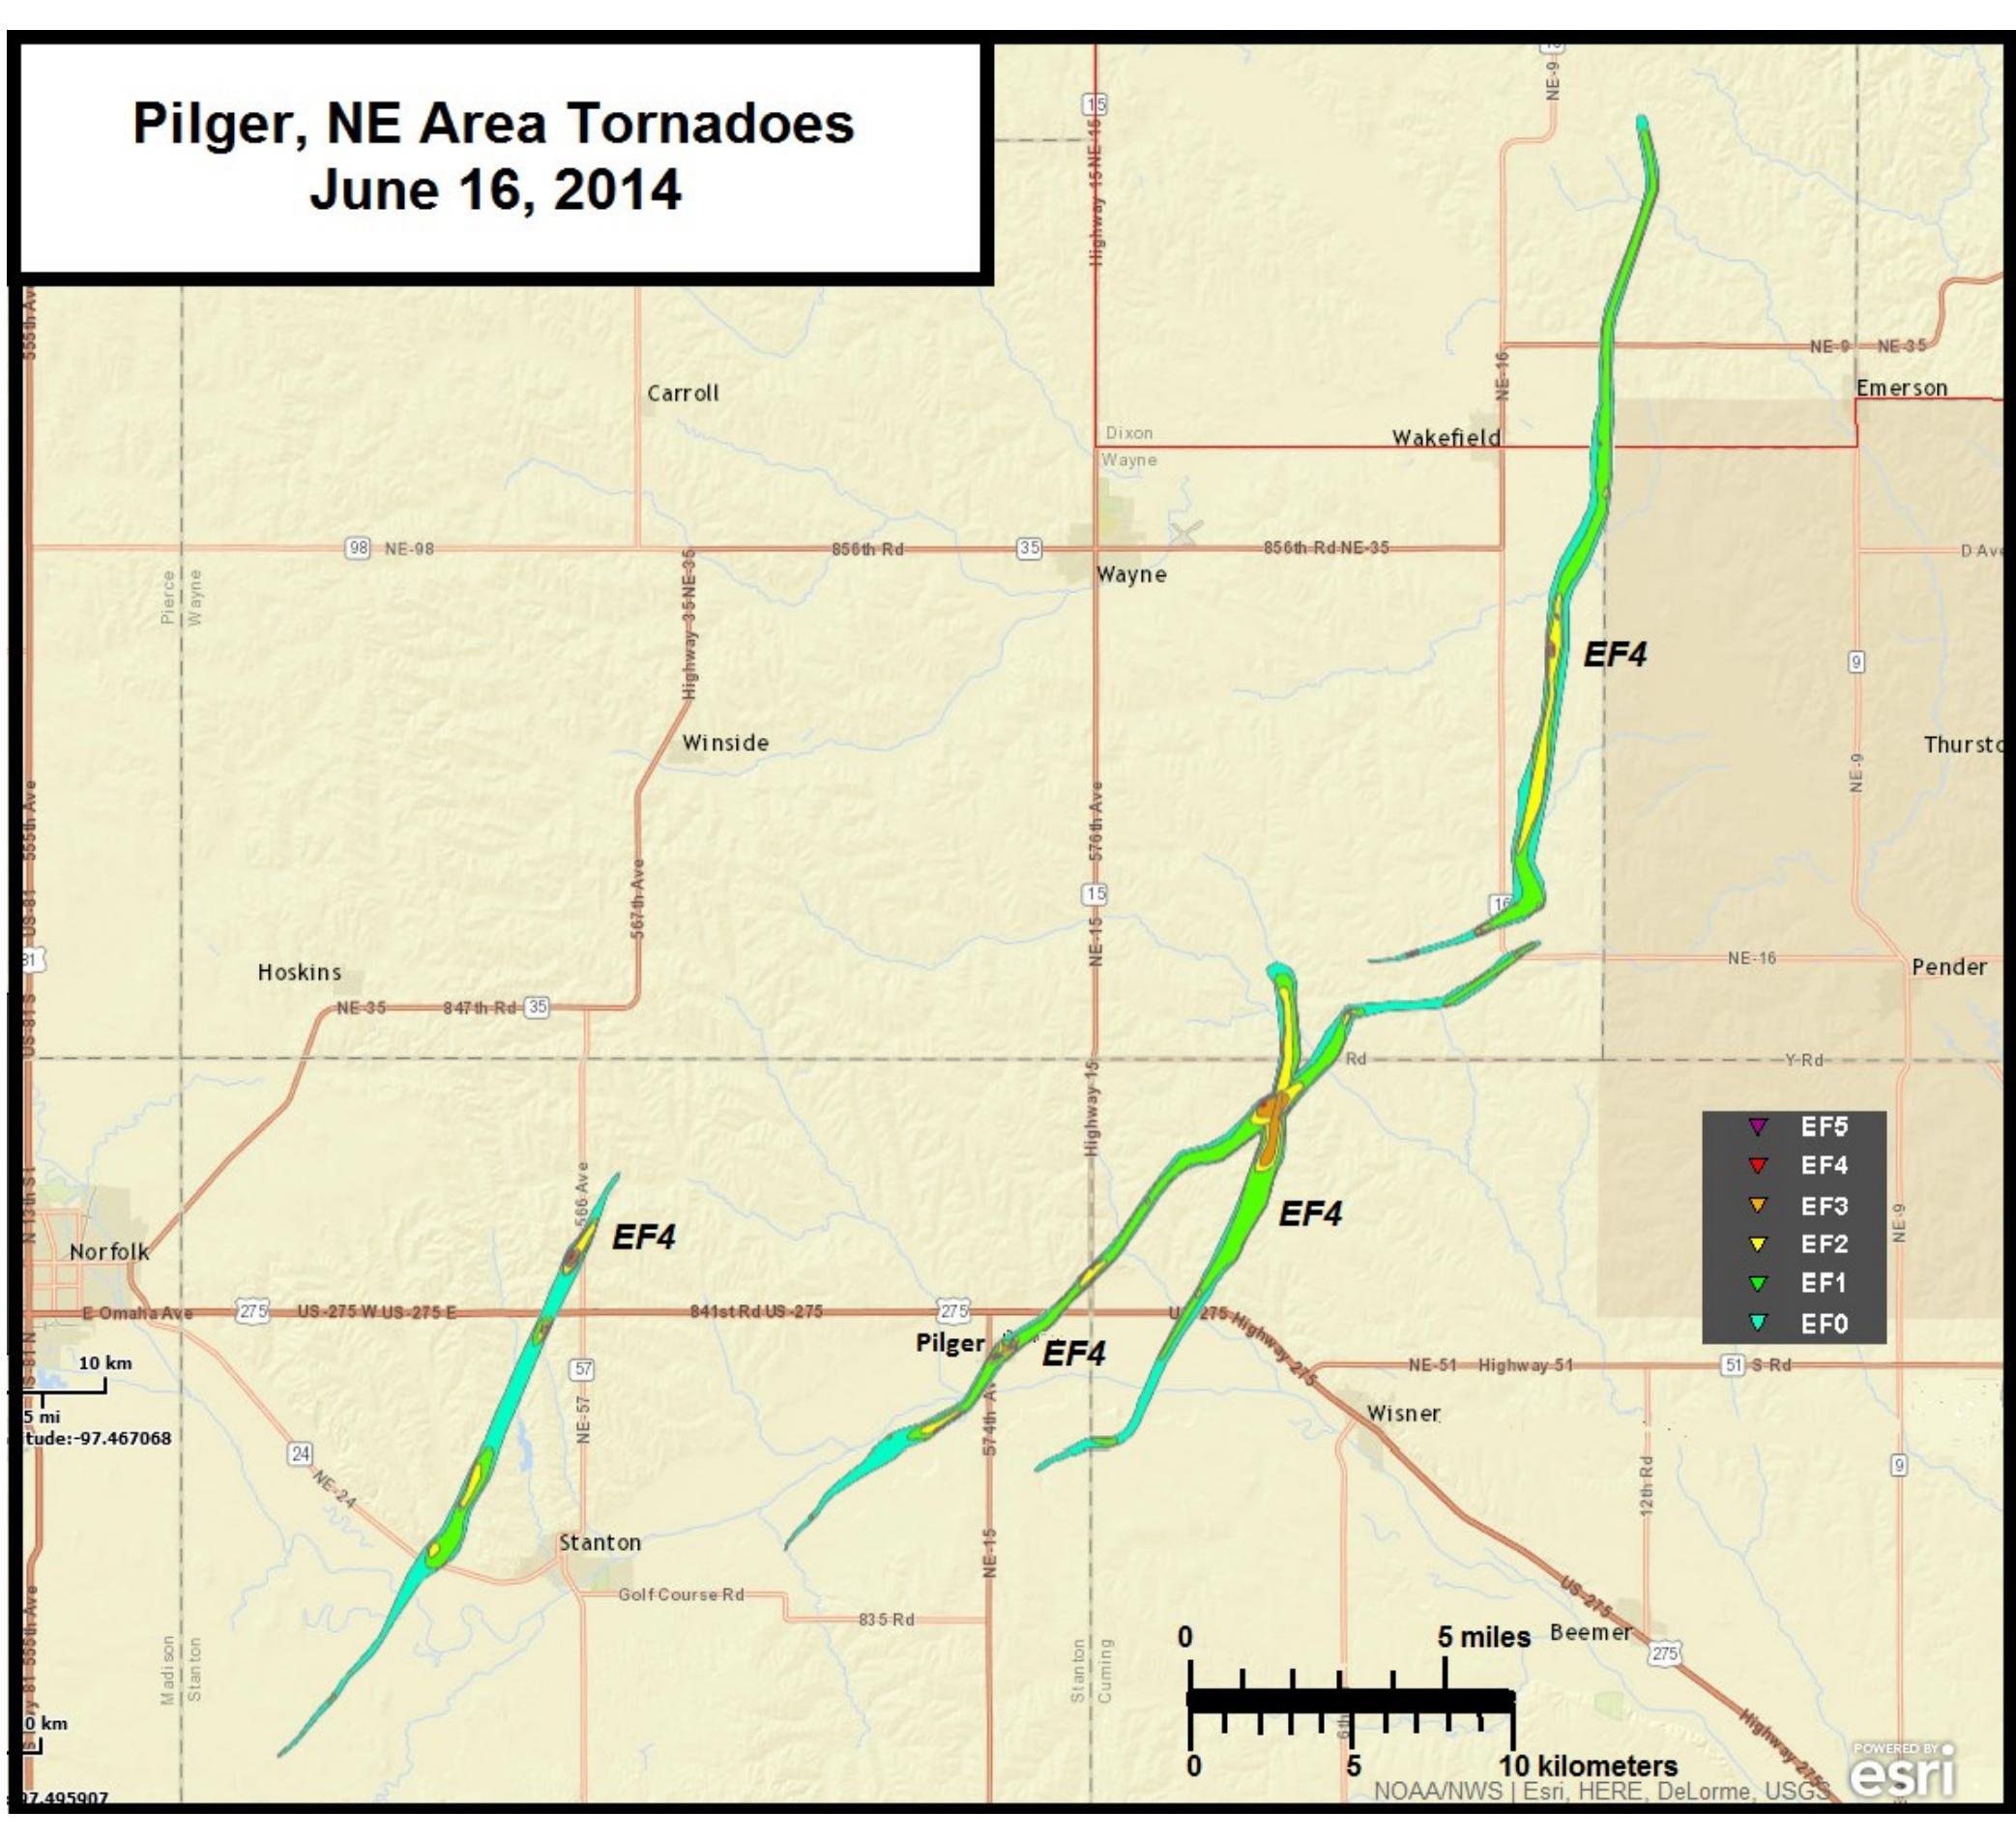
Tracks of four of the five tornadoes that struck northeast Nebraska on June 16, 2014. The map was constructed utilizing damage survey information, aerial photos, and satellite imagery. Each tornado was rated an EF4

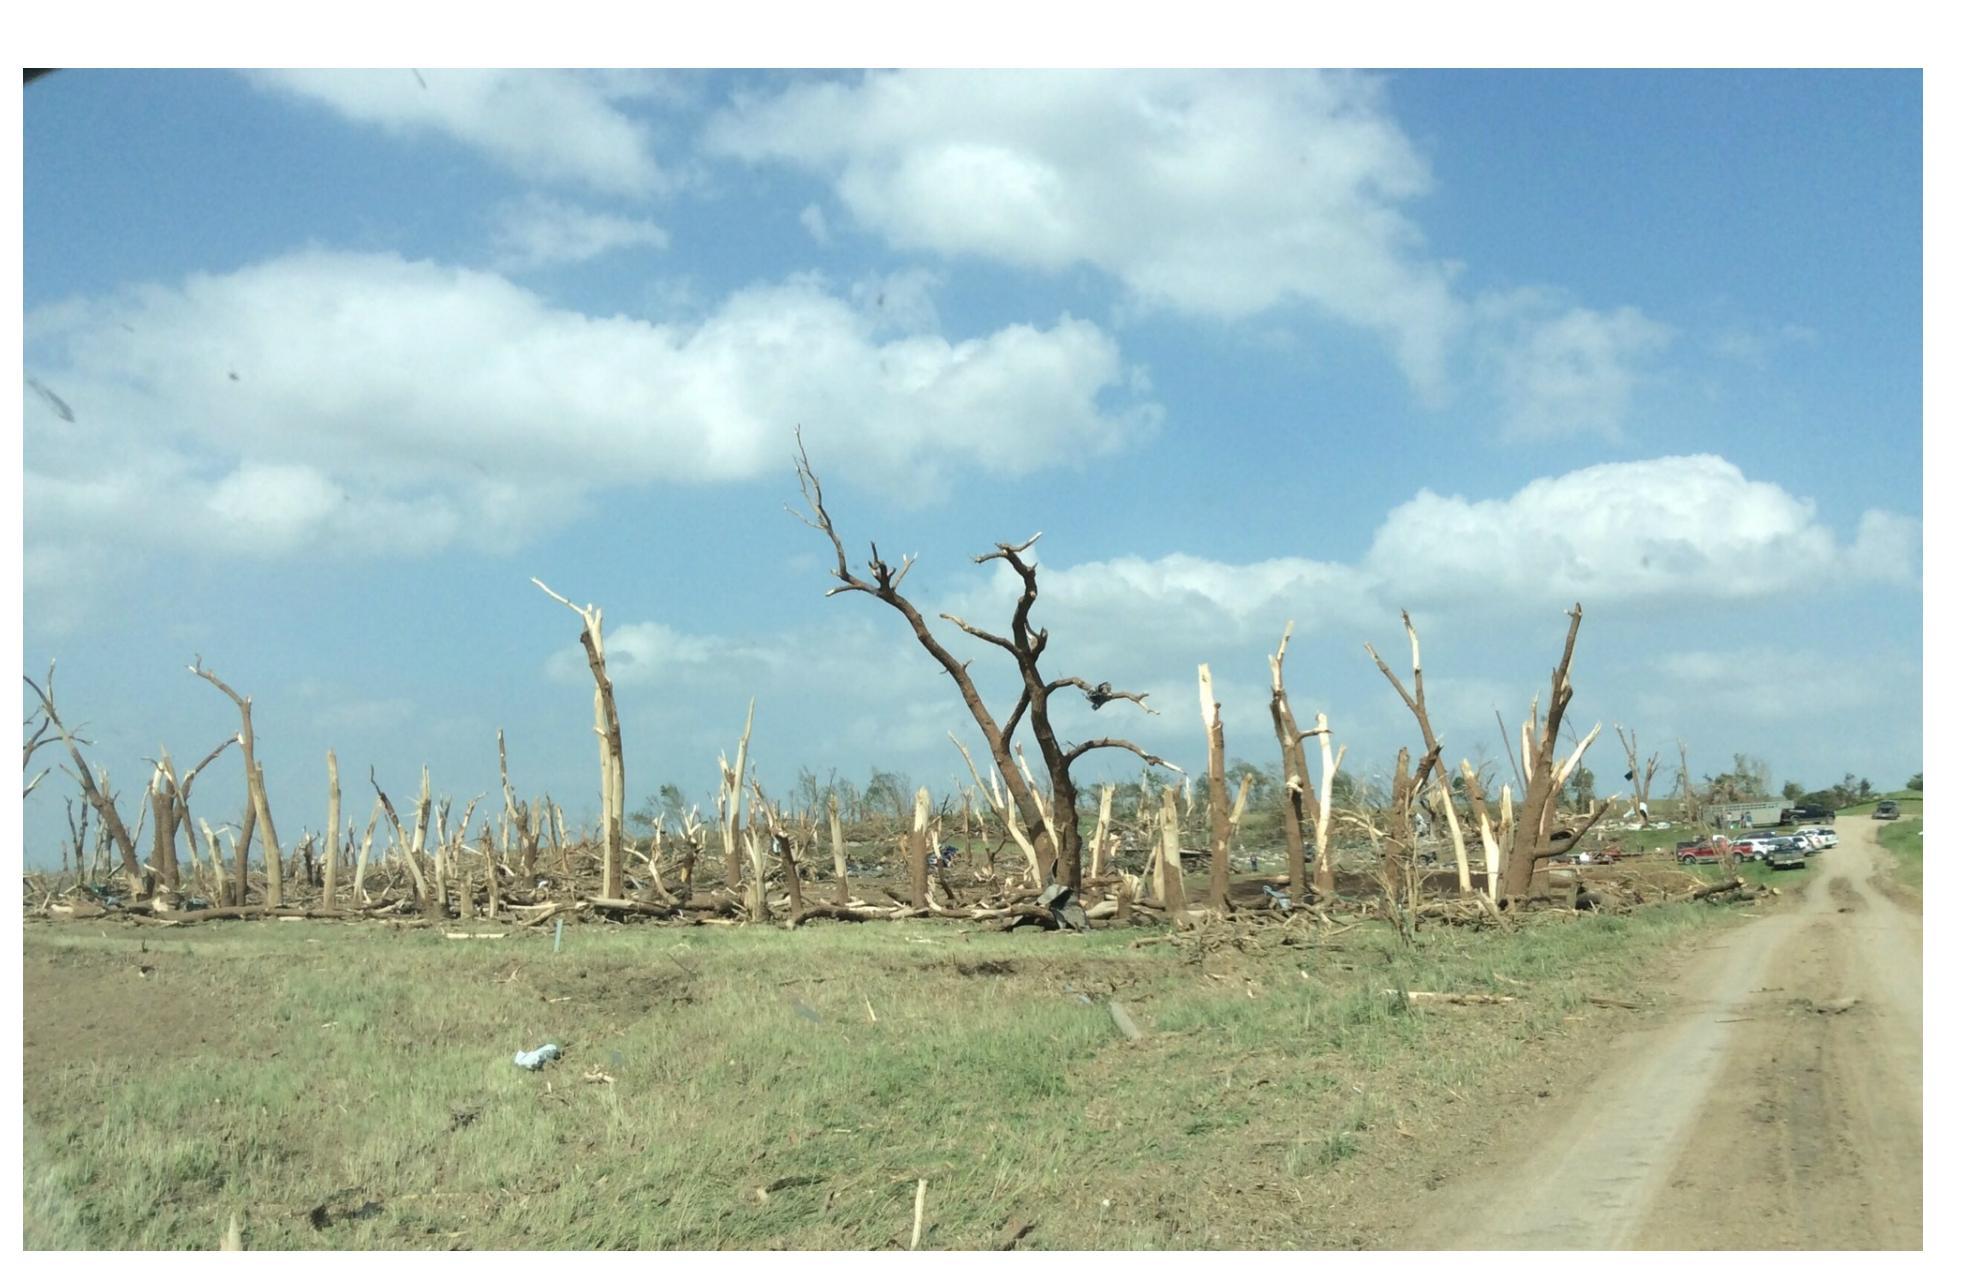
Debarked trees where two tornadoes crossed. Both tornadoes struck this farmstead approximately seven miles northeast of Pilger.

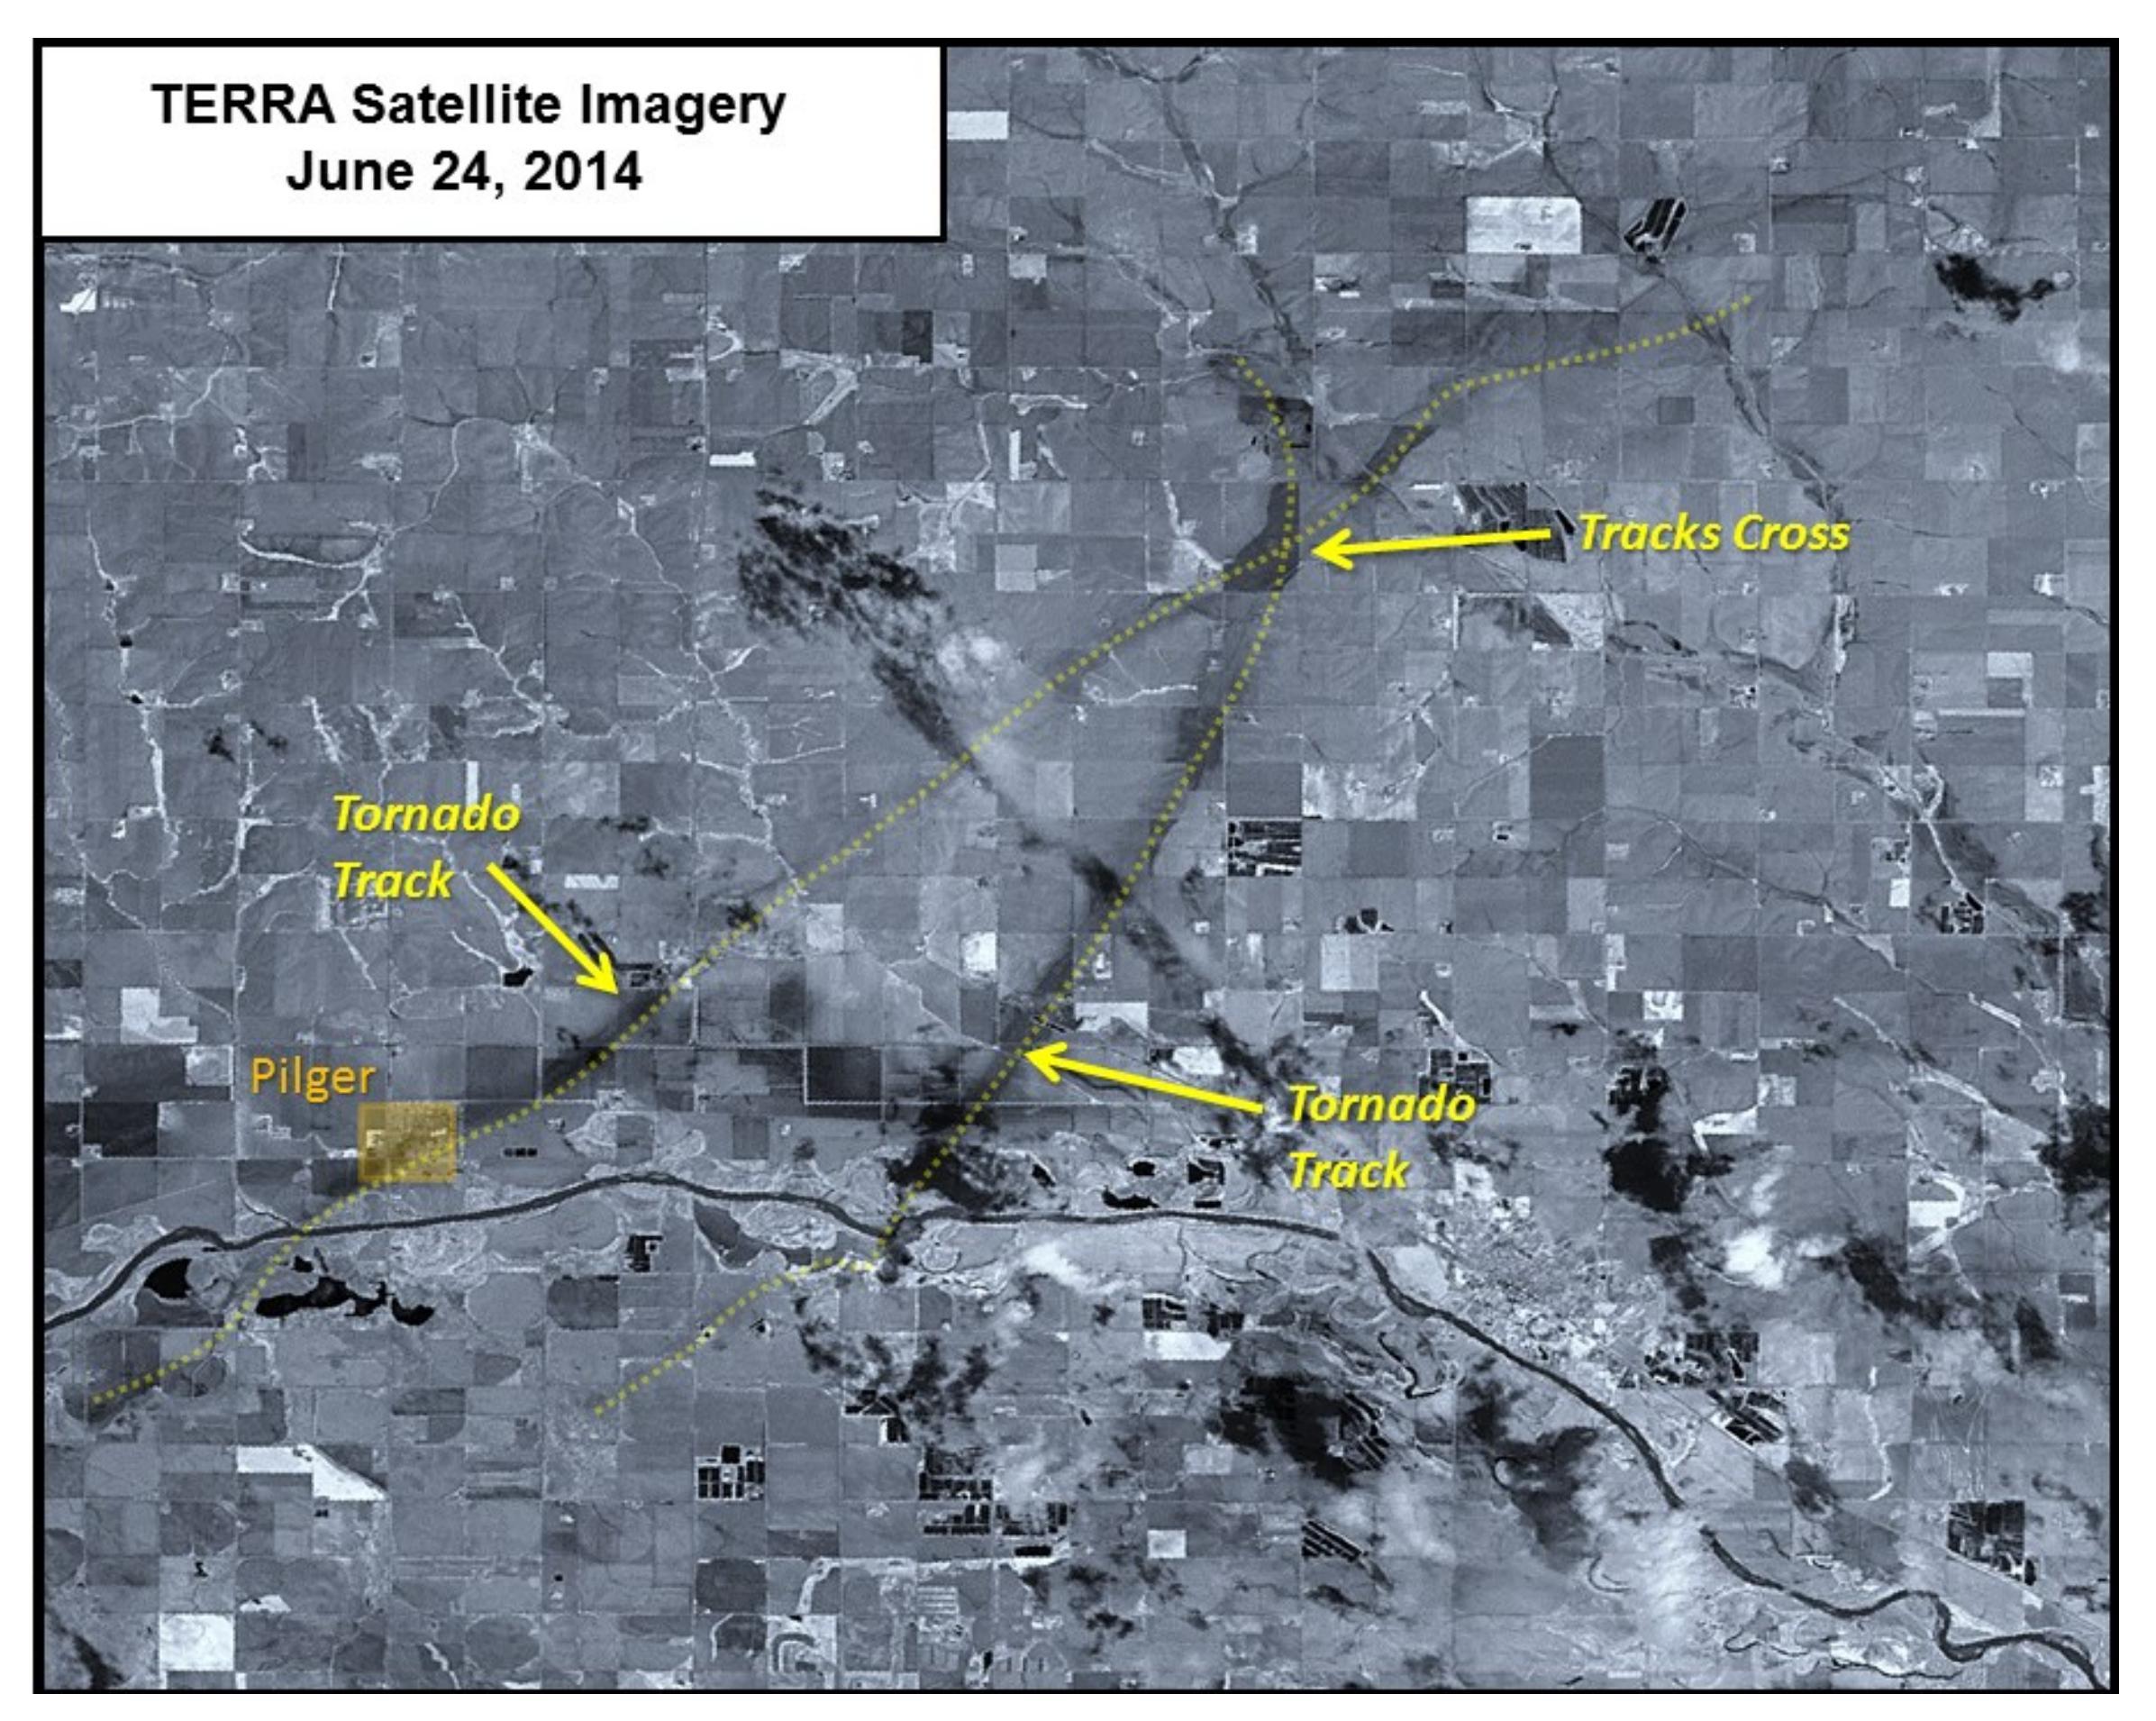
Terra satellite imagery that reveal the tornado tracks. This image clearly shows where the two tornado tracks crossed. Estimating the EF scale can be challenging at the crossover point..

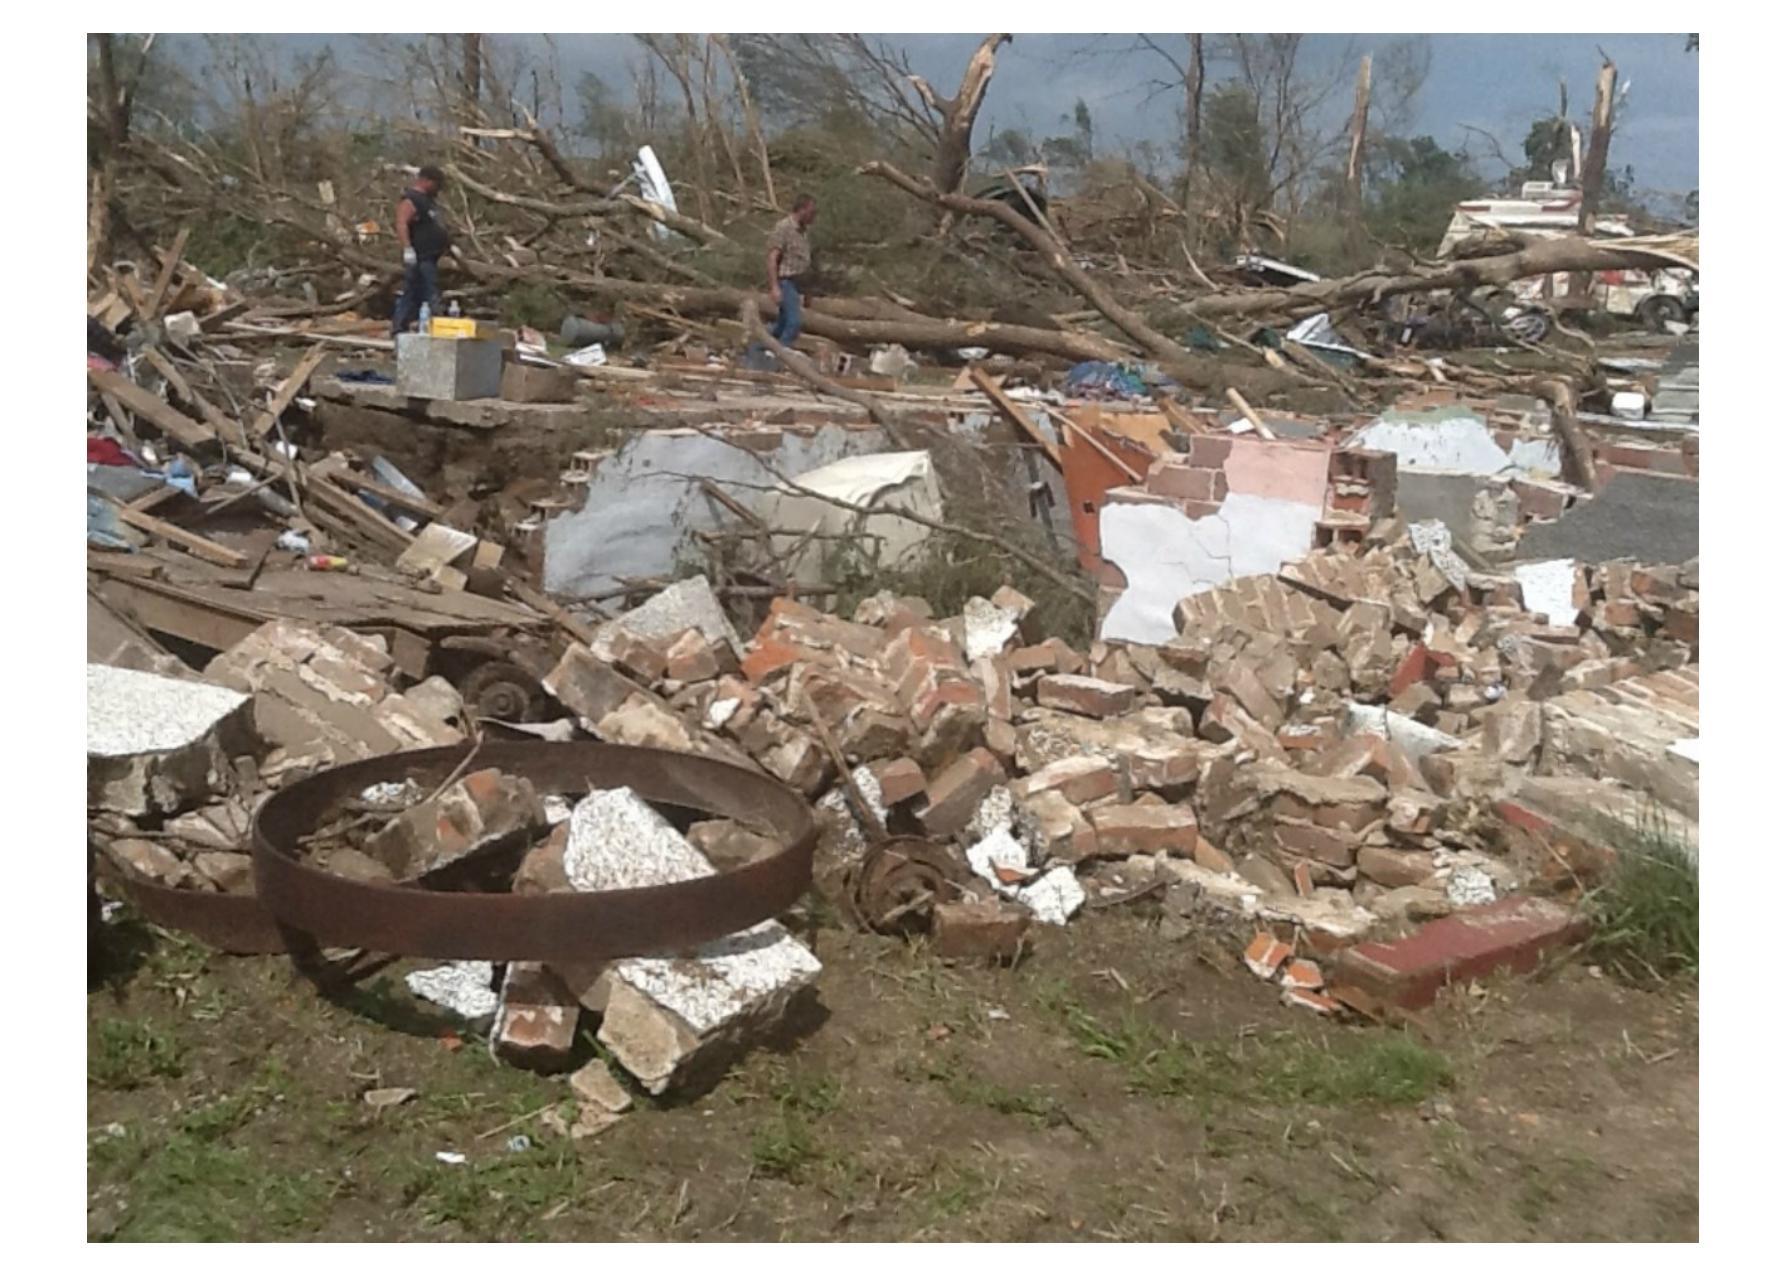
These are the remains of a farm home that was struck twice by the two tornadoes. The resident took refuge in the basement which was uncovered from the first tornado. Seeing the second tornado bearing down on him from the west, the farmer then climbed out of his basement and took shelter in a nearby storm cellar.
