Hurricane Andrew 20 years later: What have we learned?

Timothy P. Marshall*, Kenneth Gilvary, and Justin Kestner Haag Engineering Co.

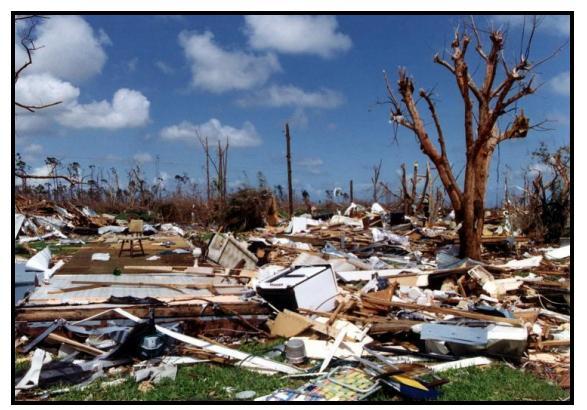
Safety standards for manufactured home construction developed by the Department of Housing and Urban Development (HUD) sometimes are called "HUD standards." At the time of Hurricane Andrew, HUD required that manufactured homes placed in hurricane regions (Wind Zone II) be designed and installed for a lateral wind load of 1.2 kPa (25 psf) and an uplift load of 0.72 kPa (15 psf). This would be equivalent to a wind speed of about 45 ms⁻¹ (100 mph). Of course, winds in Dade County exceeded this wind speed during Hurricane Andrew, and the destruction of manufactured homes was widespread. Close spacing of manufactured homes in parks contributed to shredding of neighboring homes due to flying debris (Fig. 2).

In Florida and Louisiana, we found that most manufactured homes had been anchored to the ground with stakes or augers. However, anchors either pulled out of the ground or the galvanized metal straps attached to the anchors broke. Anchorage failure led to vaulting or rolling of the homes. Where floor platforms remained intact, failures occurred where the walls were stapled or strapped to the wall bottom plates. Roof trusses also failed where stapled to the wall top plates.

Figure 2. Typical shredding of manufactured homes at a mobile home park in south Florida as a result of Hurricane Andrew.

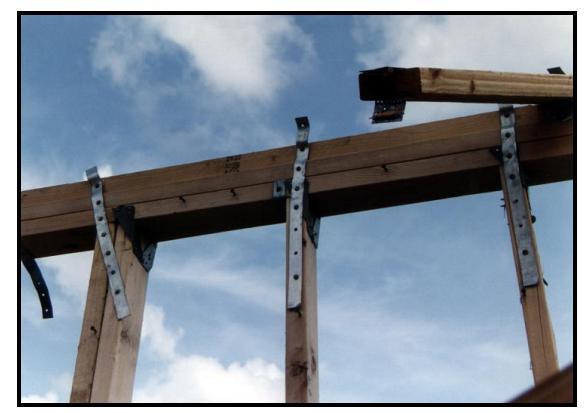
Figure 3. Loss of roof trusses due to inadequate strapping. Straps were nailed to the sides of the trusses instead of being wrapped completely around them.

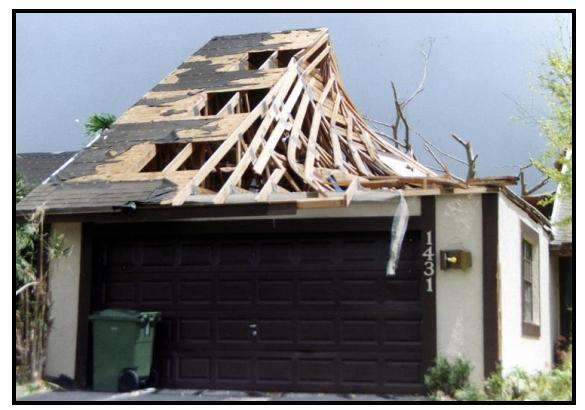
Figure 4. Rotation of wood trusses due to a lack of lateral bridging or blocking.

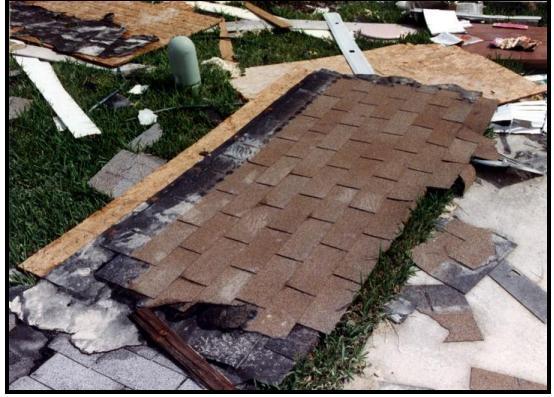
Figure 5. An entire sheet of oriented strand board (OSB) decking with shingles still attached. The roof deck had not been attached properly to the trusses.

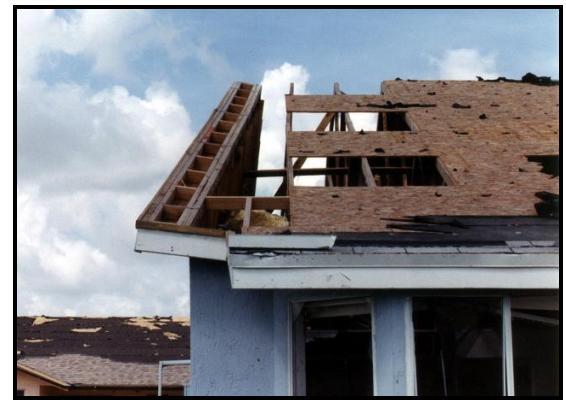
Figure 6. Ladder-rake detail at a gable end which rocked back and forth during the hurricane resulting in the loss of roof decking.

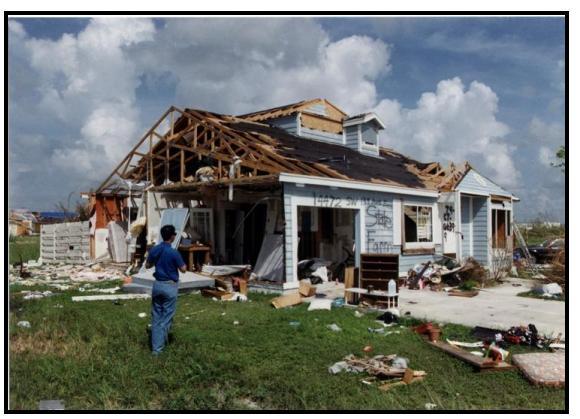
Internal pressure contributed to the loss of roofs and walls when windows and doors were breached (Fig. 7). Resultant wall openings caused additional positive pressures against the leeward and side walls. Garage doors failed either by buckling and/or detaching from the tracks. In some instances, door tracks pulled away door frames as they were not anchored properly.

Figure 7. Damage to a wood-framed house from Hurricane Andrew. Note the breached windows and doors which allowed internal pressure to push side and back walls outward.

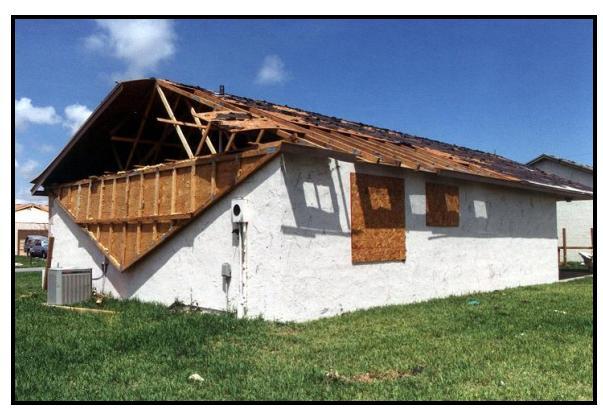
Homes constructed with CMU still had the same problems with roof coverings as did wood-framed residences. Problems included roof decking not being attached to the trusses. Gable ends were prone to being blown inward or outward because they were not secured properly to the roof framing (Fig. 8).

Figure 8. Gable end fell outward because it was not attached to the roof trusses.

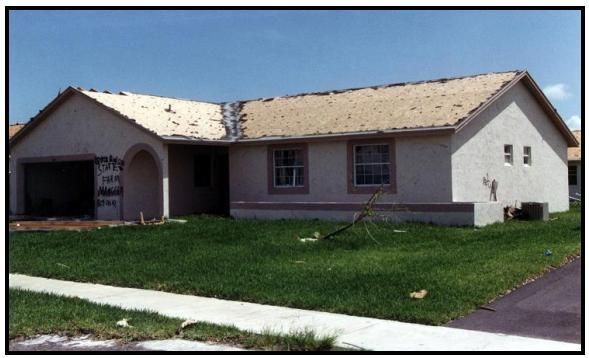
Asphalt shingles, especially the three-tab variety, were prone to being torn away by the wind. The tabs acted as "flaps" which flopped back and forth in the wind until the tabs broke loose. In some instances, shingles had been secured with staples driven so hard that the crowns cut into or penetrated the shingles. This caused the shingles to be removed in large mats or chunks. Felt underlayment tore away to expose the roof deck. Subsequent rains caused extensive water damage to interior finishes and furnishings (Figs. 9 and 10).

Figure 9. Loss of the asphalt shingle roof covering led to rainwater penetration and caused extensive interior damage.

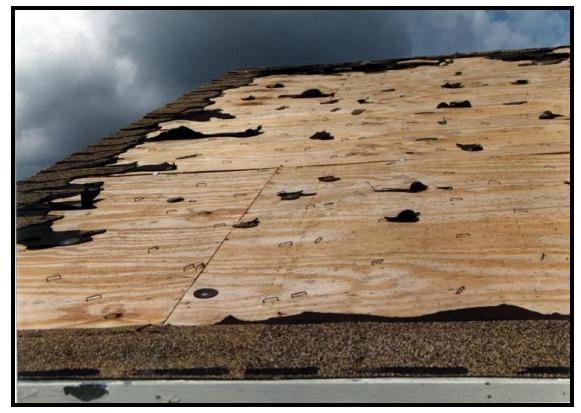
Figure 10. Close-up view of roof decking showing lost asphalt shingles and underlayment. The shingles had been installed with staples.

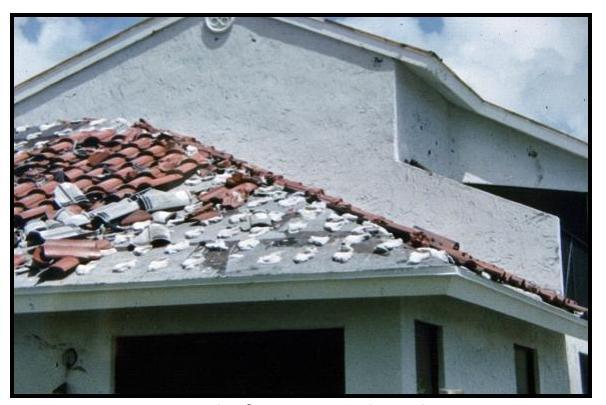
Numerous homes lost concrete and/or clay tile roof coverings. In many instances, the tiles were not attached to the roof substrate, although attempts had been made to secure the tiles with mortar placed on the underlayment. These mortar "patties" rarely bonded to the tiles (Fig. 11). When the mortar did bond to the tiles, tile loss resulted in holes being torn in the underlayment allowing rainwater penetration. Tiles nailed to wooden battens also performed poorly. In many instances, the tiles lifted over the fastener heads leaving the nailed battens intact. In these instances, fastener heads were smaller than manufactured nail holes in the tiles.

Figure 11. Removal of concrete tiles where an attempt had been made to secure the tiles with mortar.

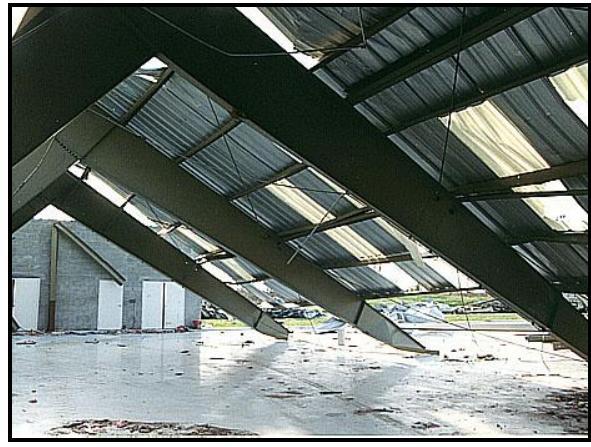
At Tamiami Airport, steel framed hangars collapsed when columns failed at welded plate connections or pulled out of the foundations (Figs. 12 and 13). However, smaller metal buildings fared much better, especially if their large doors faced directions opposite the oncoming wind.

Figure 12. Failure of a steel-framed building at the column bases.

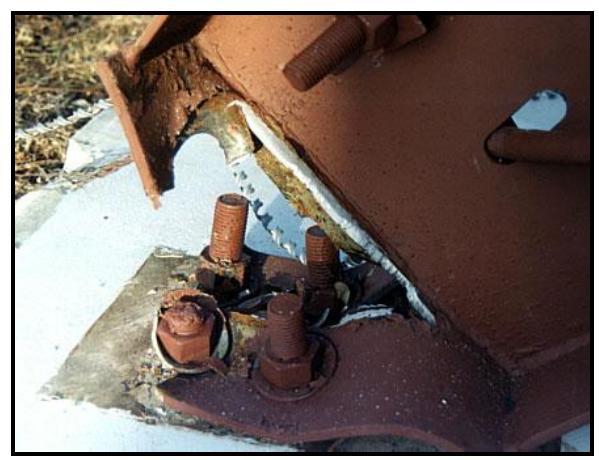
Figure 13. Failure of a welded base plate connection at the base of a column in a metal building.
