Performance of Concrete Masonry Buildings in the Joplin Tornado

Timothy P. Marshall, P.E.* Haag Engineering Company

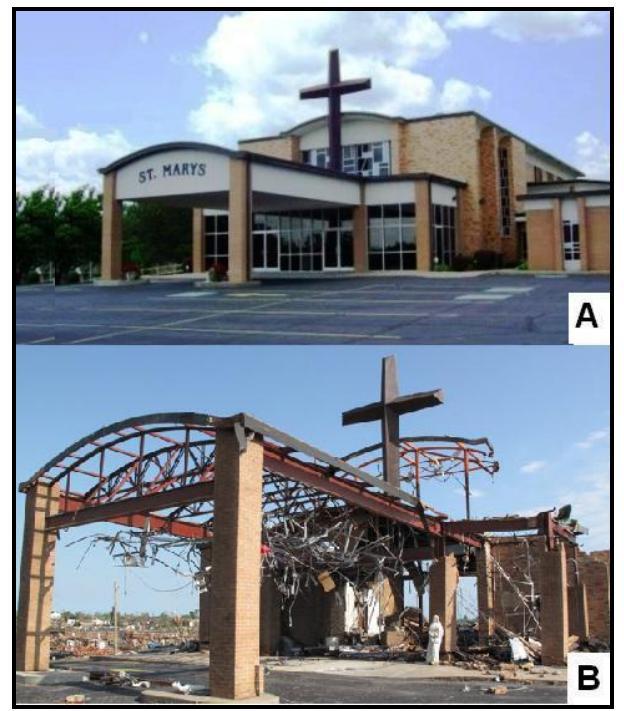
St. Mary's Church/School was in the middle of the tornado damage path. The building had a two-story sanctuary on the west end and a one-story school that extended east from the sanctuary. The center of the tornado passed directly over the building. South walls fell to the north, east walls fell to the east, north walls fell to the south, and some of the steel beams that supported the sanctuary roof, were transported west across Moffet Ave. The carport structure on the south side of the building remained intact along with the steel cross (Fig. 4).

Figure 4. South elevation views of St. Mary's Church before (a) and after (b) the tornado. The carport structure and cross remained, but the sanctuary and school structure collapsed. The pre-storm image was obtained from Google Earth.

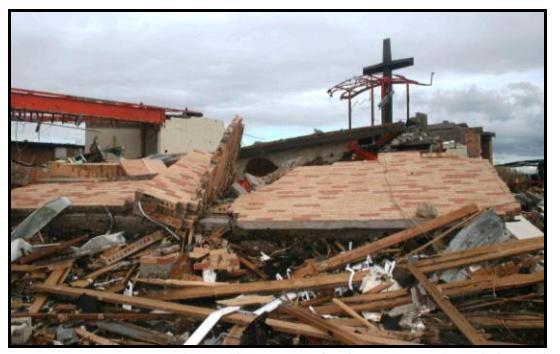
The sanctuary was a steel-framed structure with non load-bearing perimeter walls consisting of CMU interior and exterior brick veneer. There was no air space between the CMU and brick. Steel columns fell into the sanctuary pulling apart bolts that connected their base plates to the concrete slab foundation. Non load-bearing masonry walls fell inward, pivoting about bases of the walls. Close examination revealed no vertical reinforcement between the walls and the slab foundation (Fig. 5). The walls essentially were unanchored.

Figure 5. Inward collapse of the non load-bearing masonry wall on the northwest side of the sanctuary at St. Mary's Church. The unanchored wall pivoted about its base.

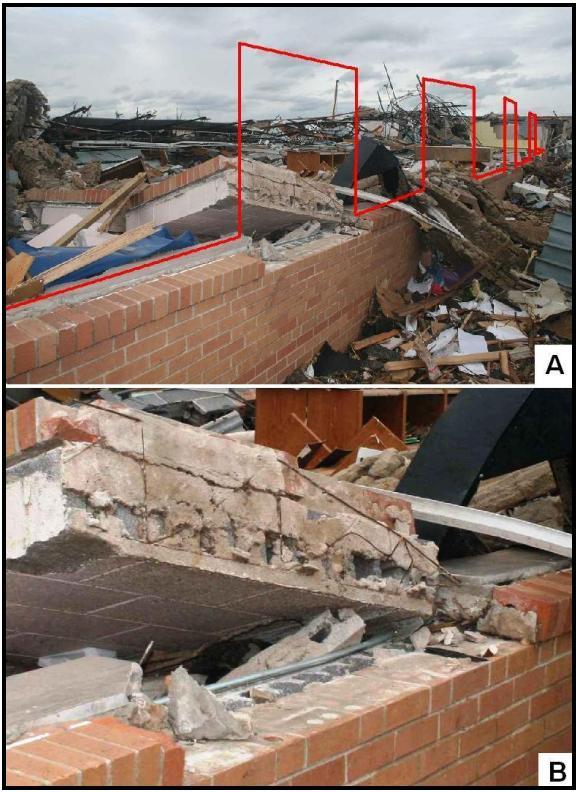
schools, classrooms had large arrays of glass windows. Windows were in the non load-bearing north and south walls. There were masonry columns, about 1.5 m wide, between the window arrays. Since the masonry columns were not load-bearing, they did not have vertical reinforcement or grouted cells. Failure of the masonry columns occurred along horizontal lines at window sill level (Fig. 6).

Figure 6. Inward failure of the south, non loadbearing, masonry wall along a horizontal line window sill level: (a) columns outlined in red, and (b) closer view showing the absence of vertical reinforcement where columns failed.

According to the EF scale, the expected value for total destruction of a large section of an Elementary School (ES) building or entire building would be 79 ms⁻¹ (176 mph), with a lower bound of 68 ms⁻¹ (152 mph), and an upper bound of 91 ms⁻¹ (203 mph). Given the observed absence of vertical reinforcement within the CMU walls, with the steel carport structure remaining intact, the author selected the lower bound failure wind speed at 68 ms⁻¹ (152 mph) or EF-3. Five cars in parking lots near the church were moved during the tornado, but remained upright.

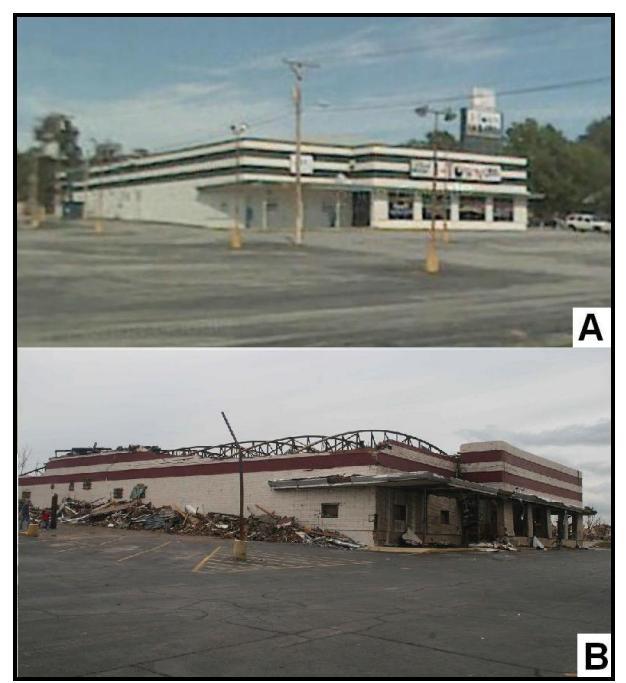
The center of the tornado passed directly over the bowling alley removing the roof covering and joists. However, steel roof trusses and the perimeter masonry walls remained intact except for a portion of the west wall that collapsed near the northwest corner apparently when struck by a truck. The northernmost truss fell when that portion of the load-bearing wall toppled (Figs. 7 and 8).

Figure 7. Southwest elevation of the bowling alley: (a) before and (b) after the tornado. Walls and trusses remained intact except at the north end of the building where a truck impacted the west wall. The pre-storm image was obtained from Google Earth.

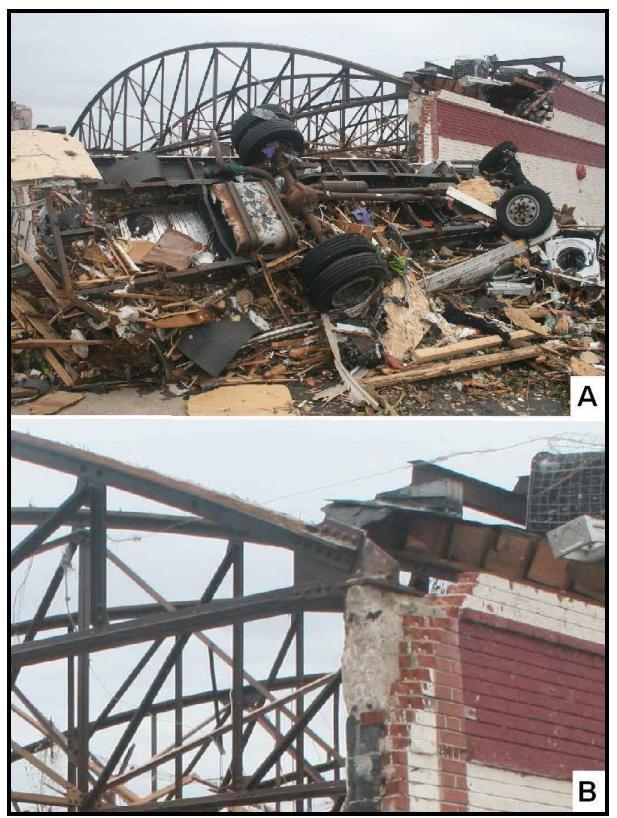
Figure 8. Damage to the west CMU wall where a truck impacted: (a) overall view and (b) close-up view showing the thick concrete bond beam atop the CMU wall.

According to the EF-scale, the expected value for uplift and removal of the roof structure for a large, isolated, retail building (LIRB) would be 60 ms⁻¹ (134 mph). If not for the truck impact, the load-bearing wall and north roof truss probably would have stayed intact. Whether the degrees of damage (DOD) 5 or 6 are selected, the failure wind speed would have been in the EF-2 to EF-3 range.

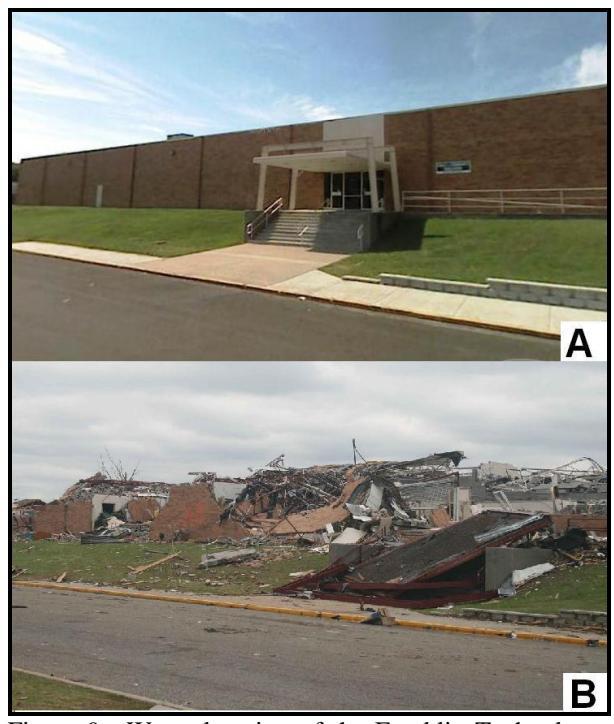
Figure 9. West elevation of the Franklin Technology Center: (a) before and (b) after the tornado. The building was located at the north end of the tornado damage path. The pre-storm image was obtained from Google Earth.

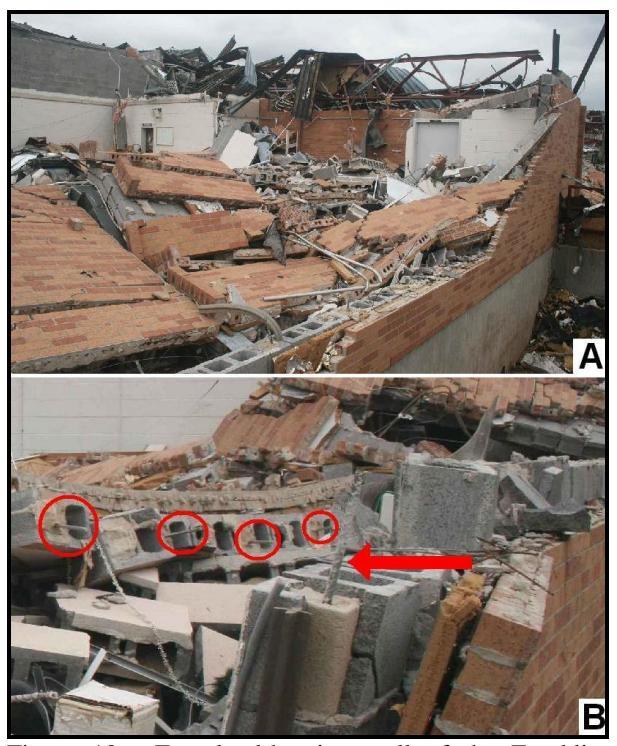
Close examination of the load-bearing masonry walls revealed failure occurred where the foundation rebar lapped the wall rebar, a few courses above the foundation slab surface (Fig. 10). At most, the lap was the height of one CMU, about 20 cm (8 in). The wall rebar simply pulled out of the grouted cells or became detached when the grouted cells broke. Non load-bearing CMU walls at the north and south ends of the building were not anchored to the footing and rotated inward at the slab surface.

According to the EF scale, the expected value for total destruction of a large section or an entire Elementary School (ES) building would be 79 ms⁻¹ (176 mph), with a lower bound of 68 ms⁻¹ (152 mph), and an upper bound of 91 ms⁻¹ (203 mph). Given the observed poor construction of the building, the author selected the lower bound failure wind speed at 68 ms⁻¹ (152 mph) or EF-3.

Figure 10. East load-bearing wall of the Franklin Technology Center fell into the building causing collapse of the roof: (a) overall view and (b) close-up view showing exposed wall rebar (circled) and foundation rebar (arrow).

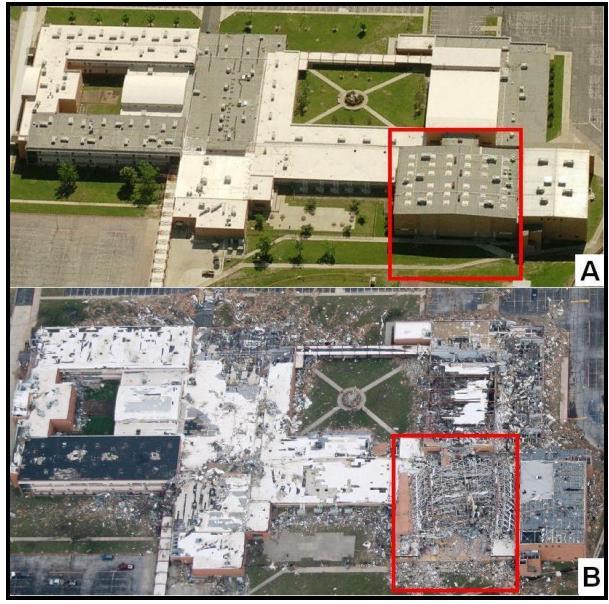
The High School was on the north end of the damage path and experienced the strongest winds from the north and east. A portion of the exterior north CMU wall and several interior partition walls fell into the second story hallway. This could have been tragic had these hallways been occupied during the tornado (Figs. 11 and 12).

Figure 11. Aerial images of the Joplin High School looking east: (a) before and (b) after the tornado. The gymnasium (red box) collapsed. The pre-storm image was obtained from Bing.com.

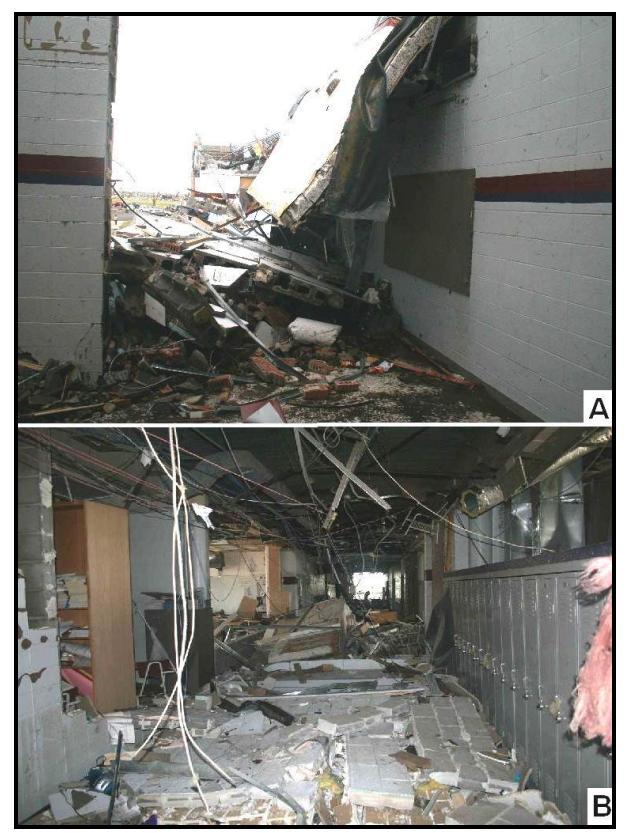
Figure 12. Collapse of second story CMU walls at the Joplin High School: (a) north hallway and (b) center hallway.

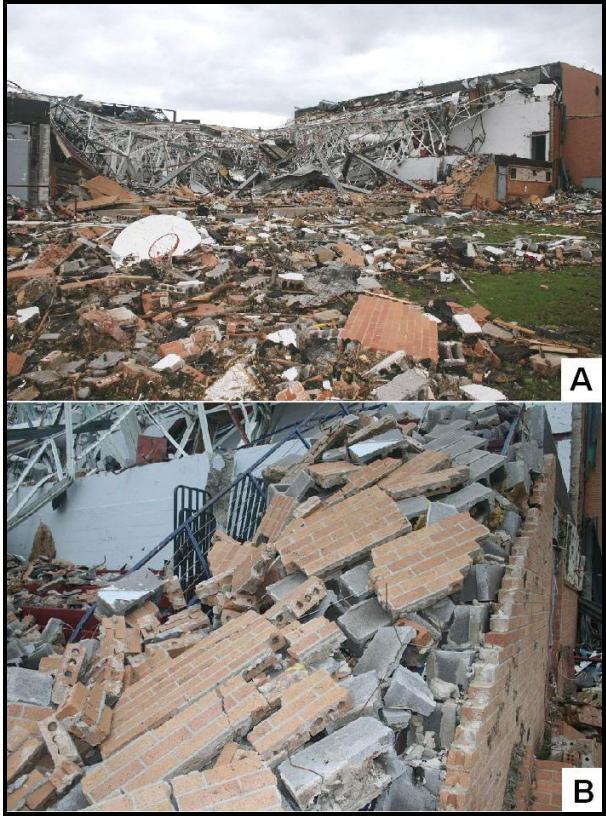
The north load-bearing wall had fallen inward causing collapse of the roof. The south end of the non load-bearing west wall had toppled inward, and the north end fell outward. Gymnasium walls were approximately 10 m (33ft) tall (Fig. 13).

Figure 13. Collapse of CMU walls at the Joplin High School Gymnasium: (a) overall view looking east, and (b) close-up of the non load-bearing west which fell inward.

According to the EF scale, the expected value for total the collapse of tall masonry walls at a gymnasium (DOD 7) would be 51 ms⁻¹ (114 mph) with collapse of exterior walls in the top floor being 62 ms⁻¹ (139 mph). The author selected the higher wind speed which is at the lower end of EF-3.

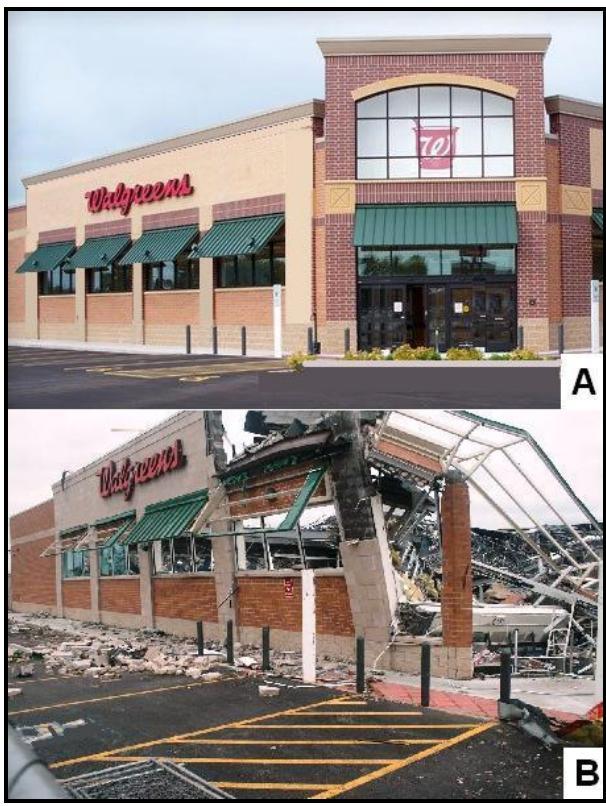
The building was in the center of the tornado damage path. The non load-bearing west wall fell inward, pivoting about the base of the wall. Positive internal pressure helped push the top of the north load-bearing wall outward, and the roof collapsed (Fig. 14).

This building was a small retail building (SRB) and the roof structure collapsed (DOD 6), along with some exterior walls (DOD 7), but the building was not totally destroyed (DOD 8). Thus, the expected failure wind speed for DOD 7 was around 62 ms^{-1} (138 mph), or EF-3 on the EF-scale.

Figure 14. North elevation of the Walgreens Drug Store: (a) before and (b) after the tornado.

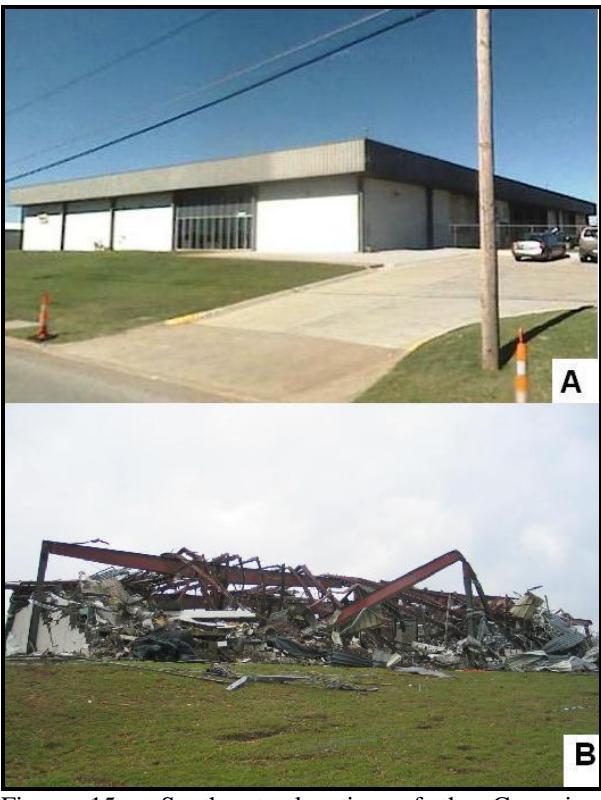
The building was in the center of the tornado damage path and completely collapsed (Fig. 15). South and west walls fell into the building while north and east walls fell outward. There was no anchoring of the CMU walls to the roof structure or foundation.

This building was selected as an automobile service building (ASB) and was destroyed (DOD 8). Thus, the expected value failure wind speed was around 70 ms⁻¹ (157 mph) or EF-3 on the EF-scale.

Figure 15. Southeast elevation of the Cummins Equipment building: (a) before and (b) after the tornado. This steel-framed structure had non loadbearing CMU walls that collapsed during the tornado. The pre-storm image was obtained from Google Earth.

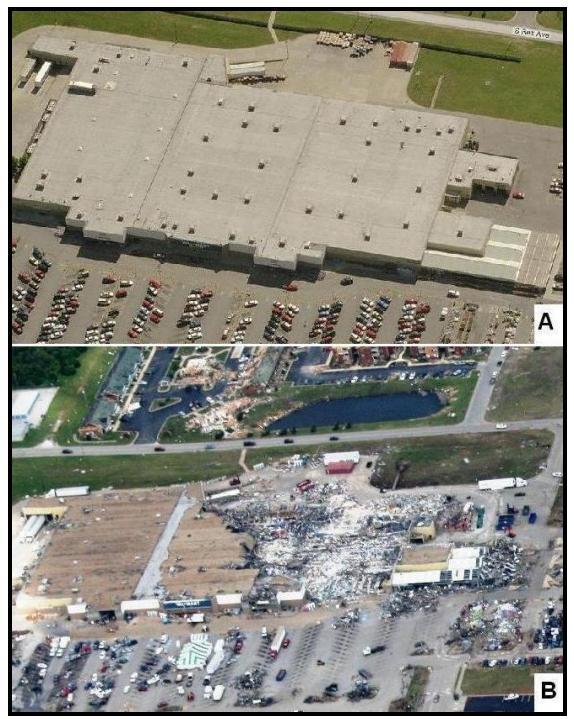
This building was near the northern edge of the tornado damage path. The south half of the building collapsed but the north half remained intact. East and west walls toppled into the building and the south wall fell outward. Failure of the load-bearing walls caused the roof to collapse (Fig. 16).

Figure 16. Aerial view looking east of the Walmart building: (a) before and (b) after the tornado. The south half of the building collapsed. The pre-storm image was obtained from Bing.com.

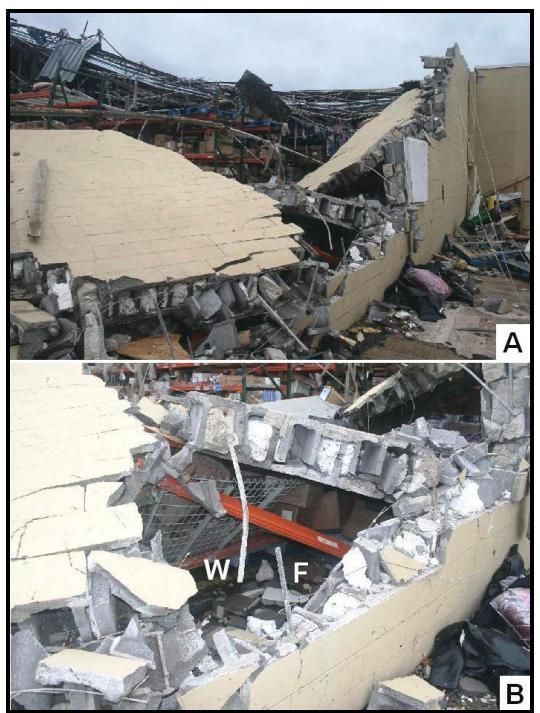
Close examination of the CMU walls indicated that walls failed where the foundation and wall rebar lapped. Both foundation and wall rebar pulled out of the broken grouted cells (Fig. 17).

According to the EF-scale, the expected value for the complete destruction of a large section of an LIRB building would be 77 ms⁻¹ (173 mph) or EF-4. Cars in the parking lot were moved, rolled, tumbled, and lofted. One vehicle was wrapped around a tree such that the frame was bent into a U-shape (Fig. 18).

Figure 17. Inward collapse of the east wall on the Walmart building: (a) overall view and (b) close-up view. Failure occurred when wall rebar (W) pulled out of the grouted cells leaving the foundation rebar (F).

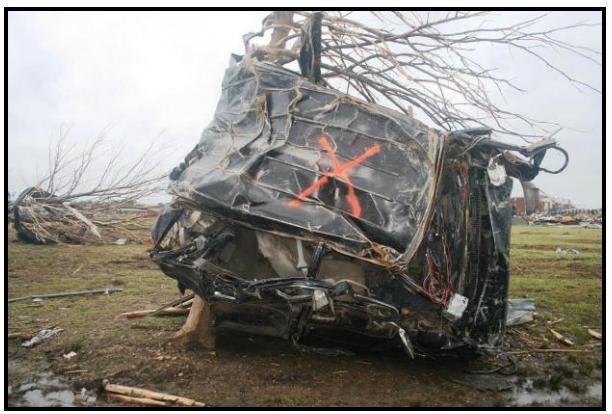
Figure 18. Four-door vehicle bent into a U-shape around a tree just south of the Walmart building.

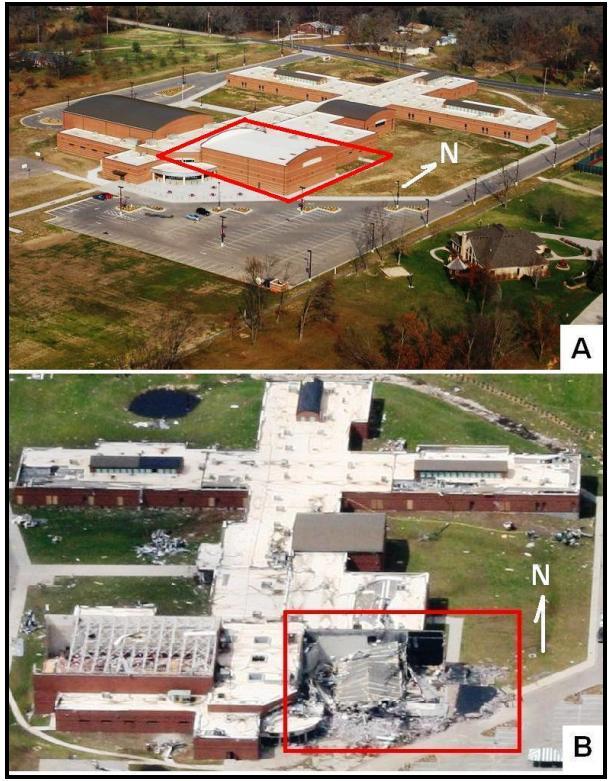
The center of the tornado passed directly over the school. Strong west winds and positive internal pressure caused the east wall in the auditorium to fall to the east and the south wall to fall to the south, resulting in collapse of the entire roof structure. Remaining CMU walls in the school remained intact. Close examination of the toppled CMU walls in the auditorium revealed that rebar extending out of the foundation simply pulled out of grouted cells at the bases of the walls while vertical rebar in the walls were pulled apart (Fig. 20).

Figure 19. Aerial view of the East Joplin Middle School: (a) before and (b) after the tornado. The red outline indicates the location of the auditorium which collapsed. The pre-storm image was obtained from Bing.com.

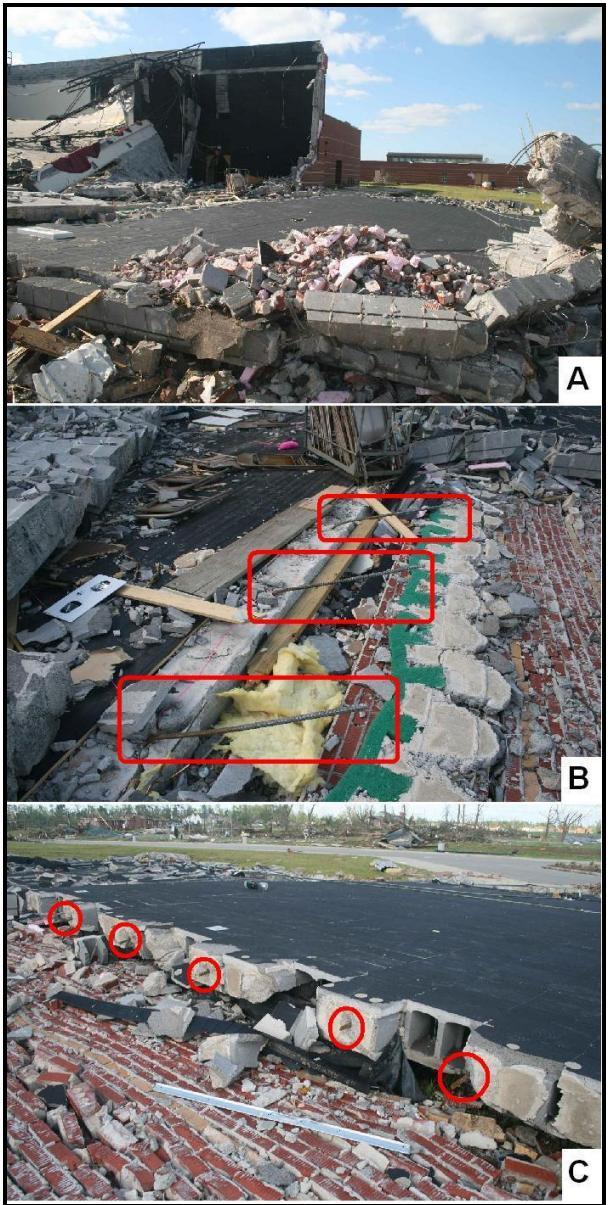
According to the EF scale, the expected value for the collapse of the roof structure for an Elementary School (ES) building (DOD 7) would be 56 ms⁻¹ (125 mph) with an upper bound of 66 ms⁻¹ (148 mph) and lower bound of 48 ms⁻¹ (108 mph). Given that collapses were confined to the two largest spans in the school, and that there was little lateral strength in the large walls, the author selected the failure wind speed at around 125 mph or EF-2.

Figure 20. Details of the east wall that failed in the East Joplin Middle School auditorium: (a) overall view looking north, (b) bent foundation rebar (circled), and (c) broken rebar (circled) at the base of the east wall.
