Damage Survey and Analysis of the 20 May 2013 Newcastle-Moore, OK, EF-5 Tornado Kiel Ortega^{1,2}, Donald Burgess^{1,2}, Gabriel Garfield^{1,3}, Christopher Karstens^{1,2}, James LaDue⁴, Timothy Marshall⁵, Tiffany Meyer^{1,4}, Brandon Smith^{1,2}, ¹Univ. Oklahoma/CIMMS ² NOAA/OAR/NSSL ³NOAA/NWS/WFO OUN **Richard Smith³, Doug Speheger³, and Gregory Stumpf**^{1,6} ⁴ NOAA/NWS/WDTB ⁵Haag Engineering Company ⁶ NOAA/NWS/MDL

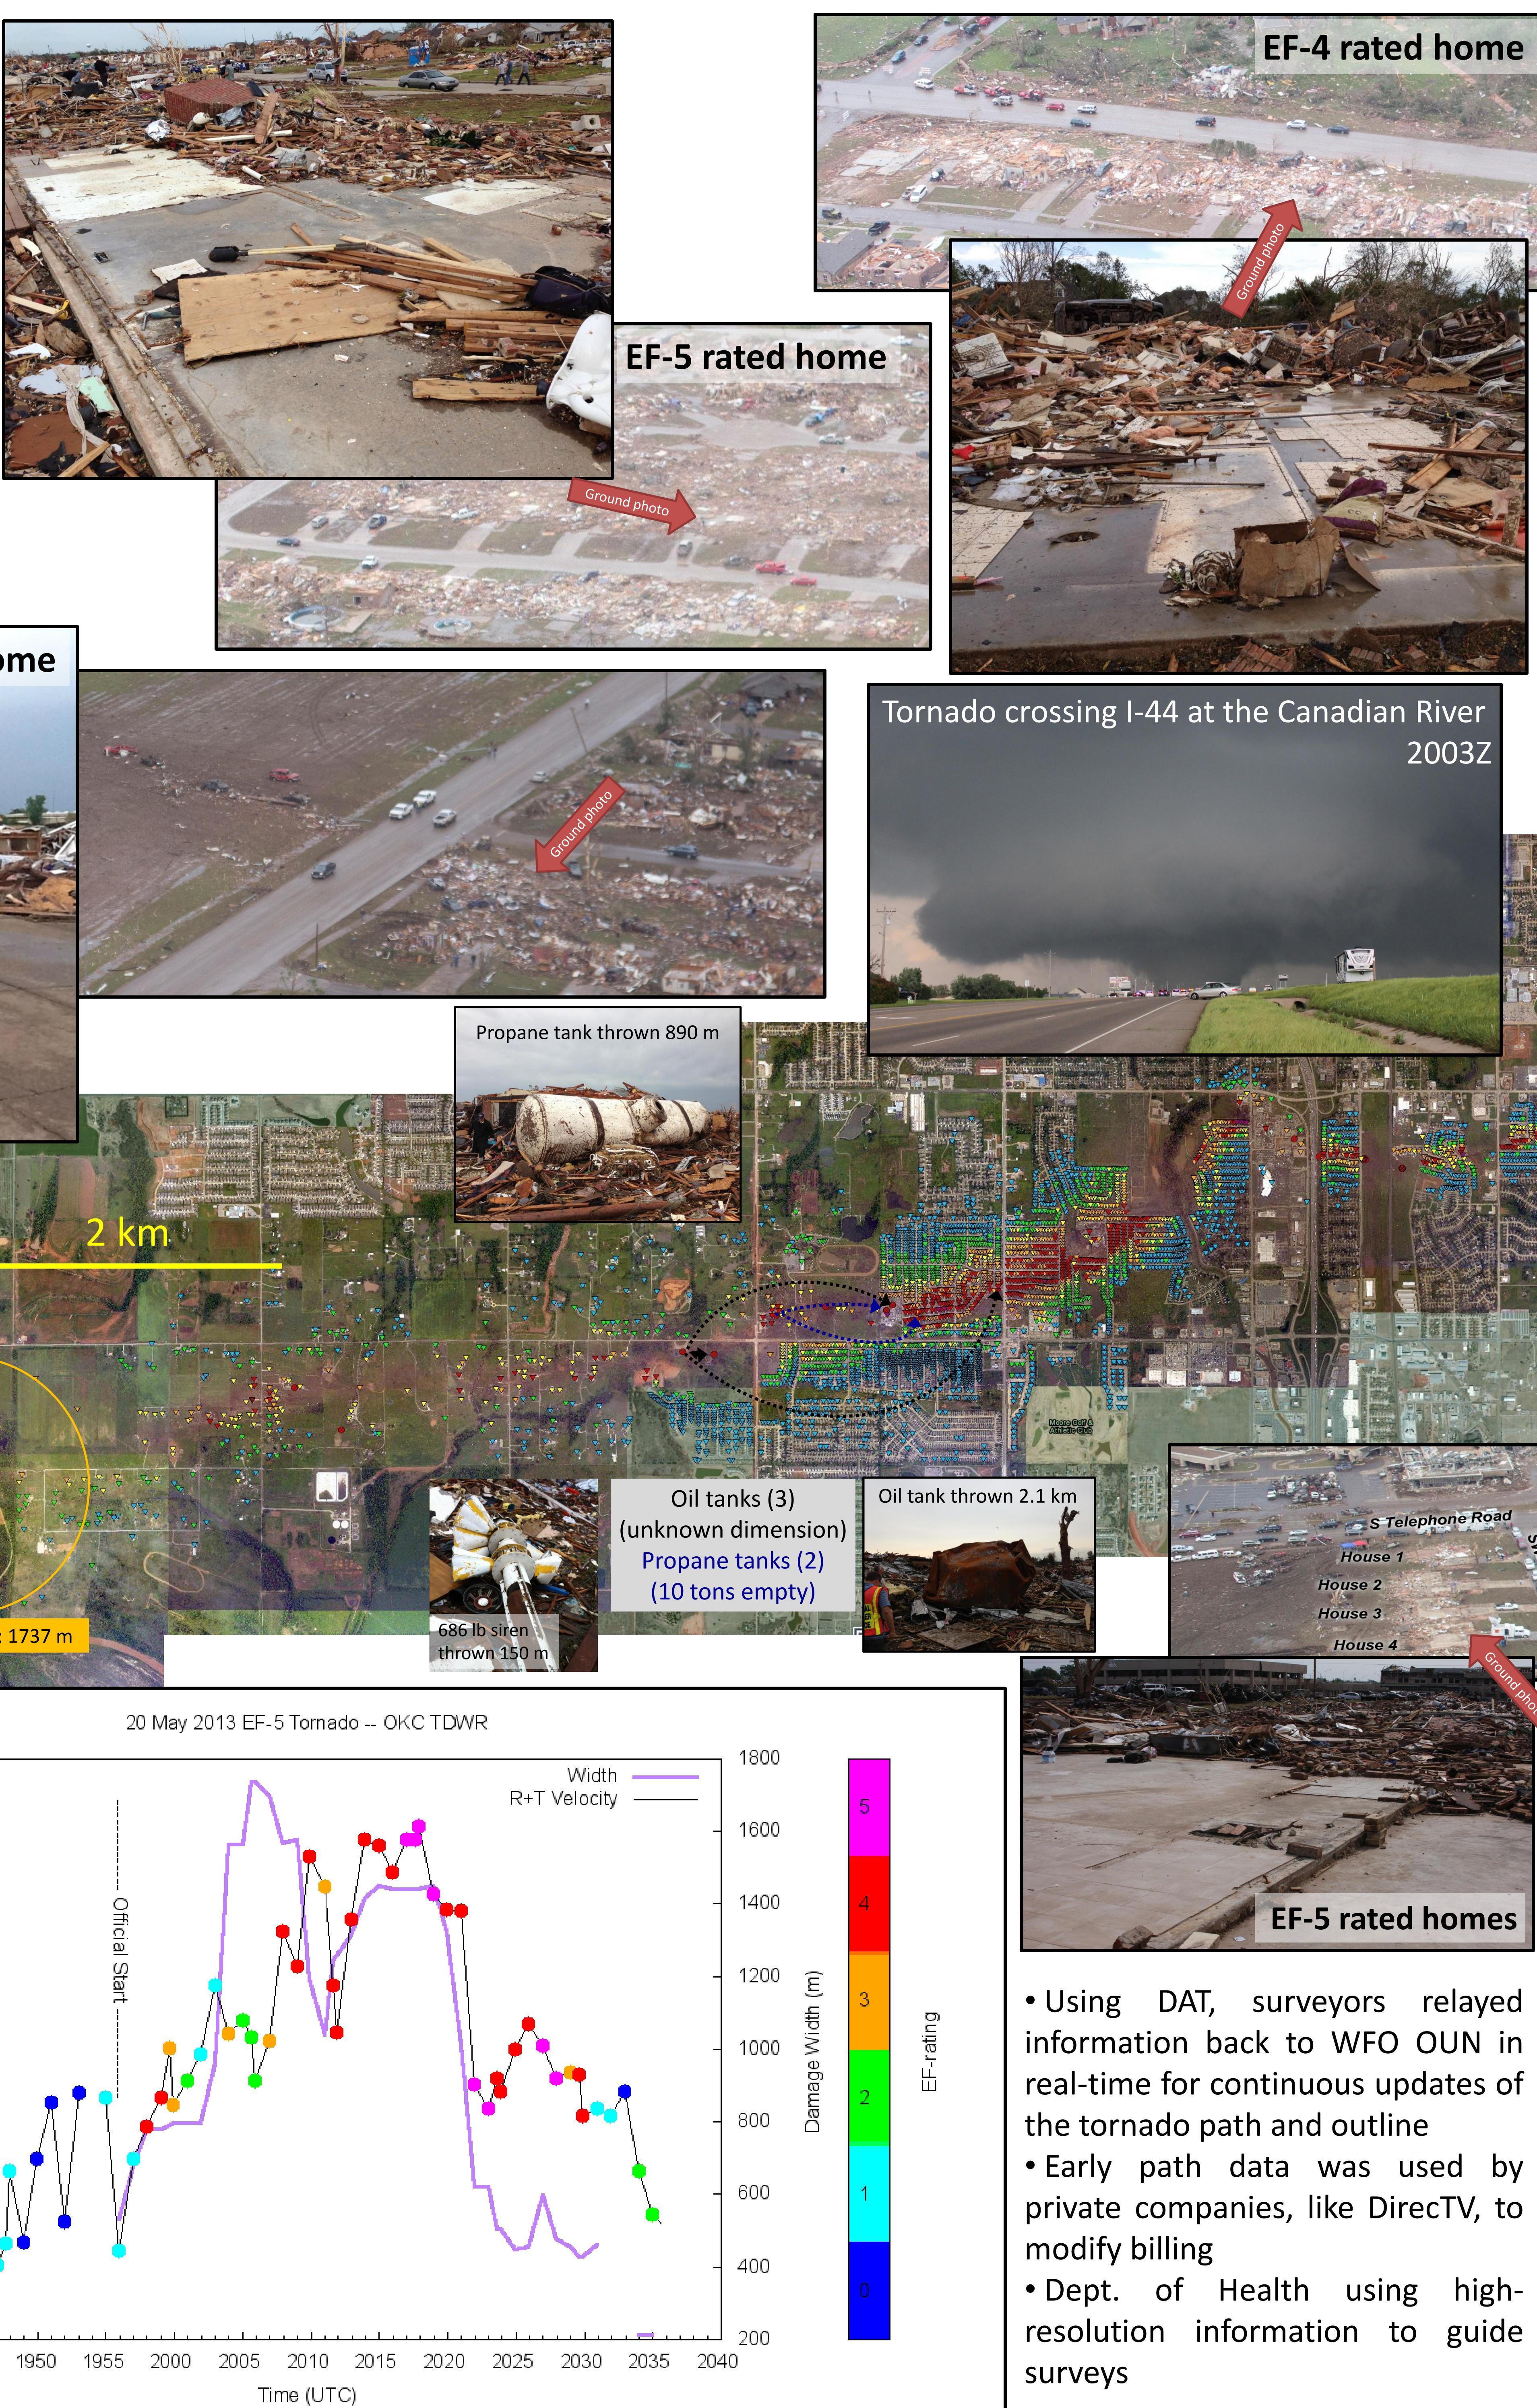
EF-4 rated home

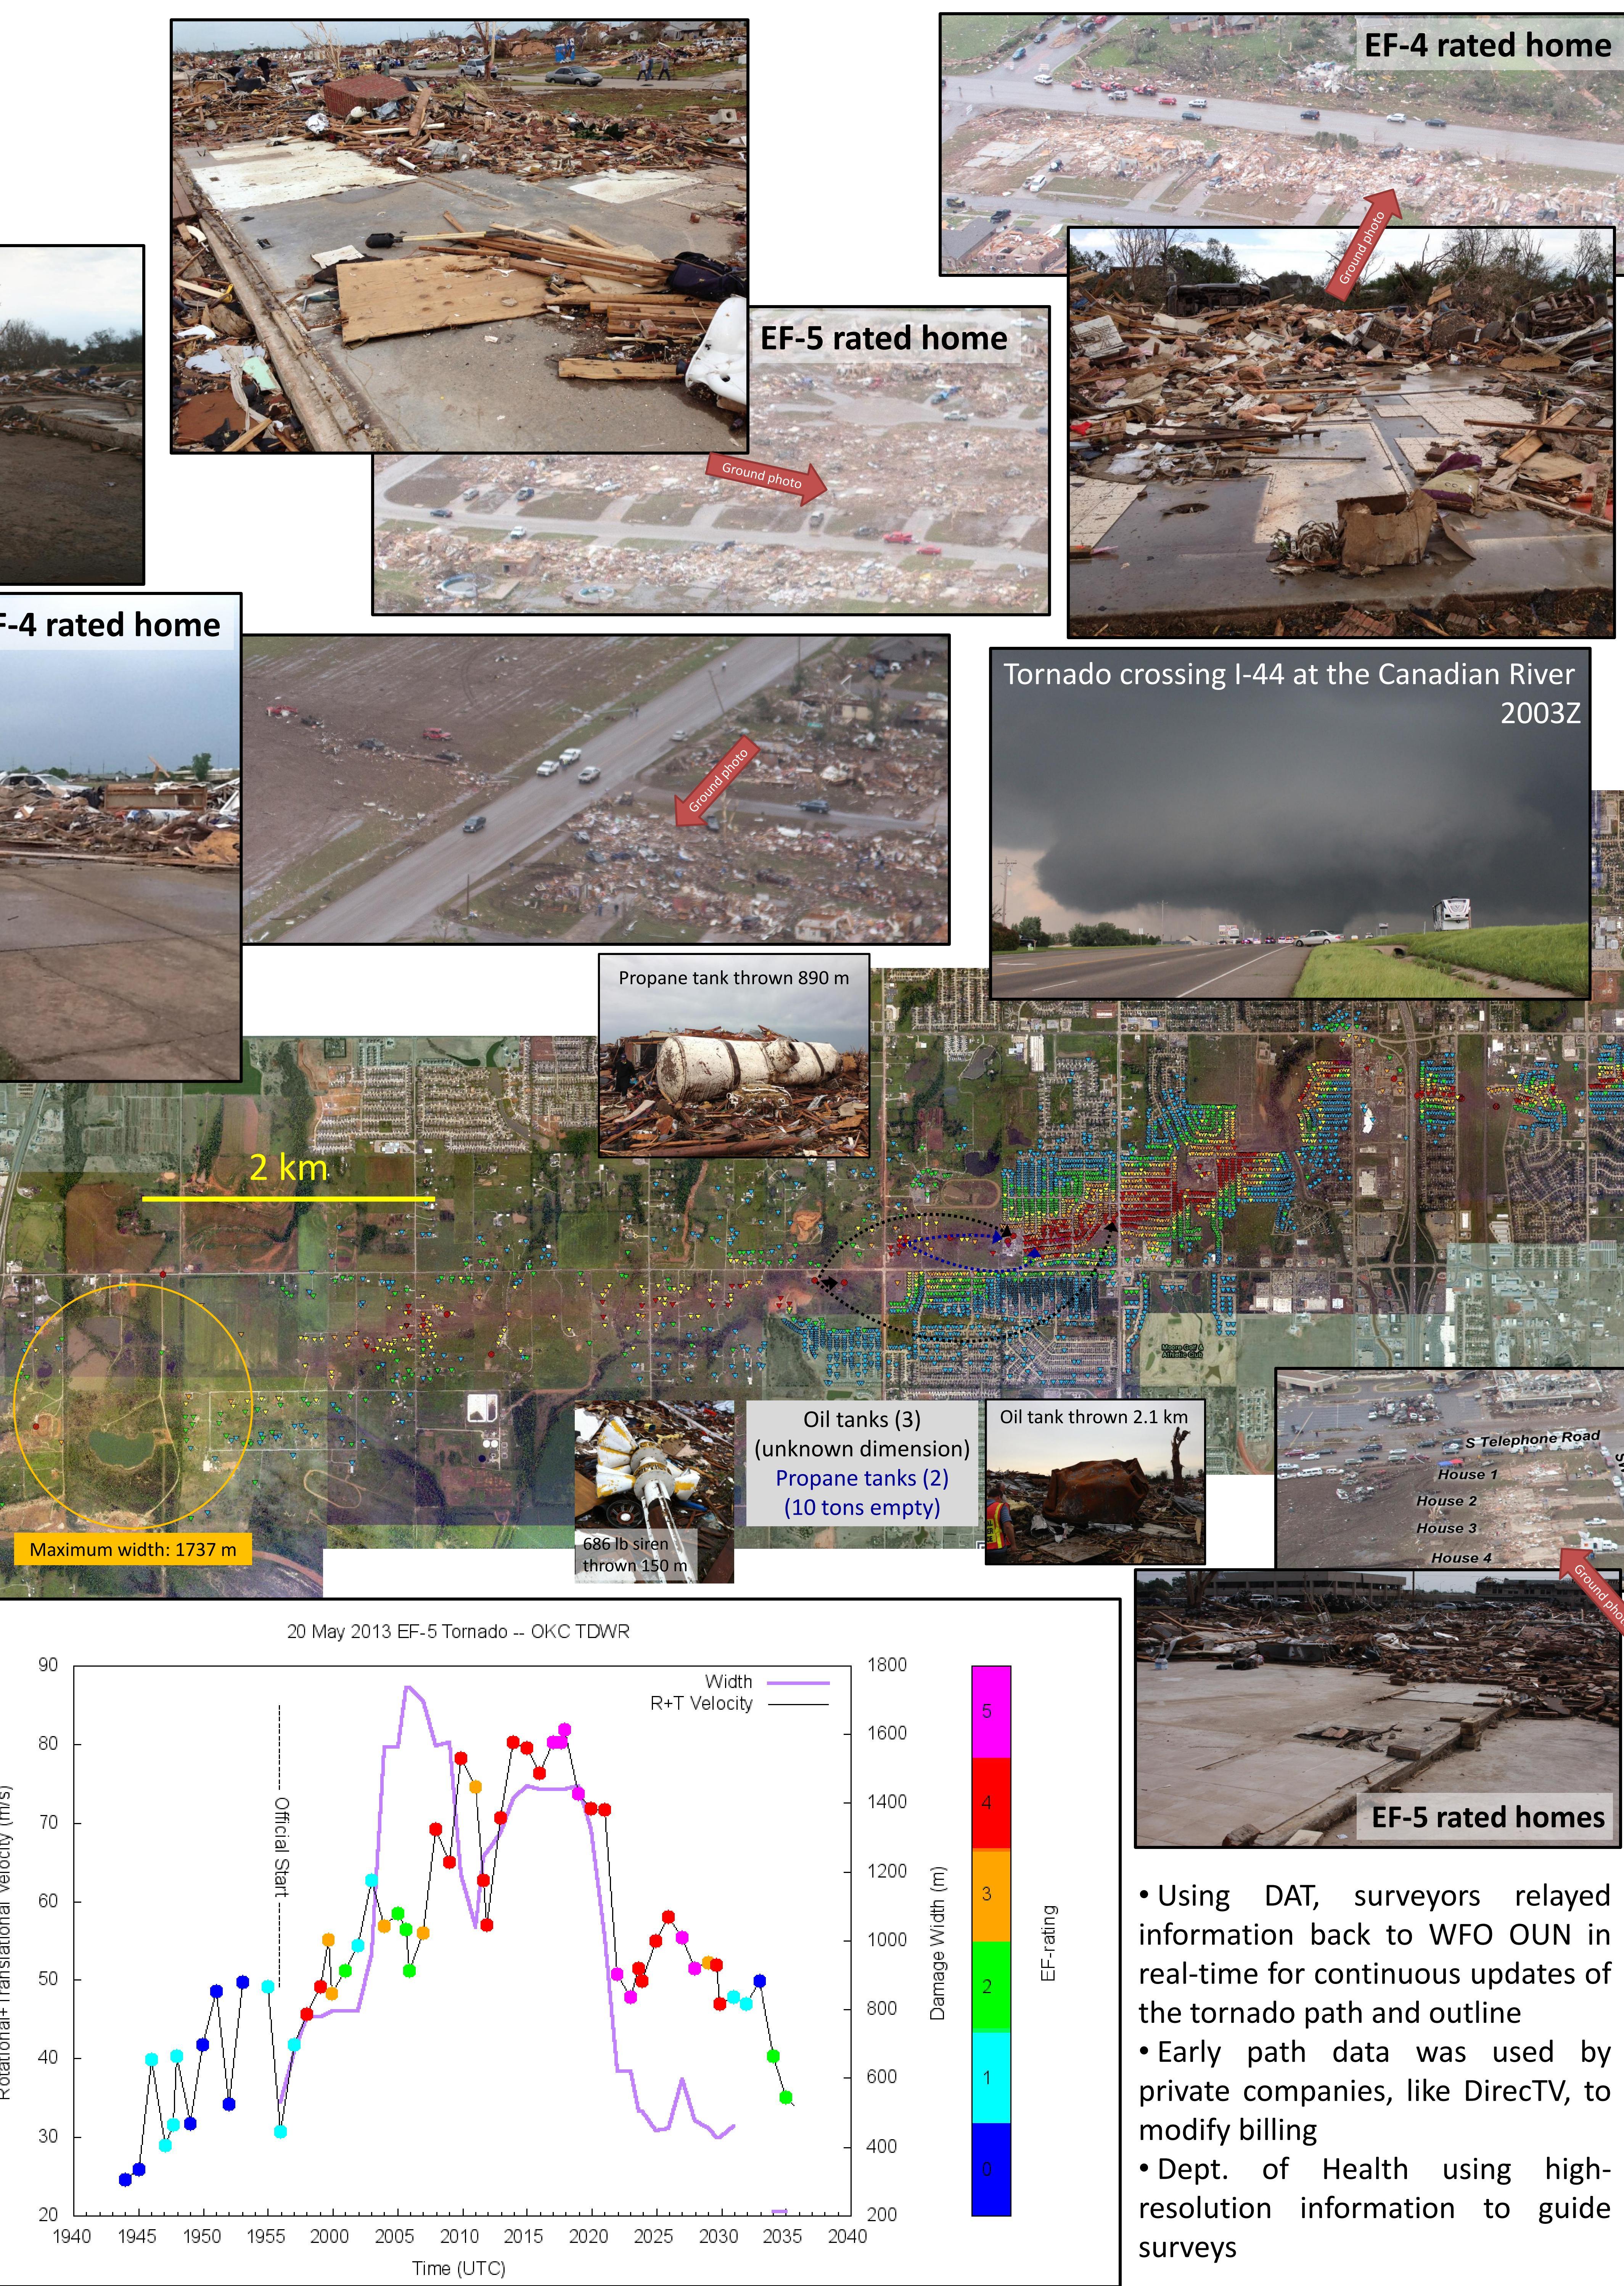
Justify EF5	Justify EF4
All had removal of some percentage of base plates	No capability to evaluate wall-to-roof connections
 All had some sort of anchor bolting; many bolts were bent. Evidence of the wall holding? 	 All had deficiencies w.r.t. WFCM Wide bolt spacing, lack of clips for wall stud-to-base plate
5 surveyed EF-5 rated homes had toe-nailed connections for wall stud- to-base plate connections	Several were within tight gradients of damage (1 w/ across the street EF1 neighbor)
Historical damage ratings of similar damage (3 May 1999, 24 May 2011)	
 Area near Moore Medical Center Tornado looped (via PX-1000 radar data) 	
 Vehicles parked at Moore Medical Center thrown west into open field and southeast into the Emergency Room entrance One vehicle landed on top of the 2-story MMC 	
	EF-scale contours (colored lines)
	Damage points (color coded by EF-rating) Tornado centerline in black
EF3 EF3 EF3 EF3 EF3 EF4 EF4 EF5 EF5 EF2 EF3 EF3 EF3 EF4 EF4 EF5 EF5 EF2 EF3 EF3 EF3 EF4 EF4 EF5 EF5 Imagery[Date: 11/7/2012 I	Yellow arrows illustrate vehicle lofting directions
