Timothy P. Marshall* Haag Engineering Co. Dallas, Texas

1. INTRODUCTION

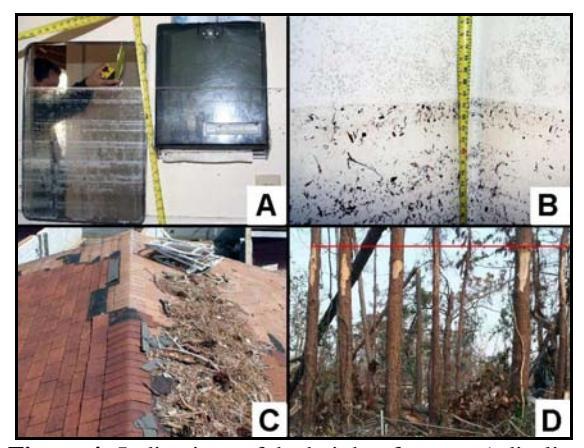
After Katrina, the author has measured the height of the storm surge at over one hundred locations along the Mississippi and Louisiana coasts using a surveyor's level and rod. Still water lines in buildings provided the best estimate of the storm surge level. The line was formed by dirt and debris in the water that was deposited on wall surfaces. Generally, the still water level was found in a room that was not breached by wave action. Occasionally, a line of grime was found deposited on glass items or rust on metal items due to contact with salt water. Sometimes scrape marks were noted on trees where floating debris repeatedly impacted and abraded the bark. In low-lying areas, some debris lines were found on roofs (Fig. 4).

Figure 4. Indications of the height of water: a) dirt line in bathroom, b) water line on wall board, c) debris line on roof, and d) scrape marks on trees.

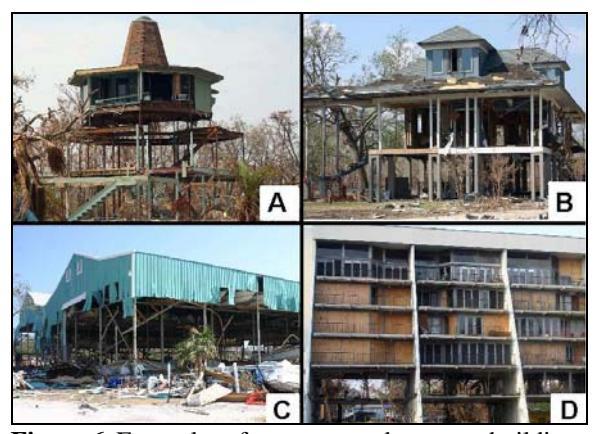
Waves were superimposed on the storm surge. The waves attacked the bases of buildings and lifted them off their foundations if the buildings were not well attached. Some buildings floated inland but the direction the building moved also depended on the wind direction as well as the ebb and flow of the water. Some buildings broke apart becoming part of an extensive debris line that extended a few kilometers inland. Buildings that remained intact, had their lowest stories gutted by the surge (Fig. 6).

Figure 6. Examples of storm surge damage to buildings in: a) Waveland, b) Bay St. Louis, c) Pass Christian, and d) Biloxi. In each instance, the bottom two stories had been gutted.

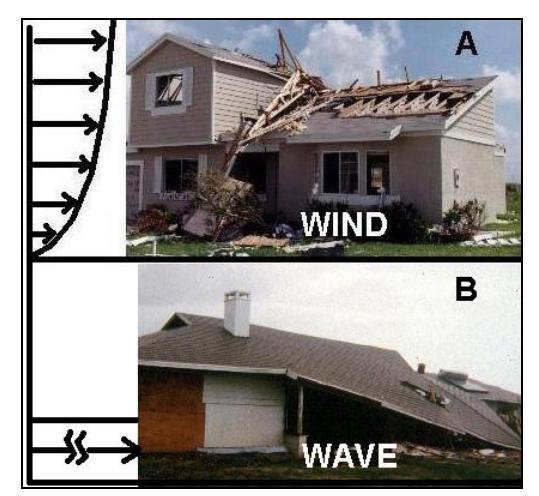
One issue in assessing hurricane damage is whether wind or wave action or a combination of both damaged a building. This issue arises since there are separate insurance policies for wind and wave damage. Not every building owner has both insurance policies. Therefore, an accurate determination of the causes and extent of building damage must be made. Wind and wave forces attack a building differently. Wind forces are greatest at roof level whereas wave forces attack the base of the building (Fig. 15).

Figure 15. Examples of wind (a) and wave (b) damage to housing. Relative forces are illustrated on left with height above the ground.

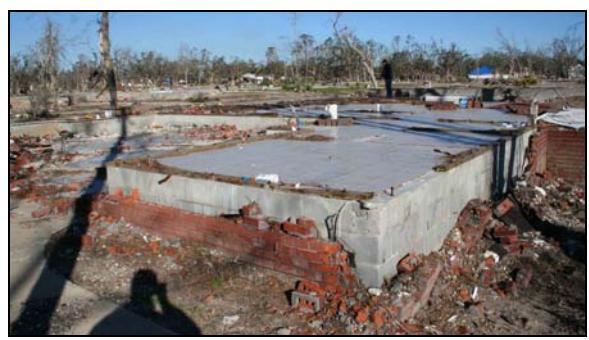
Storm surge destroyed many buildings on slab foundations (Fig. 16). Typically, the building frame was removed from the slab along with most of the contents and finish items. Occasionally, bolted wood plates remained. The force of moving water sometimes removed the carpeting and hardwood flooring. In some cases, sand was scoured adjacent or beneath the slab. The most extensive damage involved collapsing and breaking up of the concrete slab.

Figure 16. Typical home on a stem wall foundation that was completely destroyed by Hurricane Katrina's storm surge.

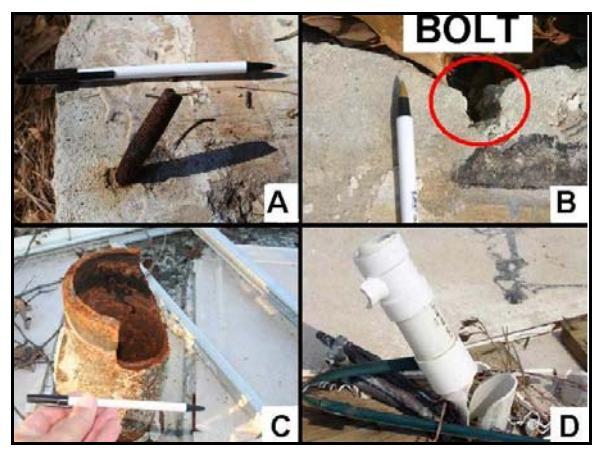
Buildings that were completely destroyed still left evidence as to the direction and magnitude of the applied forces (Fig. 17). Anchor bolts were bent along the direction of the applied force and in some instances, broke out of the leeward side of the concrete slab. Nails that secured the wall studs to the wall bottom plates also were bent along the direction of the applied force. Copper piping was quite malleable and easily bent. Brittle materials such as PVC and cast iron piping frequently were broken out on the opposite side of the applied force.

Figure 17. Indicators of direction and magnitude of the applied force: a) bent bolt, b) bolt broke out of leeward side of slab, c) broken iron piping, and d) broken PVC piping.

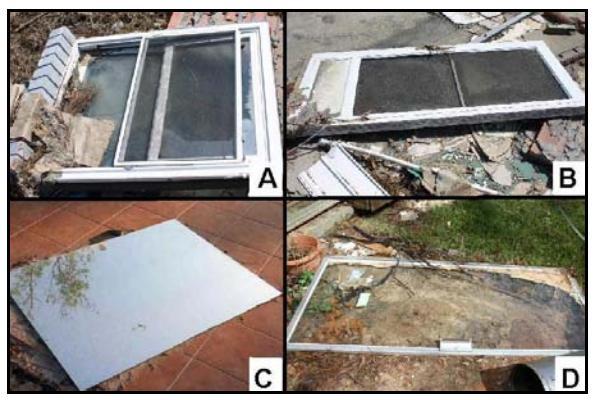
In many instances, unbroken items were found on or near slabs. These included glass doors, windows with screens, mirrors, dishes, and lights. Ceiling fans were found with blades and glass globes still attached. The lack of damage to such brittle items resulted when the home was dismantled slowly and the items fell into the water. Items beneath the water remained protected (Fig.18).

Figure 18. Unbroken items left on or near the concrete slab where houses were completely destroyed: a) window with screen, b) door with screen, c) mirror, and d) glass door.

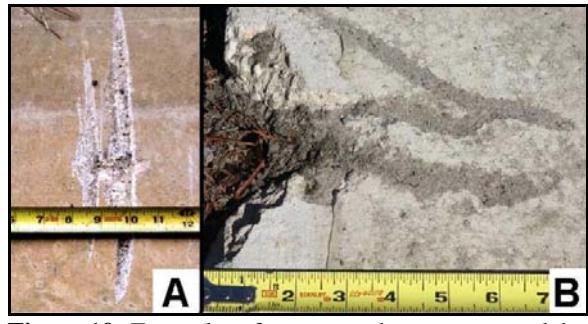
In certain instances, scrape marks were found on concrete slabs indicating where sharp objects, such as nails and bolt stems, were repeatedly pushed back and forth due to wave action (Fig. 19).

Figure 19. Examples of scrape marks on concrete slabs from a) nailed wall bottom plates, and b) bolted wall bottom plates. Wave action caused the walls to move back and forth resulting in these marks.

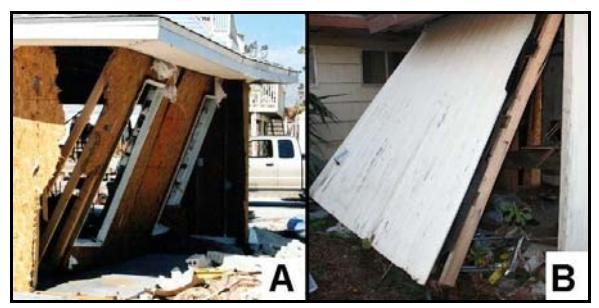
Additional evidence was obtained regarding wind and wave forces when portions of the building remained. Waves pushed the bases of walls inward on the ocean side and pushed out the bases of walls on the back side of the building (Fig. 20). If enough loadbearing walls were compromised, the building collapsed. Usually, the building collapsed on the oceanfront side first, appearing "pitched down" toward the water. Sometimes the roof remained upright on the ground. In other instances, the roof broke apart becoming part of the debris line. Low-level forces from wave action actually created a hinge at the top of the walls. In contrast, wind forces pushed the tops of the walls inward on the windward side of the building. Thus, the hinge point for wind was at the base of the wall.

Figure 20. Surge damage to walls: a) base of wall pushed inward on oceanfront side, and b) base of rear wall pushed outward. Walls were subjected to low-level forces from moving water.

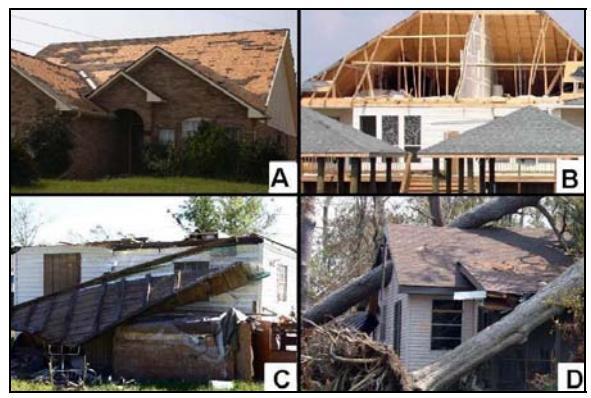
Wind damage to buildings on concrete slab foundations was limited mostly to cladding items such as roof shingles, brick masonry, vinyl siding, or windows (Fig. 21). However, in some instances, portions of the roof deck were removed and gable ends were either pushed inward or outward. Roof structures were usually strapped to the wall top plates, and therefore, few roofs were removed. The most significant damage to homes from wind occurred indirectly from trees falling on them. Trees penetrated roofs and walls causing localized structural damage as well as rainwater entry.

Figure 21. Examples of wind damage to wood-framed residences from Hurricane Katrina: a) displaced roof covering, b) loss of roof deck, c) loss of roof structure, and d) tree impact damage.

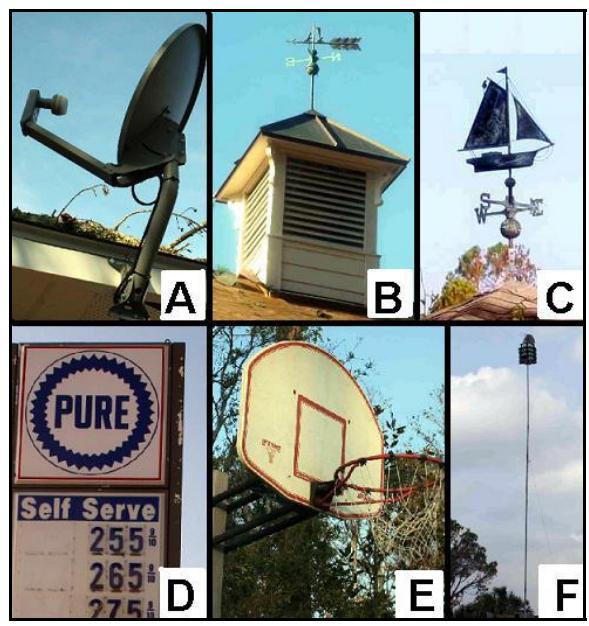
A number of items susceptible to wind forces were found undamaged even in the hardest hit areas. These included satellite dishes, cupolas, weathervanes, bird houses, and signs. Such undamaged items indicated that the wind velocities were not very high (Fig. 22).

Figure 22. Items not damaged by wind in Bay St. Louis and Pass Christian, MS in and close to the east eyewall: a) satellite dish mounted to an eave with only two screws, b) copper clad cupola, c) weathervane, d) gas station sign including plastic numbers, e) basketball backstop, hoop with net, and f) a birdhouse mounted on a 15.6 m (50 ft.) pole.

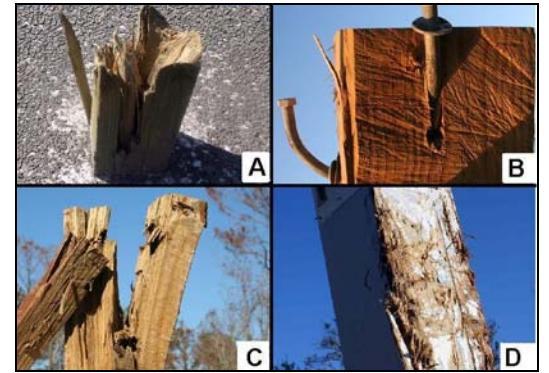
Analysis of the pilings revealed evidence of both lateral as well as uplift forces. Piles rotated or broke when impacted by lateral forces sufficient to damage them. The direction of the applied force could be determined by the direction the piles rotated. Sometimes piles were abraded or scarred by floating debris (Fig. 24). Uplift forces from wave action bent bolts at the tops of the pilings that had secured the girders. Bolts were bent in the direction of the applied force.

Figure 24. Damage to pilings from storm surge: a) broken piling, b) bolts bent upward that had secured floor girders, c) bolts lifted out of top of piling, and d) abraded and leaning piling from repeated impacts of floating debris.

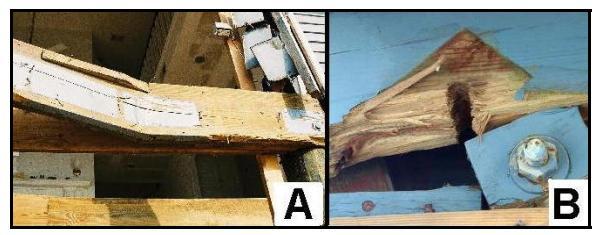
Waves high enough to reach the second story floors, frequently bent the girders landward or uplifted them from the tops of the pilings (Fig. 25). In some instances, the girders were removed along with their bolts. However, in other instances, the girders broke around the bolts leaving the bolts in the pilings. Wind was not a factor in damaging floor girders as bolted connections between girders and pilings were usually the strongest in the building. Instead, wind exploited weaker connections above (i.e. where walls were attached to floors or roofs were attached to walls). Girders that remained intact some times contained rub marks where floor members abraded the wood. In some instances, ocean debris, such as flotsam and seaweed, had been draped over the girders.

Figure 25. Surge damage to girders: a) girder bent landward (lateral force), and b) girder lifted by wave action (uplift force) breaking out of bolted connection.

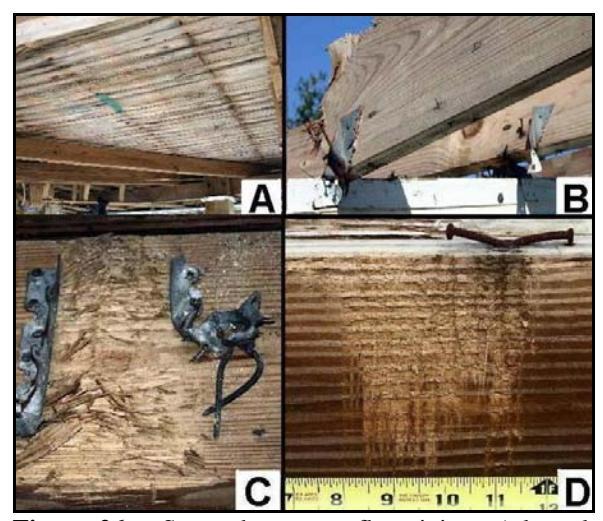
floor structure. In fact, elevated buildings damaged by wind left the floor systems intact.

Figure 26. Surge damage to floor joists: a) lateral movement of joists, b) uplift of joists which bent and broke the straps, c) and d) rub marks where joists moved up and down repeatedly against girders.

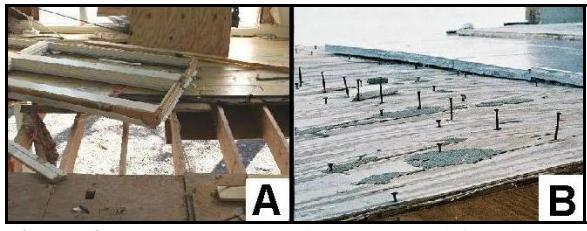
Subflooring consisted of plywood sheathing that was nailed to the tops of the joists. Rolling waves lifted floor sheathing causing the nails to back out of the wood. This process did not occur all at once but progressively as each wave struck the floor. Continued wave action dislodged sections of the floor and it floated away. However, in some instances, flooring was shuffled together and stacked like playing cards (Fig. 27). Wind did not cause this condition.

Figure 27. Storm surge damage to subflooring: a) dislodged plywood sheets, b) backing out of nails in the plywood due to repeated wave action.

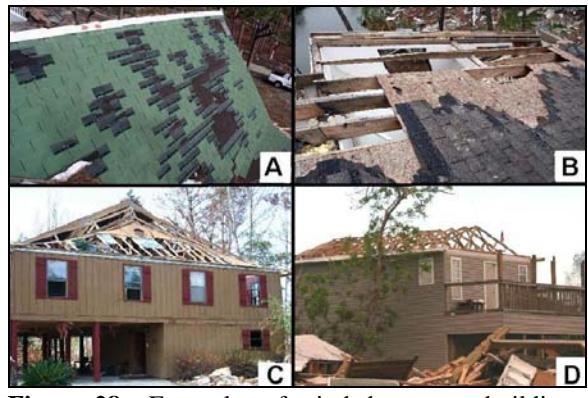
Wind damage to buildings elevated on pilings usually began at roof level with the loss of roof shingles, chimney caps, or antennas. In some instances, portions of the roof deck were removed along windward roof corners and eaves. Wind damage began at roof level, in contrast to wave damage. In rare instances, wind pushed the tops of frame walls inward or outward causing the walls to rotate about their bases. Failure occurred when straight-nailed wall bottom plates simply pulled out of the subfloor. A hinge formed at the base of the wall. Lack of proper strapping and bracing contributed to such wall failures. Floor systems were left intact in wind caused failures. (Fig. 28).

Figure 28. Examples of wind damage to buildings elevated on timber pilings: a) removal of roof covering, b) roof deck failure, c) gable end pushed inward, and d) loss of roof canopy over balcony.
