WIND EFFECTS ON ASPHALT SHINGLES

Timothy P. Marshall*, Scott J. Morrison, Richard F. Herzog, Jeffrey R. Green Haag Engineering Co. Irving, Texas

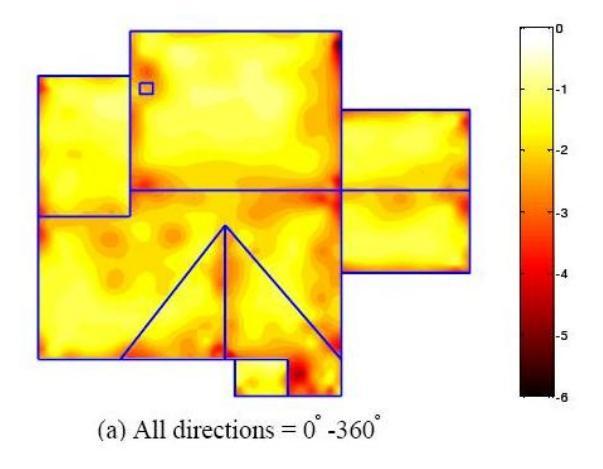
Figure 1. Peak negative uplift pressure coefficients (C_p) on a gable roof from a wind tunnel model. Wind directions were at 10 degree increments. From Liu et al. (2006)

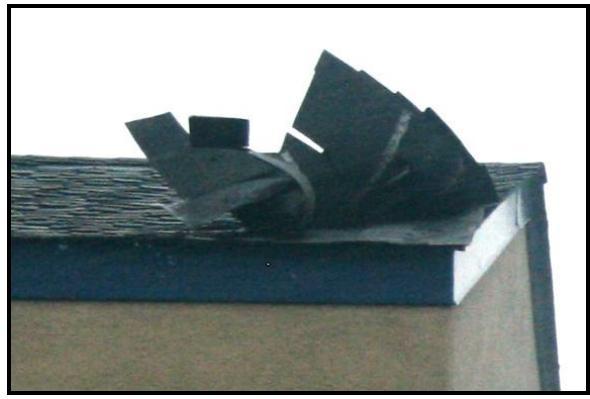
Figure 2. Uplift of asphalt shingles on the corner of a gable roof during Hurricane Gustav. Image by Tim Marshall.

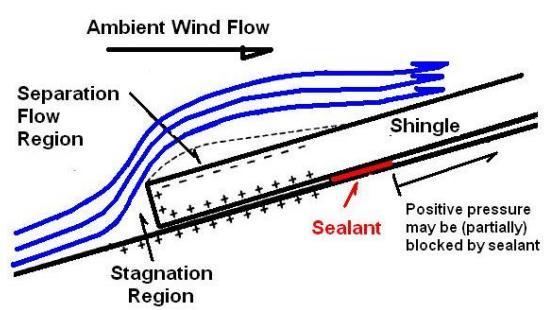
Figure 3. Idealized wind flow (blue lines) and resultant positive (plus signs) and negative pressures (minus signs) at the bottom edge of a shingle. From Peterka et al. (1997).

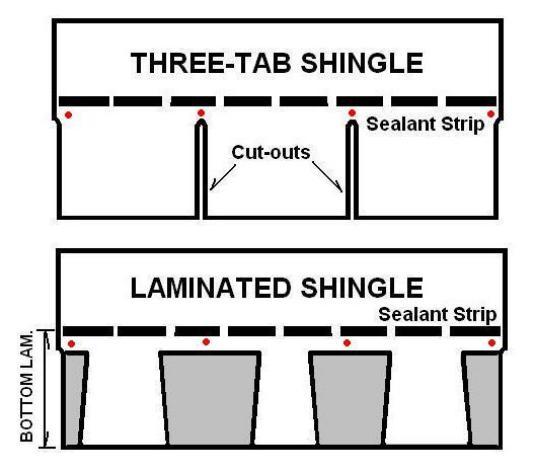
Figure 5. The two most common types of asphalt shingles are the three-tab and the laminated. At least four fasteners must be installed per shingle (standard application) as noted by locations of the red dots.

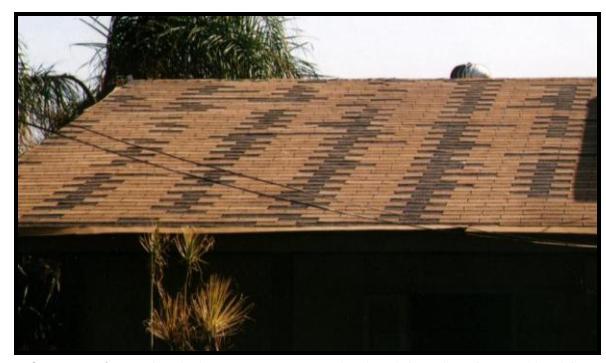
Figure 6. Wind damage to asphalt shingles installed in the racking or "straight-up" pattern after Hurricane Frances.

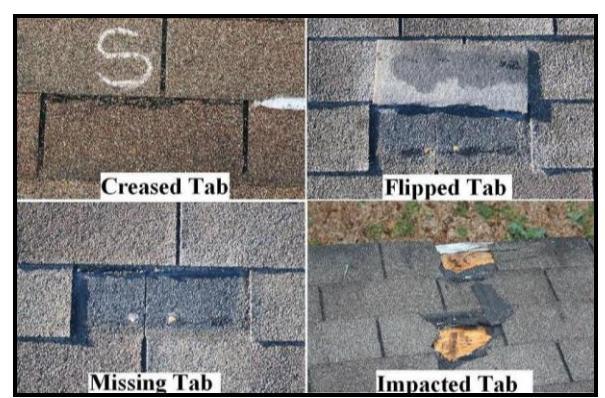
Figure 7. Various types of wind damage to asphalt shingles.

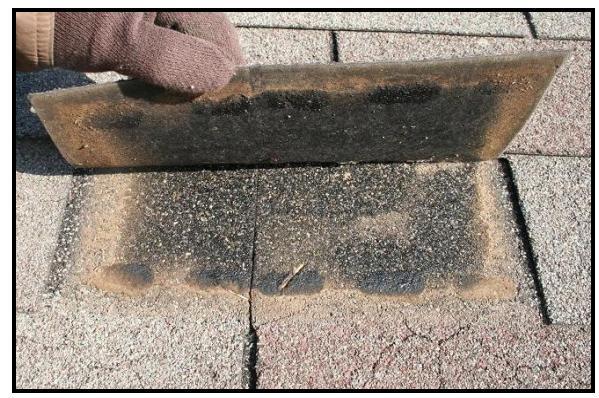
Figure 8. This aged tab had little sealant bond strength and could be easily lifted by hand. Note the crazed cracks on the shingle surface.

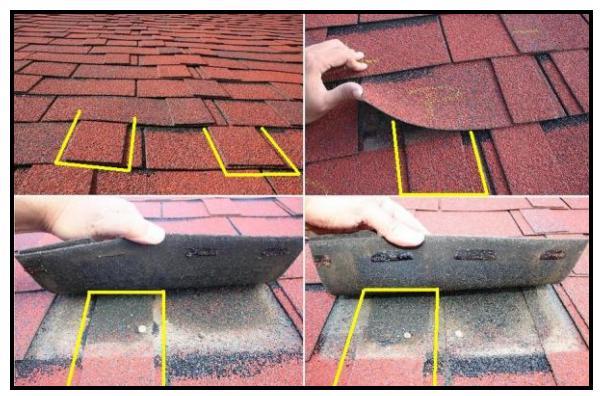
Figure 9. Rectangular tabs (outlined) adhered to the tops of the shingles prevented full contact of the overlying tabs and created air gaps between the tabs.

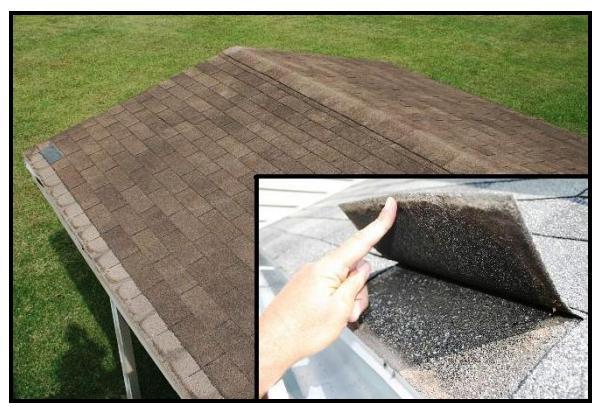
Figure 10. Loss of first tab course from Hurricane Ike as the tabs were not sealed down due to improper installation of the starter shingles as shown by inset.

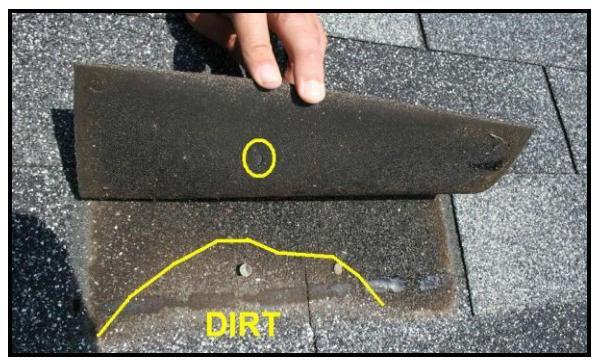
Figure 11. Elevated nail (note shadow) prevented this tab from bonding to the sealant strip. Note the dirt residue and smooth sealant on the underlying shingle and lack of sealant transfer to the bottom side of the overlying tab. The yellow circle highlights the indentation of the nail head in the bottom of the overlying tab.

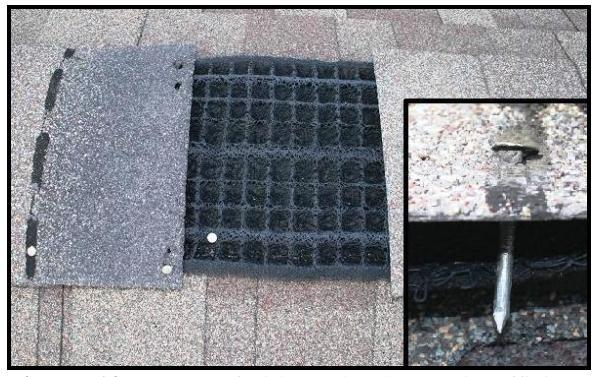
Figure 12. Loss of ridge tabs due to insufficient fastener length (inset).

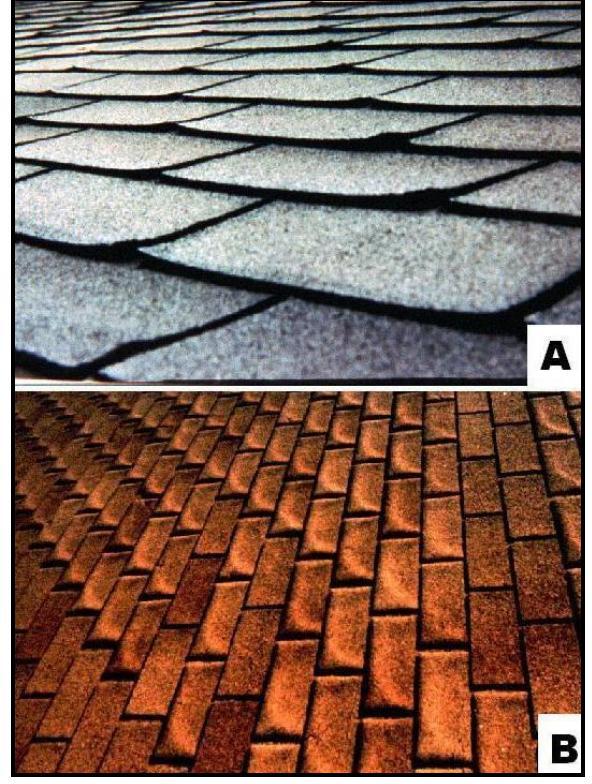
Figure 13. Examples of cupping (A) and clawing (B) of asphalt shingles. These conditions are not caused by storm effects.

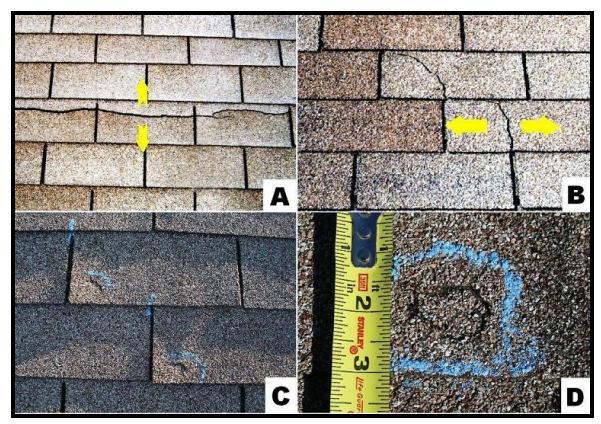
Figure 14. Examples of shingle splitting: a) horizontal, b) vertical, c) curved, and d) rounded. Such splitting is not caused by wind.

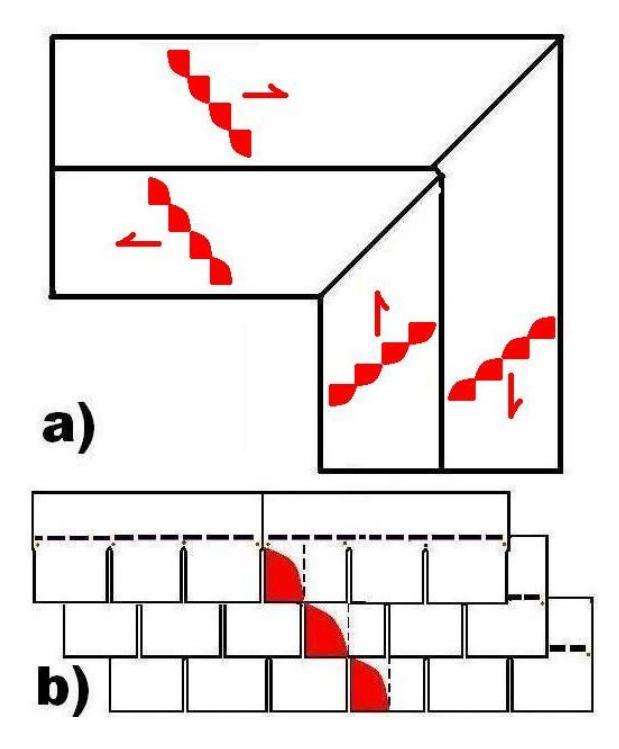
Figure 15. Diagonal pattern of shingle overlaps not bonded to the roof: a) roof plan showing open laps (arrows) pointing in different directions, and b) idealized diagram showing red shaded region where tabs could be lifted unimpeded by hand. This pattern extends diagonally upslope depending on the manner in which these shingles were installed.

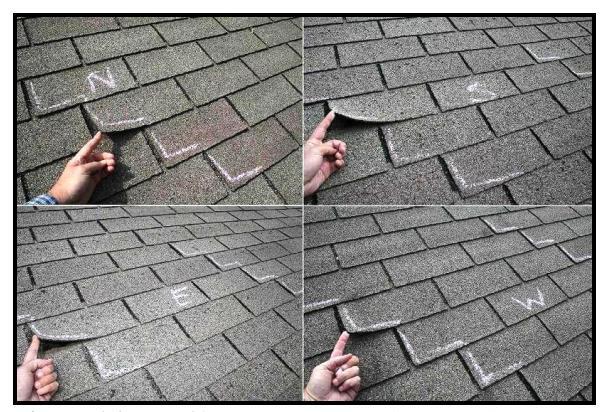
Figure 16. Roof in Norman, OK where overlaps were not bonded to the underlying shingles on each directional slope (indicated). This condition was not wind-caused.

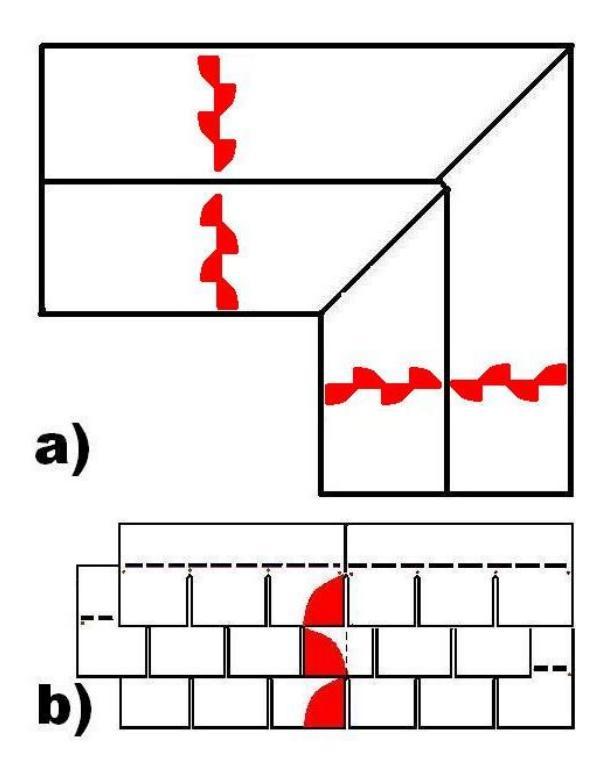
Figure 17. Straight-up pattern of shingle overlaps that are not bonded to the roof: a) roof plan showing alternating overlaps not bonded to the roof on each directional slope, and b) idealized diagram showing red shaded region where tabs were not bonded to the underlying shingles. This pattern extends vertically upslope in the manner in which these shingles were installed.

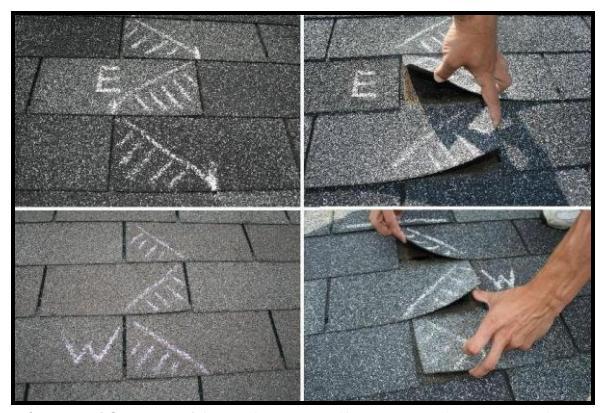
Figure 18. Roof in Minneapolis, MN where overlaps were not bonded to the underlying shingles on directional slopes (indicated). This phenomenon was not wind-caused.

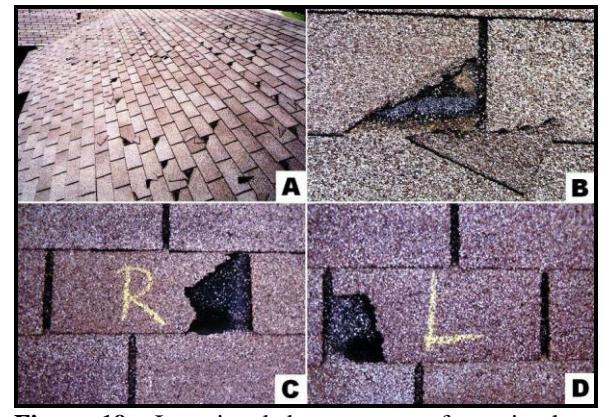
Figure 19. Intentional damage to roofs to simulate wind damage: a) broken corners upslope away from roof edge, b) broken corner left nearby, c) torn right edge of tab, and d) torn left edge of tab.

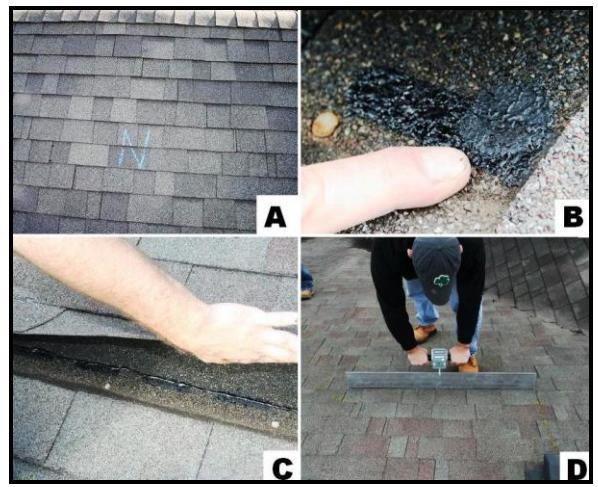
Figure 20. Pull tests on laminated asphalt shingles: a) undamaged shingles, b) dollop of asphalt plastic cement applied under shingle, c) bead of asphalt plastic cement applied under shingle, and d) pull test after 30 days.
