# P 1.6 THE LA PLATA, MD TORNADO: ISSUES REGARDING THE F-SCALE

Timothy P. Marshall\* Haag Engineering Co.

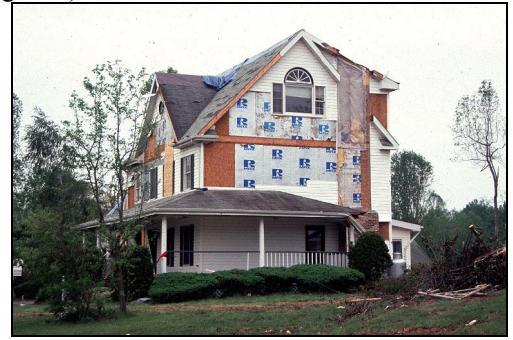
**Figure 3.** Typical F0 damage to house involved the loss of siding, fascia, roof shingles, and/or a toppled chimney.

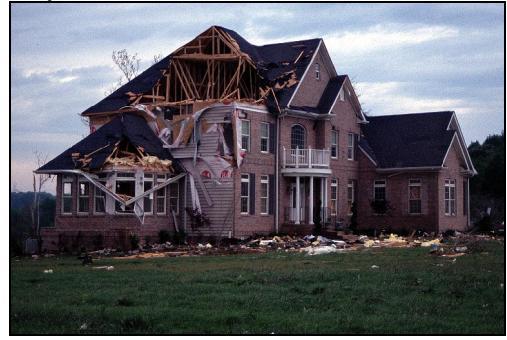
**Figure 4.** Typical F1 damage involved partial removal of the roof structure.

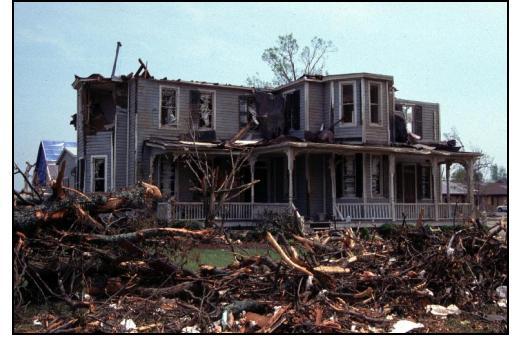
**Figure 5.** Typical F2 damage involved the removal of the entire roof.

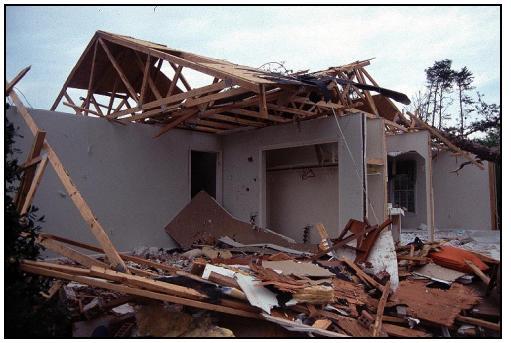
**Figure 6.** Typical F3 damage involved the removal of most of the roof and exterior walls.

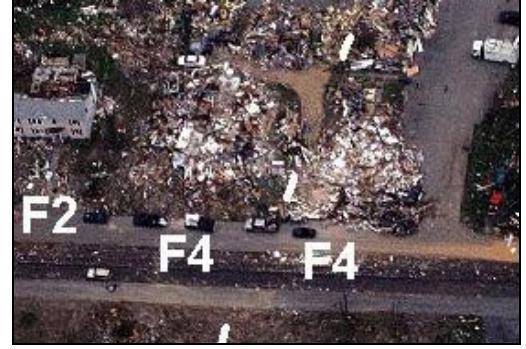
**Figure 7.** F4 damage involved the collapse of two, two-story houses in downtown La Plata, MD.

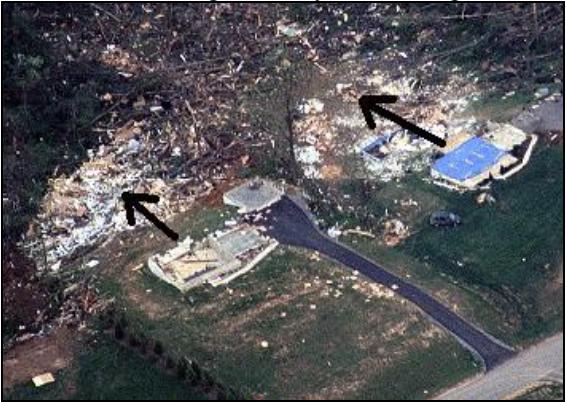
The primary issue with this event involved rating homes that literally were swept off their foundations (Figure 8). The author termed these houses as "sliders". Such homes had wooden floor systems supported on hollow-block masonry foundation walls or poured concrete foundation walls. These poorly anchored homes disintegrated when they moved off their foundations. The debris did not travel very far downwind indicating relatively low wind speeds.

**Figure 8.** Homes with poor attachment to their foundations slid off their foundations (in the direction of the arrows).

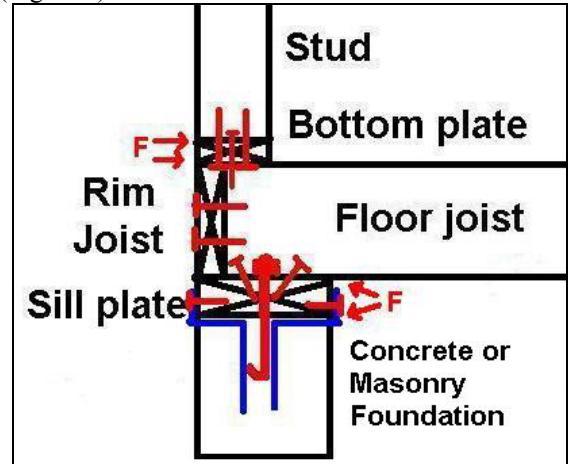
Wooden sill plates were placed between the floor joists and the tops of the foundation walls. Some sill plates merely rested on the top of the foundation walls with no attachments. Other sill plates were secured with metal straps embedded in the tops of the concrete foundation walls or in grouted cells in the tops of the concrete masonry foundation walls (Figure 9).

**Figure 9.** Wall-floor cross section at the foundation on a typical home in our survey. Nailed and bolted connections are in red, metal straps are in blue. Straps were not always present nor attached to the sill plates.

The building code in effect for Southern Maryland is the International Residential Code for One and Two-Family Dwellings published by the International Code Council (2000). This code requires that sill plates be secured to the foundation with anchor bolts spaced a maximum of six feet apart. Also, anchor bolts must be located within 12 inches of the ends of each plate section. Foundation anchor straps are acceptable as long as they provide the same strength as 1.27-cm (1/2-inch) bolts. Therefore, homes not anchored or strapped to their foundations did not conform to provisions in the building code. Interestingly, the code also indicates that foundation walls must have vertical steel reinforcement to provide a continuous load path for both gravity (dead) loads and wind uplift. We found that none of the homes that slid off their foundations met this requirement.

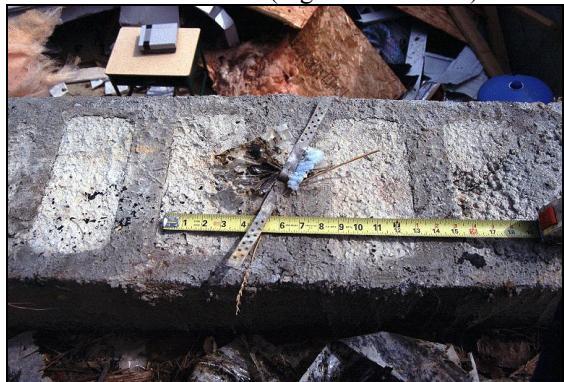
**Figure 10.** Metal straps had been installed on top of this concrete masonry basement wall but were not bent and secured to the sill plates. Therefore, this home was not attached to its foundation.

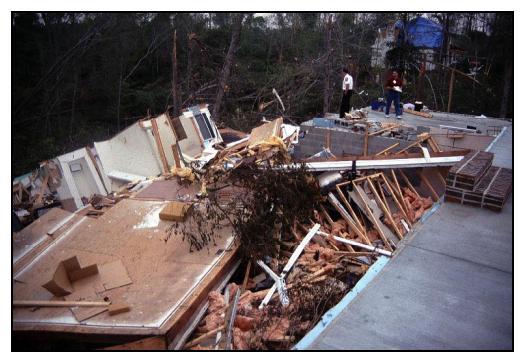
The team recognized two modes of failure with sliding homes. Homes slid off their foundations with or without the floor platform. Homes that slid away with the floor typically were split-level. The windward side of the home was situated on grade whereas the leeward side of the home had an exposed basement wall that usually faced a ravine. Frequently, the rear basement wall rotated outward as the home and floor slid away. The house then disintegrated as it tumbled into the ravine (Figures 10 and 11).

Figure 11. Split-level home on concrete masonry basement wall fell into ravine as rear wall collapsed.

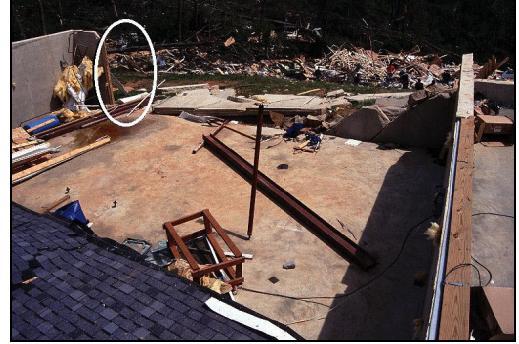
In some instances, a door or sliding glass door along the rear basement wall weakened the wall against lateral forces (Figure 12).

**Figure 12.** A door (circled) separated the concrete wall foundation reducing its strength. Also, the wall was not anchored to the footing and fell outward as the home slid off its foundation. Steel reinforcement was installed only at the wall corners.

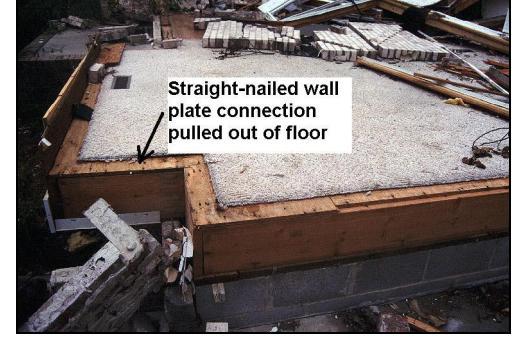
Another failure mode involved removal of the home but the floor platform remained intact. Failure occurred where the wall bottom plate was straightnailed into the floor. Nails rarely penetrated into the floor joists. Walls simply rotated, pulling out the fasteners and the home collapsed (Figures 13 and 14).

**Figure 13.** This home slid off its foundation when the straight-nailed bottom plate pulled out of floor. The sill plate was attached to the foundation with straps.

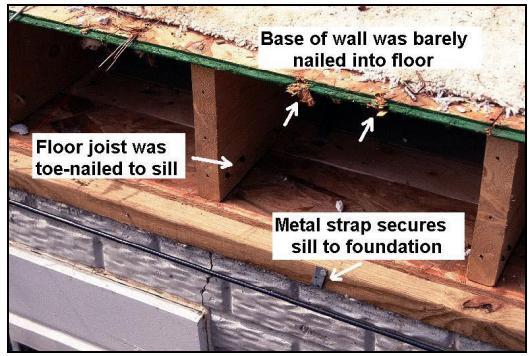
**Figure 14.** This floor remained on the concrete foundation while the rest of the home slid way. The sill plate was anchored to the concrete foundation wall with metal straps. However, nail holes at the edge of floor indicated the wall bottom plate was barely nailed. Nails had been driven into open joints between the floor and rim joists.

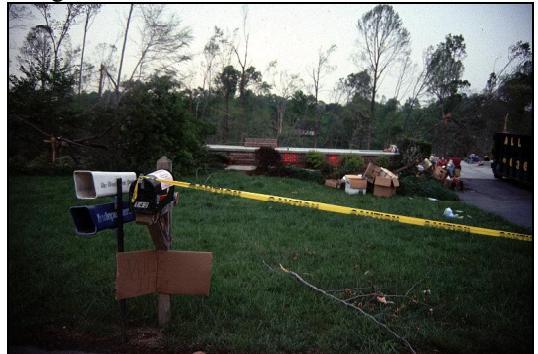
**Figure 15.** This poorly anchored home slid off its foundation into a ravine. Mailboxes remained intact, indicating winds were probably less than 45 m/s (100 m.p.h.).

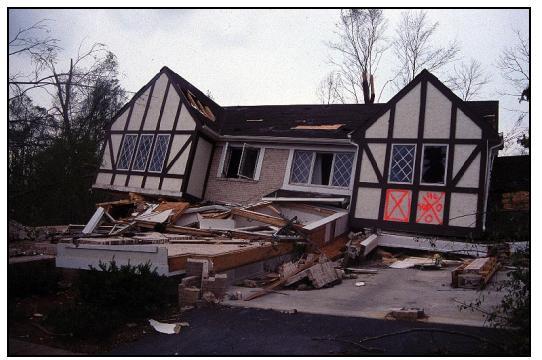
**Figure 16.** A two-story home was reduced to onestory as first story walls simply rotated and pulled out the straight-nailed connections between the bottom plate and floor. There was minimal damage to the roof and trees indicating winds probably were no greater than about 45 m/s (100 m.p.h.).

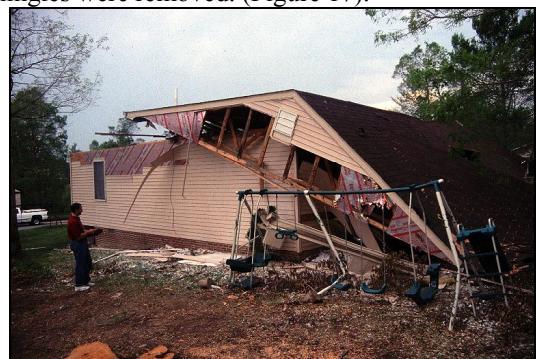
Team members encountered one instance where the roof slid off a house intact. Wooden roof trusses spanned the width of the home (about 10 meters) and were toenailed to the wooden top plates at each wall. However, bottom chords of the trusses were not connected to the interior wall partitions. Broken windows and doors caused internal pressure to help lift the roof structure off the house. Only a few roof shingles were removed. (Figure 17).

**Figure 17.** This roof slid off the house. Trusses were toenailed to the tops of the walls. However, only a few roof shingles were displaced.

Normally, a house that loses its roof structure would be assigned an F2 damage rating. However, it was decided to reduce the damage rating to F1 given the limited anchoring of the roof and lack of damage to the roof shingles and surroundings. It was determined that winds of about 32 m/s (70 m.p.h.) lifted this roof.

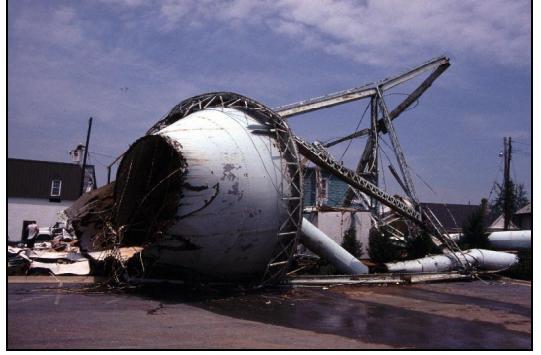
The 100 year old La Plata water tower had toppled during the tornado. The tower was located on the north end of the tornado damage path. Four steel legs buckled and the tower fell to the southwest sending a torrent of water that flooded three houses. Each leg was attached to a concrete footing with a single bolt. Bolts on the north legs failed in tension leading to the collapse of the tower. Although, bending of the steel legs was impressive, the water tower was situated in an area where F1 damage occurred to wood-framed buildings (Figure 18).

**Figure 18**. Toppled steel water tower was impressive but occurred in an area of F1 damage.

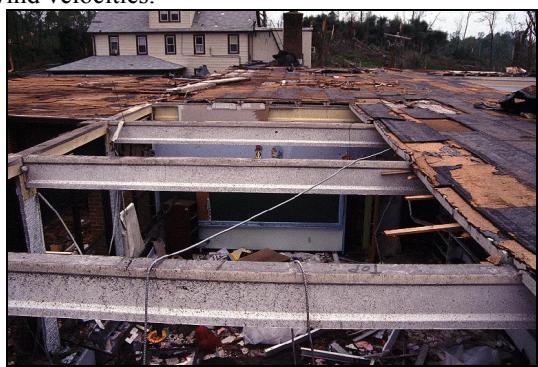
Numerous concrete roof planks were removed from the Arch Bishop Neale School on the west side of La Plata. Each concrete plank measured eight feet long by four inches thick. The planks were supported by precast concrete beams but were not anchored to the beams (Figure 19). Again, the damage was impressive, however, the school was adjacent to a residence that sustained F1 damage. Also, two manufactured homes adjacent to the school sustained F1 damage.

**Figure 19.** Loss of concrete roof planks on a school was impressive but occurred in an area of F1 damage.
