THE ROLE OF LITIGATION IN THE DISCOVERY OF A PROBABLE UNDOCUMENTED F1 TORNADO IN MUNSTER, INDIANA (27 JUNE 1995)

Walter A. Lyons, CCM* Yucca Ridge Field Station, FMA Research, Inc, Fort Collins, Colorado

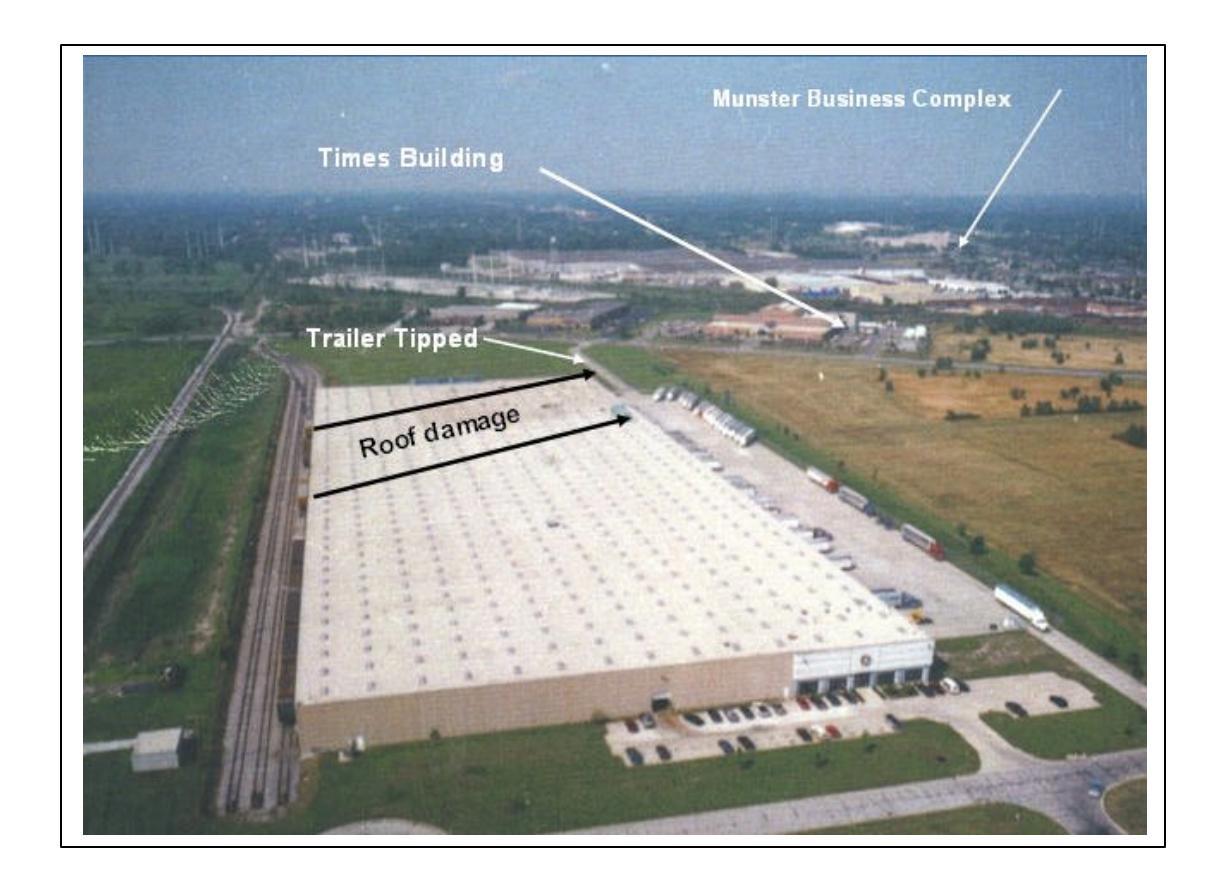
Figure 1. Aerial photograph (looking north) of a GE warehouse in Munster, IN, that sustained wind damage to the north end of the roof during the thunderstorm of 27 June 1995. Other building complexes also sustaining damage are indicated.

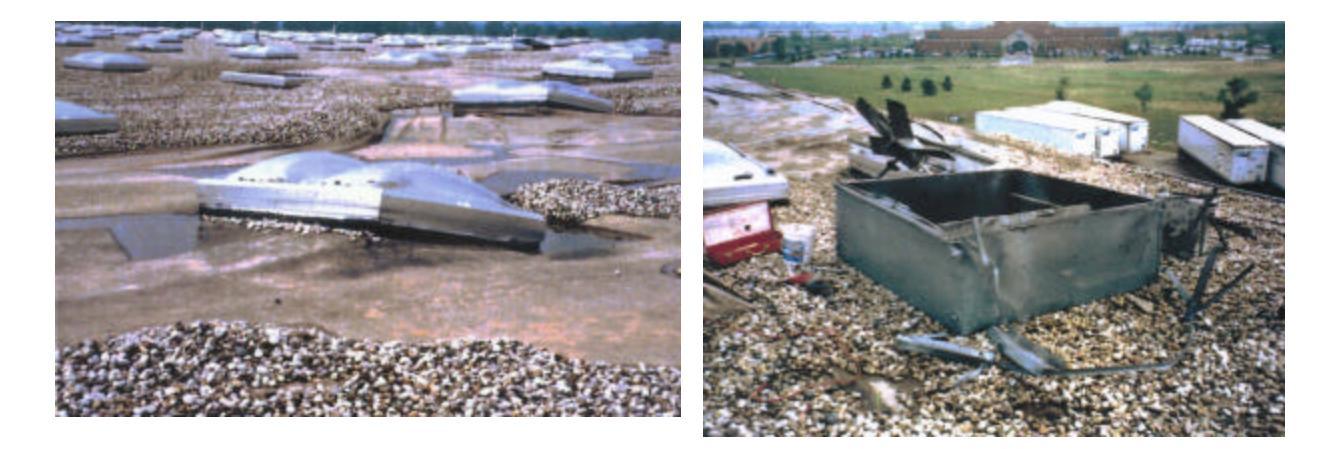
- 100 meter-wide swath of roof damaged

- 2 inch diameter river rock thrown off roof

both to the east AND the west

- large HVAC unit (~500 lbs?) torn from roof mooring and hurled ~100 m to northeast

Figure 2 (left) Ballooned roofing fabric, scoured 2 inch diameter river rock and damaged skylights covered a large section of the north portion of the GE warehouse roof. Figure 3 (right) Large HVAC unit ripped from this mooring and tossed into the field northeast of the warehouse.

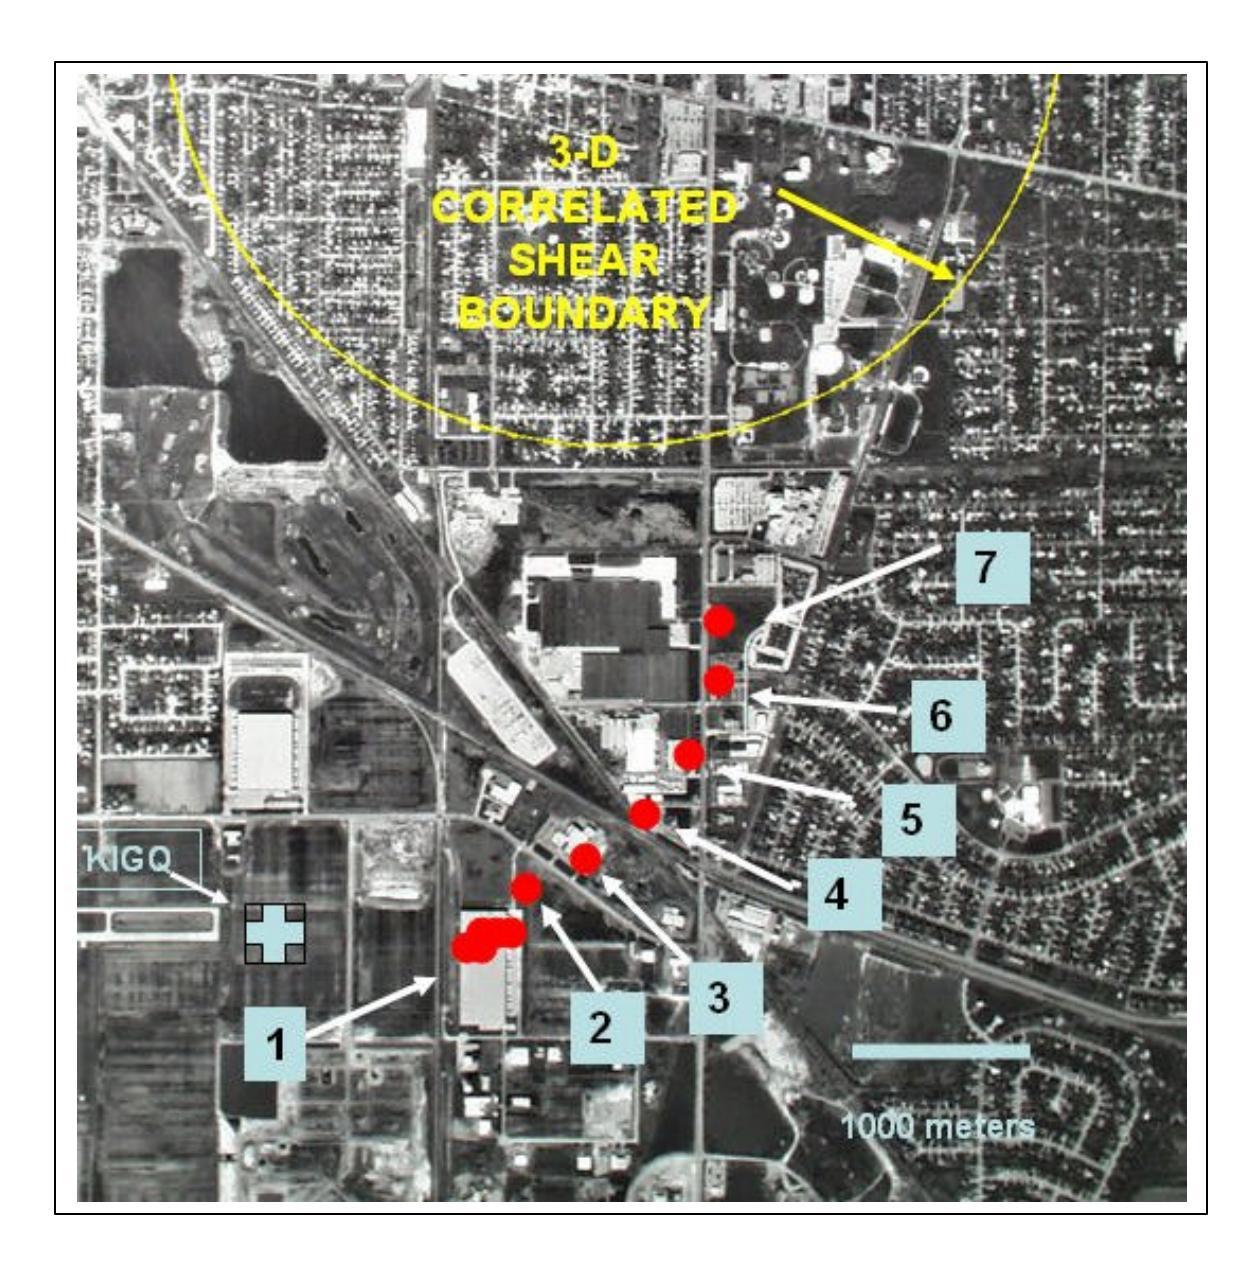
The above are plotted on an aerial photograph (Fig. 12). It is clear that the damage, while sporadic, lies in a narrow curvilinear swath less than 100 meters wide and which extends sporadically for slightly more than 2 km. The damage swath could be considered as spiraling inwards towards the weak circulation center identified by radar. The damage characteristics are typical of FO and F1 intensity. An independent engineering report estimated a 105 mph wind would have been required to remove the warehouse roof HVAC unit from its moorings. Schmidlin et al. (2002) note that only 4% of vehicles involved in F1 and F2 tornadoes are actually tipped over. Though the newspaper delivery truck, an empty panel van with a high center of gravity, would probably be more prone to tipping than most vehicles, but this simply can not be explained by 55 mph straight-line winds. The damage track appears to have moved northeastwards along an eastward-propagating gust front. Had this been classic straight-line wind damage, the orientation would be expected to have been oriented much more east-west.

confined to 100 m width and extended for about 2.0 km. Thus, it would appear to fit easily within the criteria proposed by Knupp (2000) to distinguish straight-line microbursts from small tornadic vortex winds. The sporadic nature of the damage suggested one or more suction vortices. The damage path, which ran almost parallel to the advancing gust front, curved inwards towards the cyclonic circulation (3-D correlated shear) of the parent storm. Aside from damaging a large swath of the warehouse roof, impacts included large (>2 inch) river rock being hurled off the roof in both east and west directions. overturned trailers and delivery trucks, debris carried more than a half mile, heavy VAC equipment being uplifted and removed from roofs, damage to other roofs and small trees being uprooted and tossed. We believe the evidence compiled is consistent with a short-lived F1 tornado.

Figure 12. Damage locations (red) with identification numbers as listed in text. The damage path is discontinuous, and measures approximately 100 meters wide by slightly over 2 km long. The southern portion of the 3-D Correlated Shear feature detected by the KLOT radar is indicated in yellow. The Lansing, IL AWOS sensor location (KIGQ) is located west of the warehouse.
