## 2.1 IMPROVED THUNDERSTORM WEATHER INFORMATION FOR PILOTS THROUGH GROUND AND SATELLITE BASED OBSERVING SYSTEMS

A. Tafferner<sup>\*</sup>, C. Forster<sup>1</sup>, Martin Hagen<sup>1</sup>, T. Hauf<sup>2</sup>, B. Lunnon<sup>3</sup>, A. Mirza<sup>3</sup>, Y. Guillou<sup>4</sup>, T. Zinner<sup>5</sup>.

### Abstract

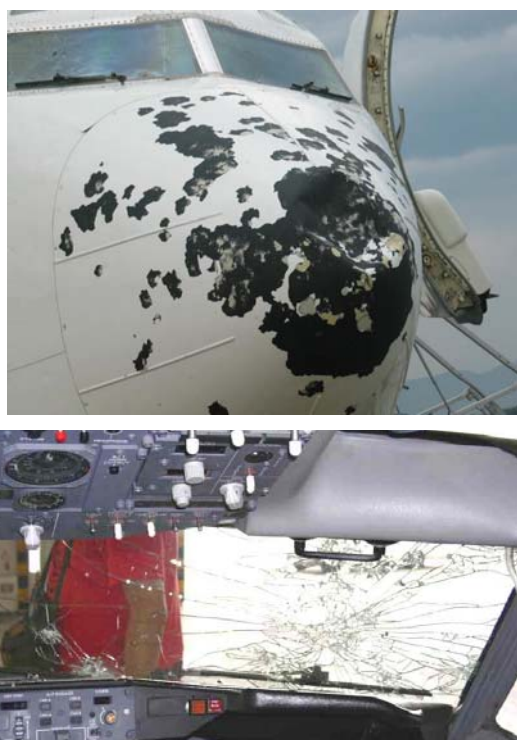
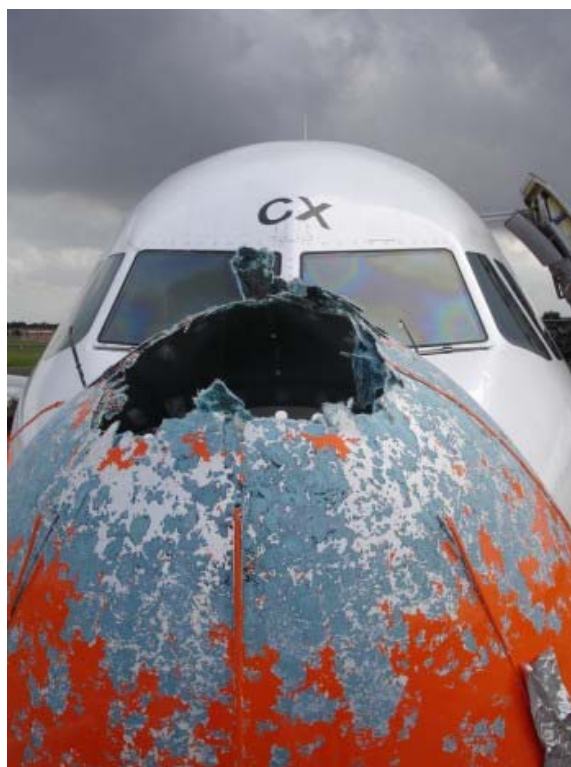
**Figure 1:** Nose and wind shield damage of two aircraft hit by hail stones during passage of thunderstorms. Left: Easy Jet Boeing 737 after take-off from Geneva, 15 August 2003. Right: WindJet A319 near Catania on Oct 1st 2009 (The Aviation Herald, Photo: ATRDRIVER)

aircraft is passing through it, the duration of exposure, the type of aircraft and the flight phase. Figure 1 shows two examples where aircraft have been hit by hail when passing through a thunderstorm. In both cases the aircraft's nose has been heavily damaged, and in one case also the wind shield has been cracked.

A photograph taken after landing (figure 1, right) shows a hole in the aircraft's radome due to hail encounter. Also it is noted in the Aviation Herald page by referring to a report from a mechanics after landing that *"the airplane experienced wind shear of +50/-50 knots on final approach to Palermo prompting the crew to initiate a go-around. The airplane did not climb until after passing the runway at very low height despite the engines at full thrust"*.

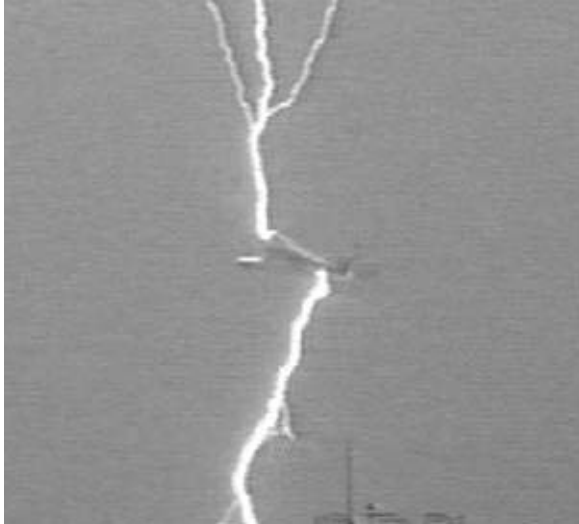
**Figure 2:** Aircraft hit by lightning. Photograph found on the internet. Reprinted and discussed by Uman and Rakov (2003).

However, lightning strikes cause electronic equipment to malfunction which might affect safety. Figure 2 shows a lightning stroke which was probably triggered by the aircraft itself after take off from a Japanese Air Force Base as described in Uman and Rakov (2003).

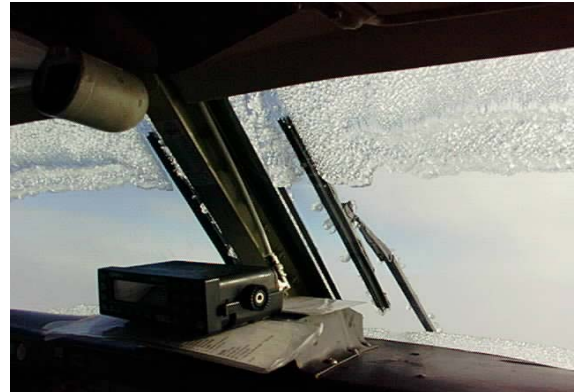
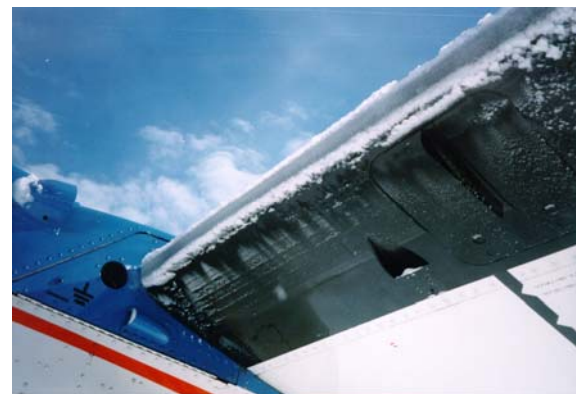
**Figure 4:** wind shield and wing icing after a flight of the DLR Dornier 228 aircraft in severe icing conditions.

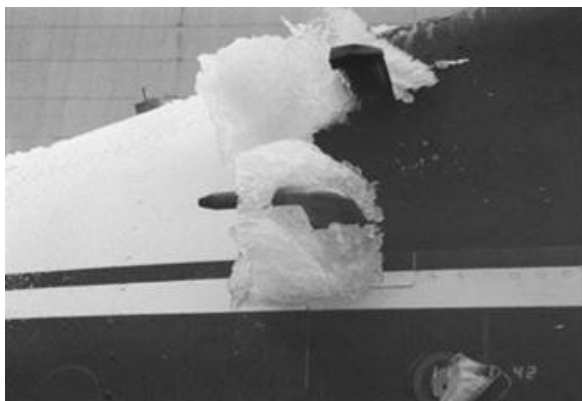
**Figure 5:** Icing of Pitot tubes, picture taken after landing of a flight of the DLR Dornier 228 aircraft in severe icing conditions.

There have been numerous incidents and also a few accidents due to aircraft icing, e.g the ATR-72 crash near Chicago 1994 (Sand and Biter, 2000). Icing of the Pitot tubes can result in wrong speed indications for the pilots or the onboard computer. In two cases of unintended descent within the upper parts of two independent thunderstorms a complete freezing of the Pitot tubes was observed even though the anti-ice (heating) systems were activated (Hauf et al., 1999). Figure 5 shows icing accretion on the Pitot tubes of the DLR Dornier 228 after landing.

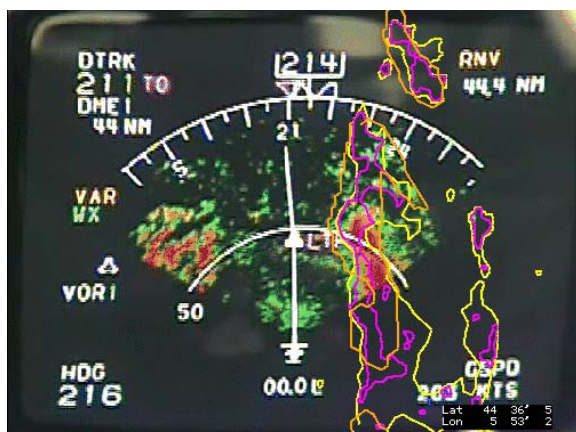
**Figure 7:** On board radar image for 14h05 UT on 19th August 2008. WIMS CB objects for 14h05 shown in yellow and pink for bottom objects moderate and severe plus orange contours showing CB top objects.

As an example, we reprint here, figure 7, a snapshot of the radar display recorded during an experimental flight (figure 14 of Sényesi et al., 2009). The CB Weather objects from the WMS are shown as outlines in figure 7. CB bottom objects are pink and yellow representing severe and moderate hazards. CB Tops are orange and represent a moderate hazard. The spatial distribution of the CB weather objects agree well with the close range radar depiction to the forward right of the aircraft position (near the 50 nm range circle). However, beyond the close range, Cb weather objects indicate additional thunderstorm activity and also another cell further away (beyond the 100 nm range circle). Both these Cb cells are later confirmed after 10 and 20 minutes respectively by the onboard radar as the flight continues. Note that the radar returns on the left side beyond 50 nm are due to ground clutter and therefore not confirmed by CB WIMS as thunderstorm activity.

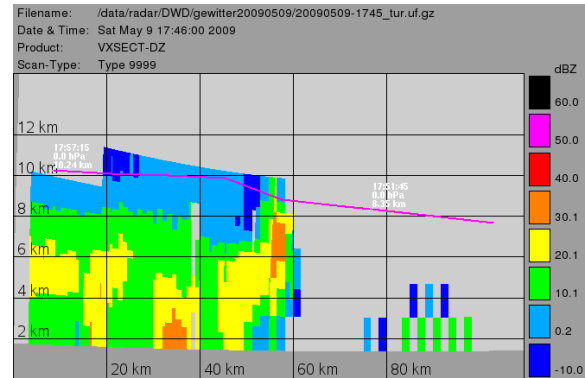
**Figure 10:** Vertical section through the radar reflectivity field as gained from the Türkheim radar at about 1748 UT along the flight path (pink line). Aircraft positions marked for 1751 and 1757 UTC.

During that particular flight phase when the aircraft approached the thunderstorm region from the east, the aircraft was ascending (refer to the pink line in Fig. 10). Provided the radar only performed a horizontal scan without tilting, it probably did not detect the small cell because it was
