# Roof Damage Issues in Hurricanes

Timothy P. Marshall, P.E.\*  
Haag Engineering Company

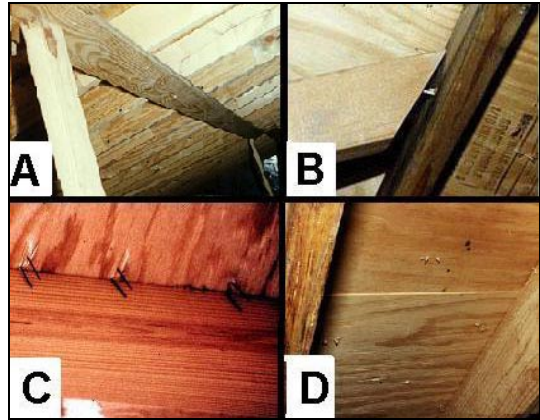
**Figure 1.** Inherent deficiencies in roof construction not related to wind: A) sagging of rafters due to inadequate support, B) gap between rafter and ridge beam from poor joinery, C) deck staples that missed the rafter, and D) wavy roof deck from lack of clips.

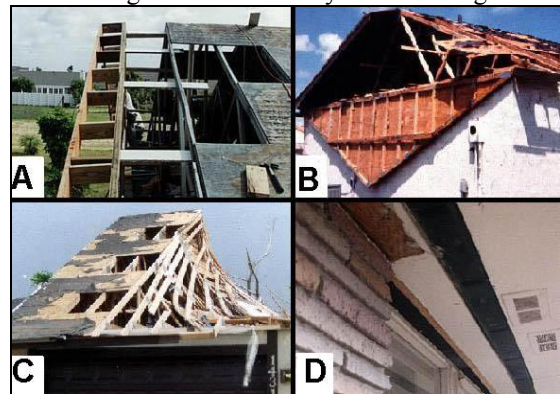
**Figure 2.** Examples of wind damage to the roof structure: A) removal of decking, B) failure of gable end, C) rotation of trusses, and D) shifting of a roof due to tree impact.
