Timothy P. Marshall, P.E.*
Haag Engineering Company

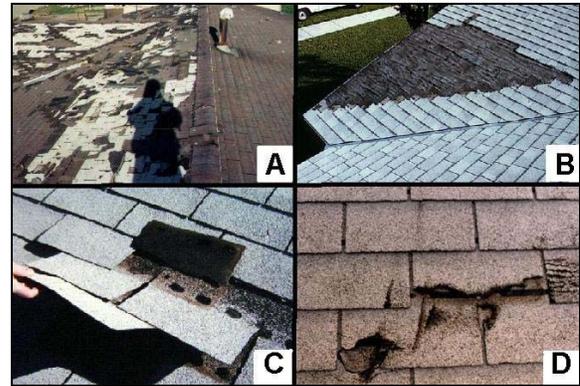
Figure 3. Wind damage to asphalt shingles: A) shingles removed from windward slope, B) windward rake damage, C) loose and flipped shingles, and D) impact damage to shingles from flying debris.

Wind uplift tends to remove asphalt shingles from the roof. This can lead to a combination of disbonding, creasing, and displacement of the shingles (Figure 3). Fasteners secured to the roof deck are usually stronger than the shingles themselves. Therefore, when shingles are torn from a roof during high winds, the fasteners usually remain in the roof deck. Windward eaves, corners, ridges, and rakes are areas that are most susceptible areas to wind damage because of higher aerodynamic uplift pressures in these regions.

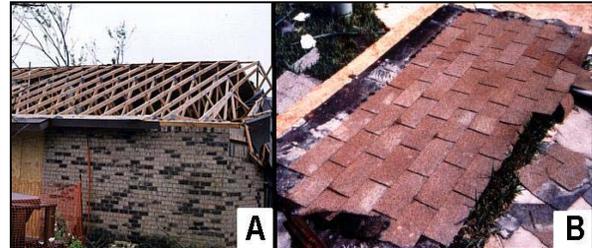
Figure 7. Examples of wind damage to roof decking: A) Loss of entire roof deck since it was not fastened to the trusses, B) entire deck sheet with shingles still attached.

There needs to be sufficient spacing between the deck boards to allow for expansion and contraction. Also, aluminum H-clips should be installed in the joints between the roof decking centered between the rafters. If nail guns are used to install the decking, care must be utilized to make sure the roof deck is fastened to the rafters or joists. Otherwise, the roof deck can be removed during the wind (Figure 7.)

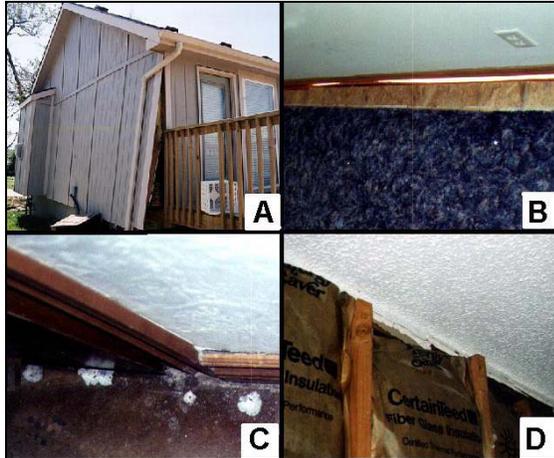
Figure 12. Examples of wall failures due to wind: A) base of wall pushed outward, B) failure of bottom plate to wooden floor connection, C) failure of bottom plate to concrete slab connection, and D) failure of wall stud to top plate connection.

forces. However, exterior walls without adequate shear bracing are subject to catastrophic failures. Outward acting pressures tend to pull out the nailed connections at the top and bottom wall plates (Figure 12). Therefore, nailed connections should be designed to resist both inward and outward forces.

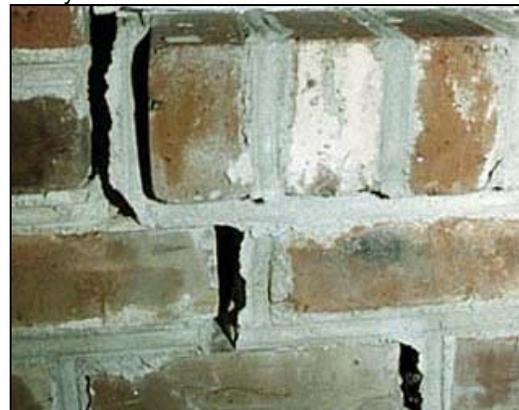
Figure 15. Stair-step crack in brick masonry from differential foundation movement. This distress was not caused by the tornado.

Mortar is a mixture of Portland cement, sand, water, and lime. The lime is utilized to increase workability of the mix. Masonry walls are particularly susceptible to cracking due to differential (up and down) foundation movement. Drainage conditions, locations of trees and downspouts, all affect the soil moisture content. Window and door openings are naturally weak points in the wall where the distress concentrates. Cracks and separations that open with height (V-shape) indicate settlement on either side of the crack whereas cracks tapering closed with height indicate settlement at the base of the crack (Figure 15). Old masonry cracks become discolored with time as they accumulate dirt, paint and debris. In contrast, recent cracks appear fresh and unweathered with broken pieces of masonry along the fractures. The Brick Institute of America (1991) has a number of excellent technical bulletins on masonry wall distress.

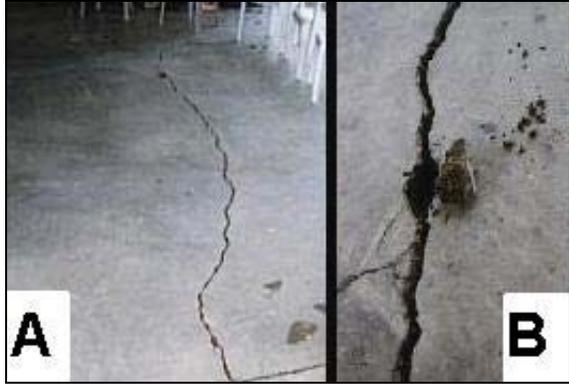
Figure 21. Cracks in concrete slab not caused by wind: A) center crack and B) close-up view showing dirt in crack.

An examination of the crack interior often will determine whether the crack is new or old. Cracks become discolored with time as they accumulate dirt, paint or debris (Figure 21). Edges of the cracks become rounded with continued wear. Water entering the cracks can lead to rusting of reinforcing steel and the resulting expansion can lead to spalling (removal of the concrete).

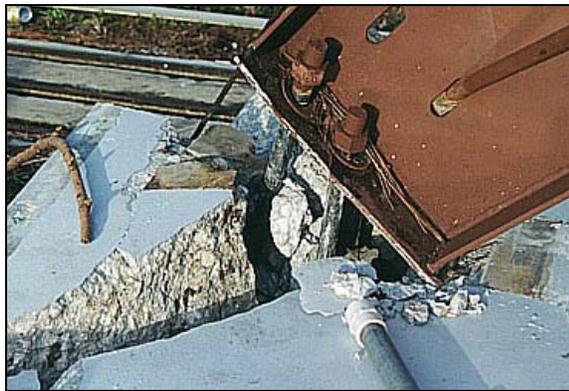
Figure 22. Cracks in concrete slab caused by the rotation of the steel column that failed in the wind.

In contrast, cracks caused recently do not have these characteristics. Recent cracks appear fresh and unweathered with broken pieces of the concrete along the fractures. Concrete slab cracks associated with wind usually are found in the direct load path of a failed building component (Figure 22).
