# Enhancing Local River Flood Hazard Communication at the Rio Grande Valley

Mike Castillo, Alfredo Vega, Barry S. Goldsmith, and Jeral Estupinan  
NOAA/National Weather Service Brownsville, TX

## Abstract

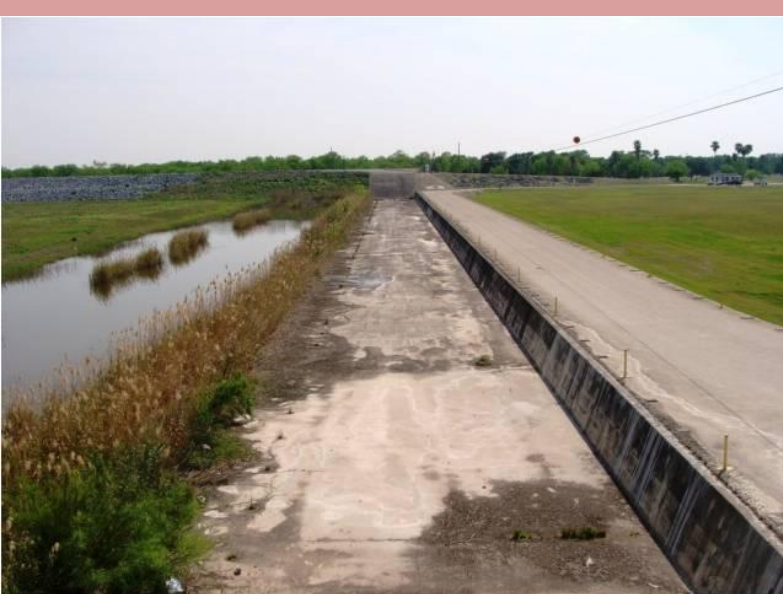
Banker floodway before diversion at Anzalduas

Farther downstream, the Lower Rio Grande Valley Flood Control Project, including the Anzalduas Diversion Dam and the series of floodways (spillways) on both sides of the United States and Mexico border were activated. This includes the Banker Floodway, the Main Floodway, the North Floodway and the Arroyo Colorado in the United States. During the latter half of July and into early August 2010, the floodways were generally at half capacity, meaning water levels were several feet high but sufficiently below the height of the levee system. Visual and measured levels generally ranged from 1.2 to 2.4 meters across the system, which begins at Anzalduas and stretches east to just south of McAllen and Pharr toward Progresso Lakes, then curves northward between Weslaco and Mercedes (after a split with the Arroyo Colorado), then turns east at La Villa before entering extreme northern Cameron County, and passes between Combes and Sebastian before entering rural southern Willacy County.

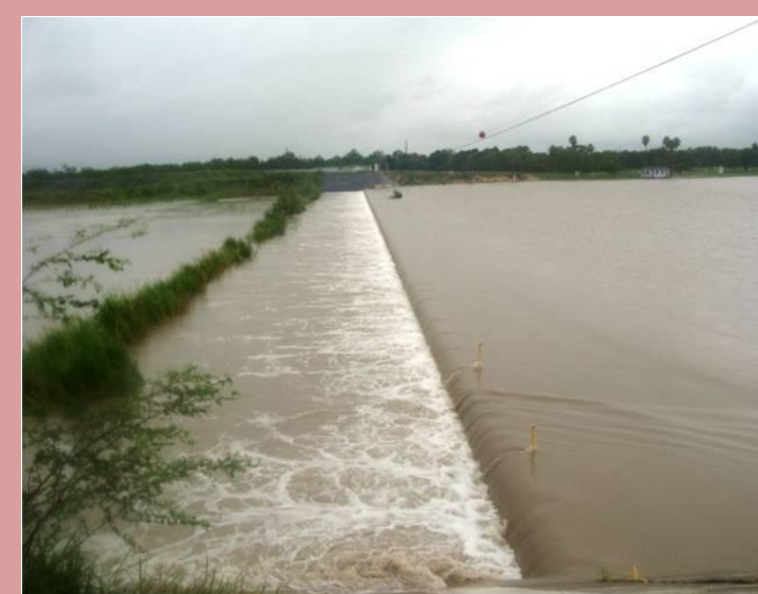
Banker floodway after diversion at Anzalduas on 8 July 2010

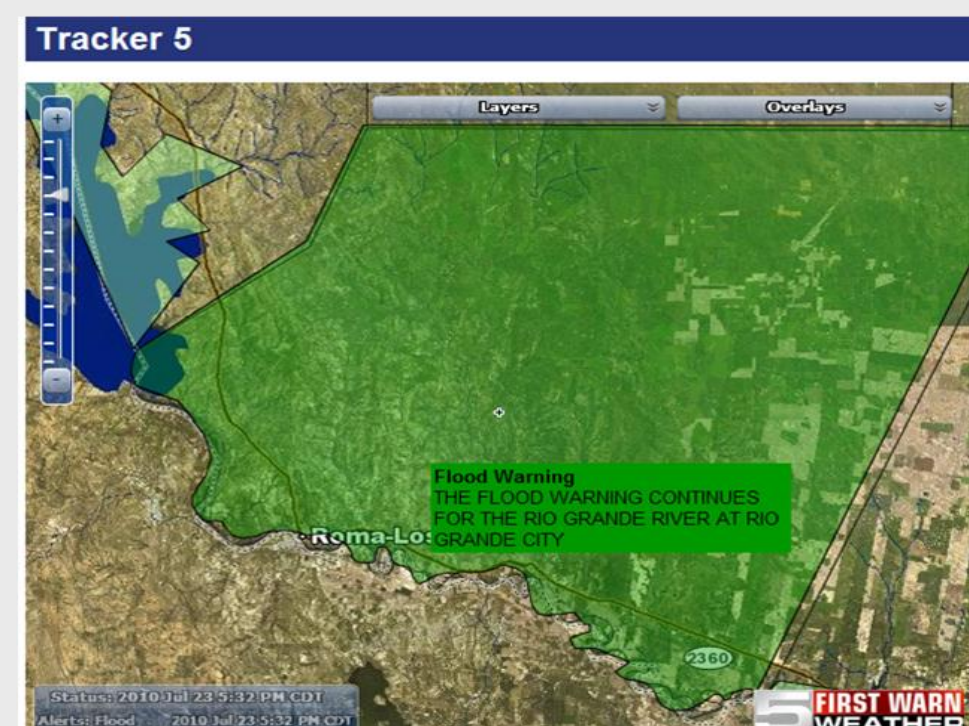
River Flood Warning for Rio Grande in Starr County

One of the major challenges was conveying the risk of flooding for several areas in more than one county, while using one established river forecast point for a river gage between Falcon Lake and Anzalduas. Another challenge was how to address the issue of flooding in the floodways, as well as the flooding inside the levees between Anzalduas and Retamal. Using graphics and news articles on the internet along with traditional text-based Flood Warning and Hydrologic Advisory products, the WFO Brownsville office was able to address many of these challenges.

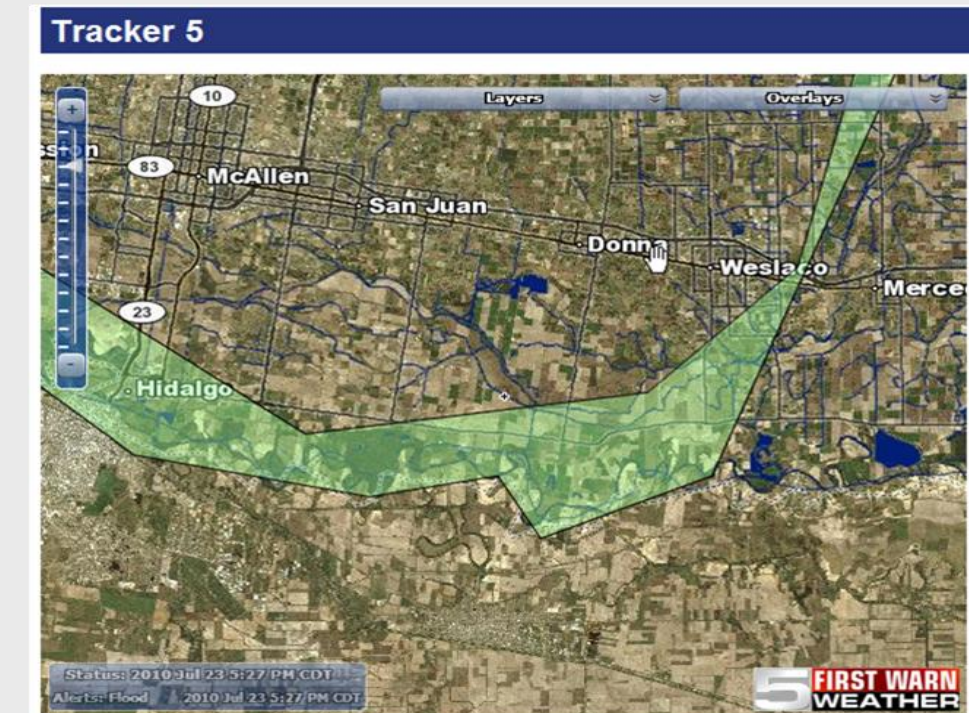
Hydrologic Advisory for the Floodways in Hidalgo County and the Santa Ana NWR along the Rio Grande

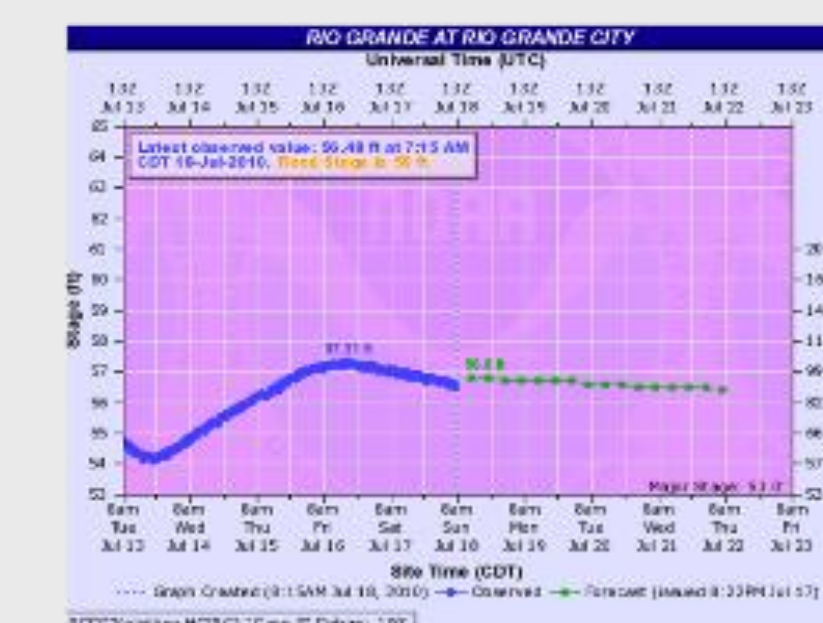
Figure B

Diversion Floodways on the U.S. Side of the Rio Grande

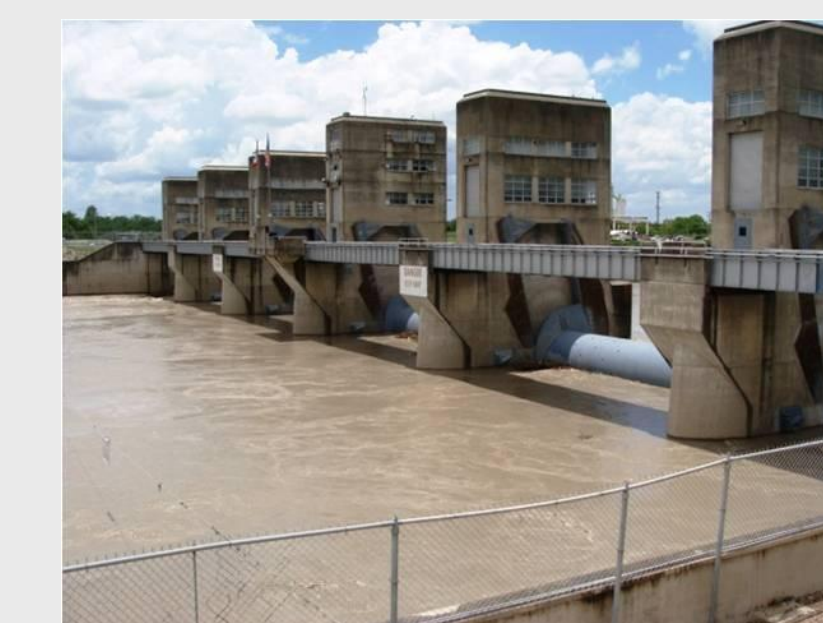
U.S. diversion dam at Anzalduas

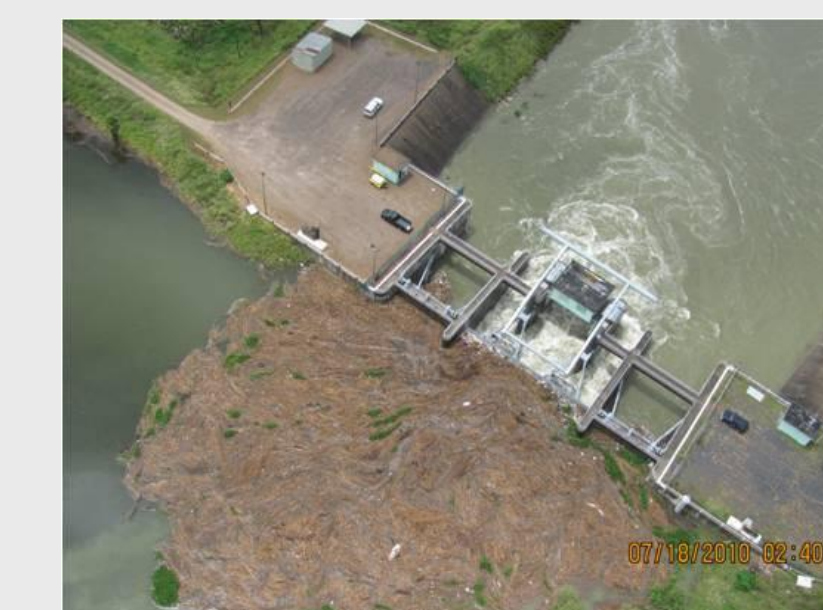
Mexican diversion dam at Retamal
