# Weather Conditions over southern Ontario on the night of November 18, 2010 during the crash of a small aircraft

## American Meteorological Society 93<sup>rd</sup> Annual Meeting 2013 16<sup>th</sup> Conference on Aviation, Range and Aerospace Meteorology

### Introduction

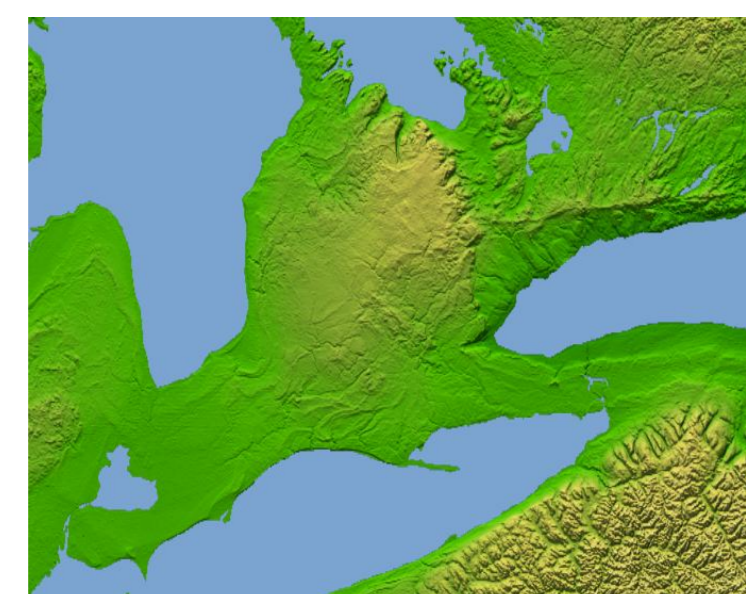
(Left) Topographic relief chart for the region of southern Ontario between Georgian Bay and Lake Ontario shows some rising terrain that may assist in orographic uplift in NW flow conditions. (Courtesy of NASA)
