# Effect of land-use on urban landslide in heavy rainfall

Ri Jin · Hai-Yan Zheng · Kyoo-seock Lee

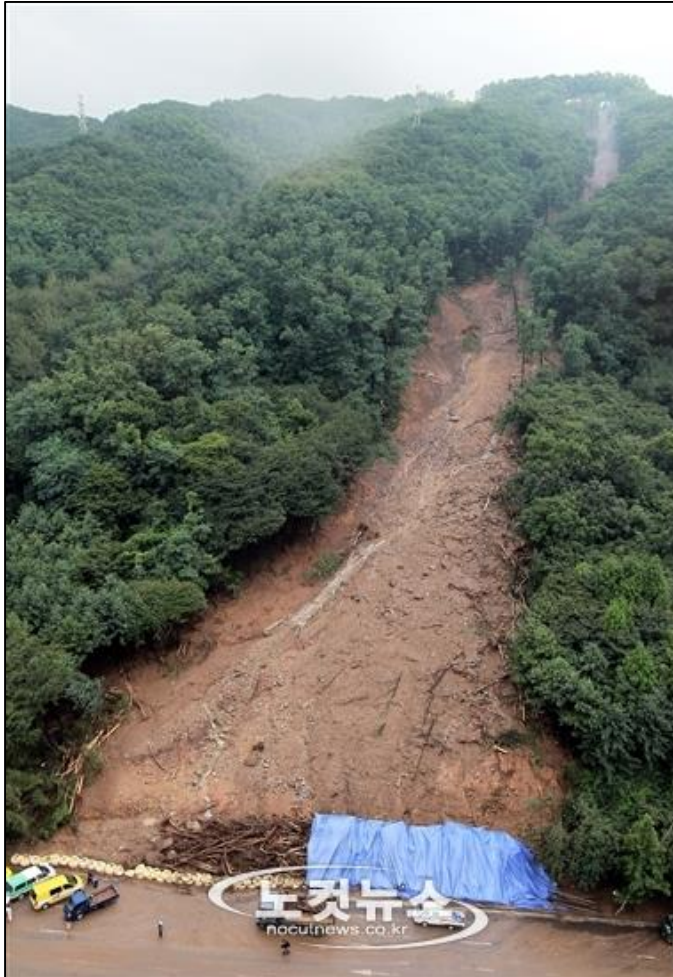
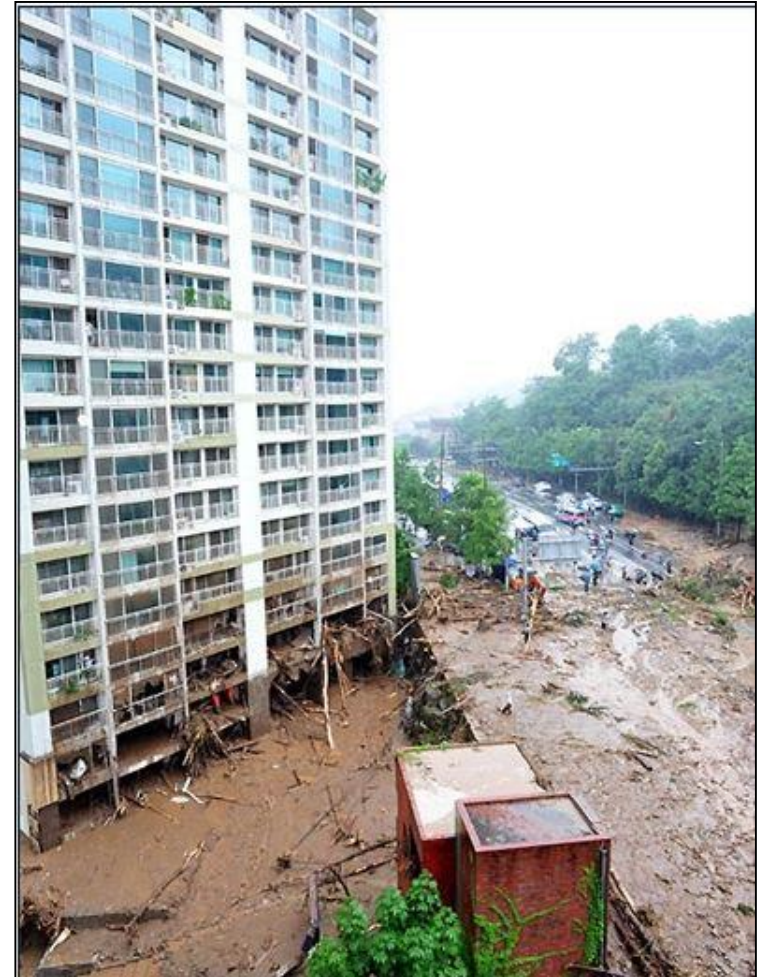
Figure 2. One of the study site was damaged by landslide
