Side-by-side tree and house damage in the May 2013 Moore, OK EF5 tornado

Chris J. Peterson
Dept. of Plant Biology
University of Georgia

Christopher M. Godfrey
Dept. of Atmospheric Sciences
University of North Carolina at Asheville

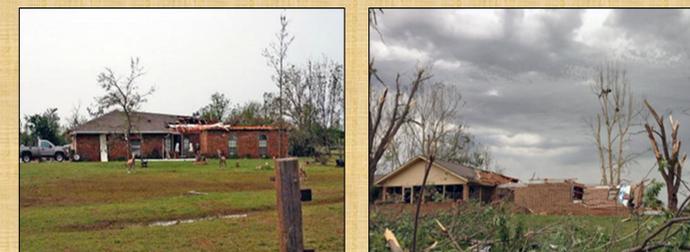
Both of these houses were rated EF2 damage. Based on current DoDs, trees should be uprooted. Instead, several show minor damage or defoliation, while one large tree is stubbed and debarked.

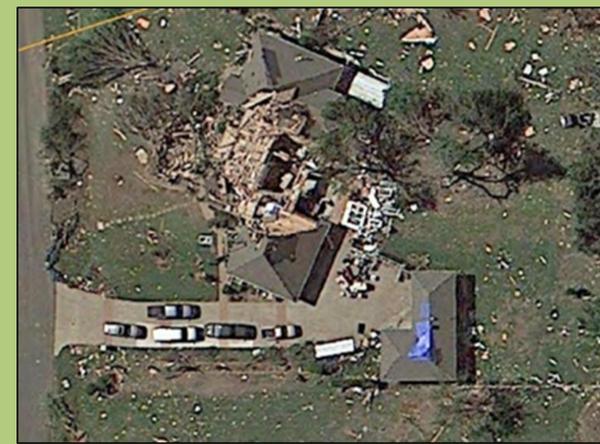
Figure 2: Post-storm image of the same home after the May 2013 tornado. House damage was rated EF1. Image from Google Disaster Response.

One example, showing the pre- and post-tornado aerial (nadir) imagery, along with an oblique photo from a newspaper helicopter (lower right).

Table 1 summarizes tree damage for trees near the home shown at left. Notably, tree damage varies from EF0 to EF3 using current EF-scale DoDs.
