**SIDE-BY-SIDE TREE AND HOUSE DAMAGE IN THE MAY 2013 MOORE, OK
EF5 TORNADO: LESSONS FOR THE ENHANCED FUJITA SCALE**

1. INTRODUCTION

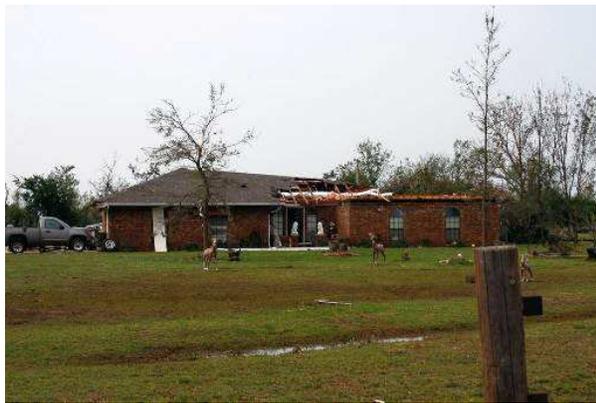
Fig. 6 shows a house with damage that was rated EF2.

FIG. 6. House with EF2 damage.

Note that on the EF scale, EF2 winds are expected to produce breakage of large branches, as well as snapping and uprooting of both hardwoods and softwoods (see Table 1). However, the photo shows two large hardwood trees in very close proximity to the house, yet they remain standing with most branches intact. Notably, the trees are both severely defoliated, suggesting that perhaps defoliation is an indicator of moderate winds within a tornado, yet defoliation is not currently considered within the DoDs for tree-focused DIs.

A similar situation is evident in Fig. 7. The damage to this house was rated EF2, yet the expected EF2 damage is clearly not evident on the large hardwood in the center of the photograph. In the case of either photo (Figs. 6 and 7), it is difficult to blame the discrepancy on the small-scale spatial variations within a tornadic circulation (and thus claim that the trees were far enough away that they were subjected to lower wind speeds), because in both cases aerial imagery shows that the trees are less than 5 m away from the houses. While the well-known small-scale variability within a tornado could certainly offer a plausible explanation in a minority of cases, it seems unlikely that the maximum wind speeds could vary over

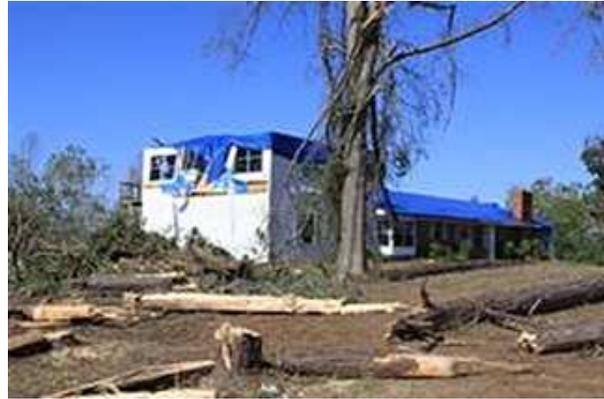
FIG. 7. House with EF2 damage.

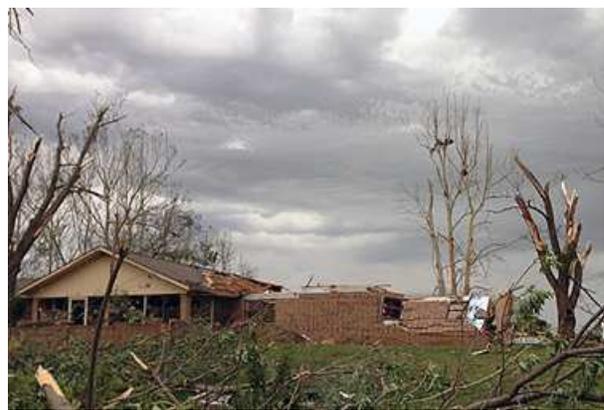
FIG. 8. House with EF2 damage.

Finally, Fig. 8 shows the opposite pattern. In this situation, the house experienced EF2 damage, but the large tree to the far right, which is only 4 m from the corner of the house, was stubbed and partially debarked. These patterns of damage indicate EF3 winds given the DoDs in the EF scale. One notable observation is that debarking may be primarily a phenomenon of urban and residential areas. The authors have collectively examined thousands of trees across more than 15 tornado damage areas in forests and have rarely seen debarking.

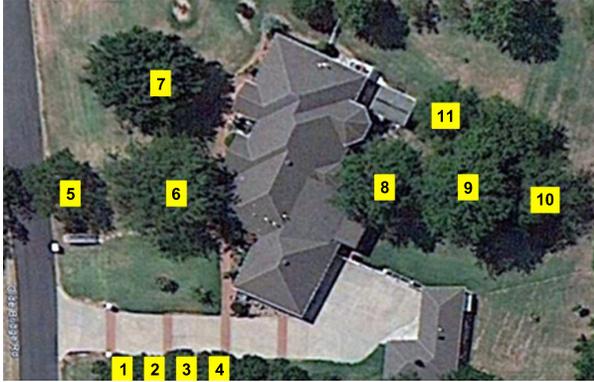
The following discussion illustrates the process of damage evaluation through an analysis of remote imagery. The large home shown in Fig. 9 is on South Olde Bridge Rd., just north of SE 4th Street in Moore, OK. This image captured from Google Earth shows the pre-storm condition of the structure. Figs. 9 and 10 have both been rotated 180° to match approximately the view of the newspaper photograph shown in Fig. 11. Note that the trees are quite visible in each image, including very small trees such as the two saplings just above the driveway (not numbered).

FIG. 9. Pre-storm image of a residential structure. Numbered labels refer to the individual trees listed in Table 2. Image source: Google Earth.

Table 2 shows an example of the key information acquired from an analysis of the imagery in Figs. 9 through 11. Note that several trees were stubbed, but not debarked, though the present EF-scale DoD presents these two types of damage together, thus not allowing them to be recorded separately. Note that while all of these trees are near the same FR12 structure that received a damage rating of EF1, the nearby trees exhibit a broad range of levels of damage.

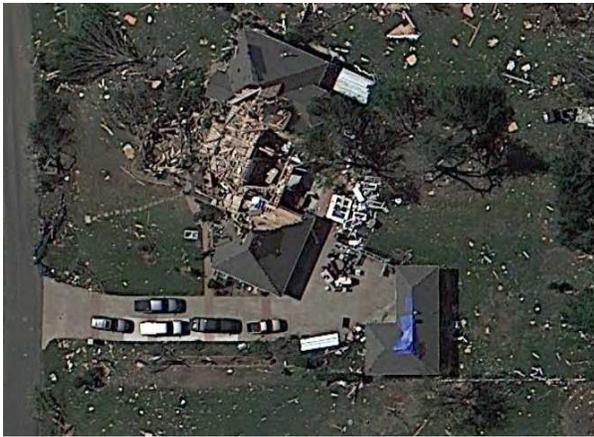
The image shown in Fig. 10 is a 15-cm resolution aerial nadir photograph obtained from the Google Crisis Response site. The extensive roof damage evident in this image led the NWS damage assessment team to rate the damage to this home as EF1 (i.e., uplift of roof deck and loss of significant roof covering material). The trees lying on the ground after snapping or uprooting show up clearly and their damage is readily apparent, but the fate of other trees (e.g., the small trees labeled 1 through 4

FIG. 10. The same structure shown in Fig. 9 captured from a 15-cm resolution aerial photograph. Image source: Google Crisis Response.

below the driveway) is more difficult to discern.

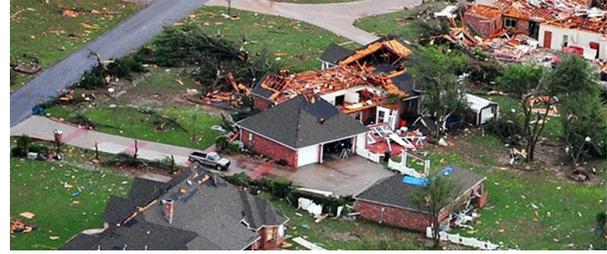
Fig. 11 shows a publicly-available photograph published by USA Today. This is an oblique image, looking roughly from the bottom and slightly to the right of the images shown in Figs. 9 and 10. Note that the disposition and condition of several of the trees are much more readily apparent in this image than in the post-storm aerial photograph shown in Fig. 10.

FIG. 11. The same structure shown in Fig. 9 captured from a helicopter. Image source: USA Today.
