860 Decision Support Services and Impacts of the Flash Flood and Debris Flow in Mount Charleston, Nevada, 28 July 2014

Michael Paddock*
NOAA/National Weather Service, Las Vegas, Nevada

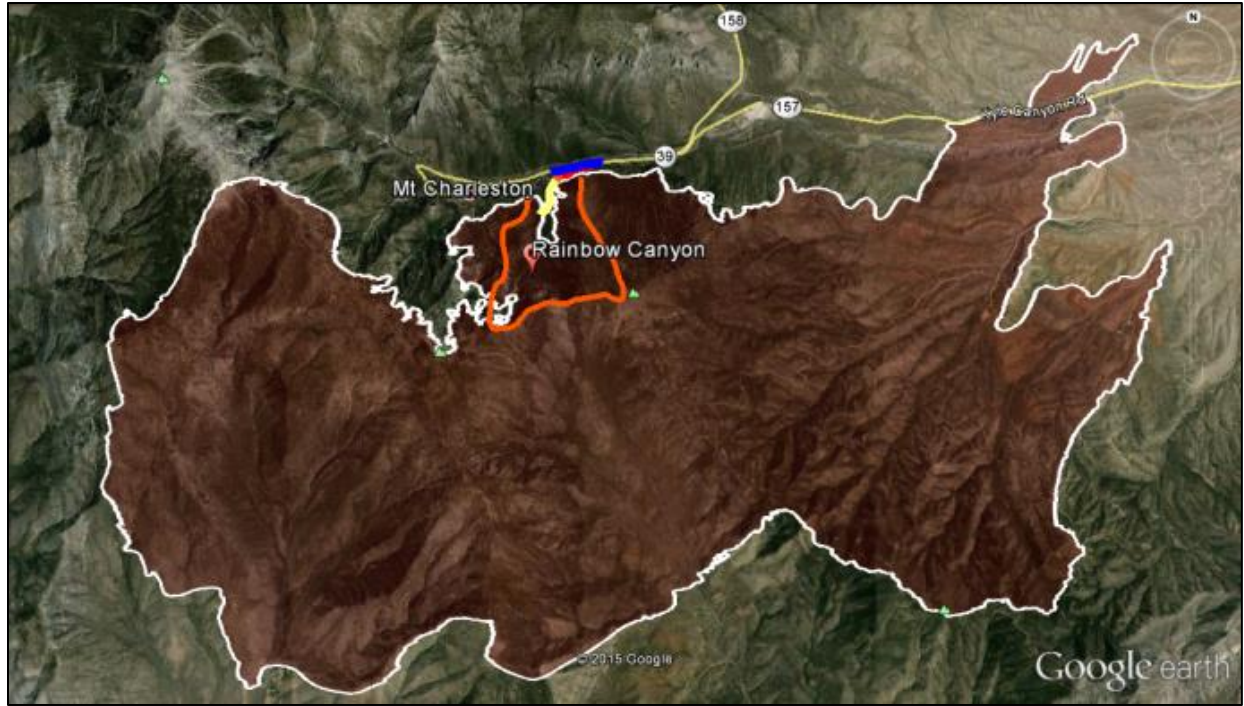
Figure 2. The maroon area outlined in white depicts the Carpenter 1 wildfire burn scar, 27,881 acres. The area outlined in red is Rainbow Canyon, which contains the heavily damaged Rainbow Canyon subdivision during this event.

The Carpenter 1 wildfire was a large wildfire in the Spring Mountains of Clark County in southern Nevada. The fire was started by lightning on 1 July 2013 and consumed 27,881 acres between the elevations of 1524 through 3352.8 meters (5,000-11,000 feet) MSL by the time it was fully contained on 17 September 2013 (National Interagency Fire Center 2013). The fire burned with moderate to severe intensity resulting in hydrophobic soils over much of the burn scar. The main populated location impacted was Mount Charleston, Nevada. [Figure 2](#) illustrates the size of the burn scar and a few key locations throughout Mount Charleston.

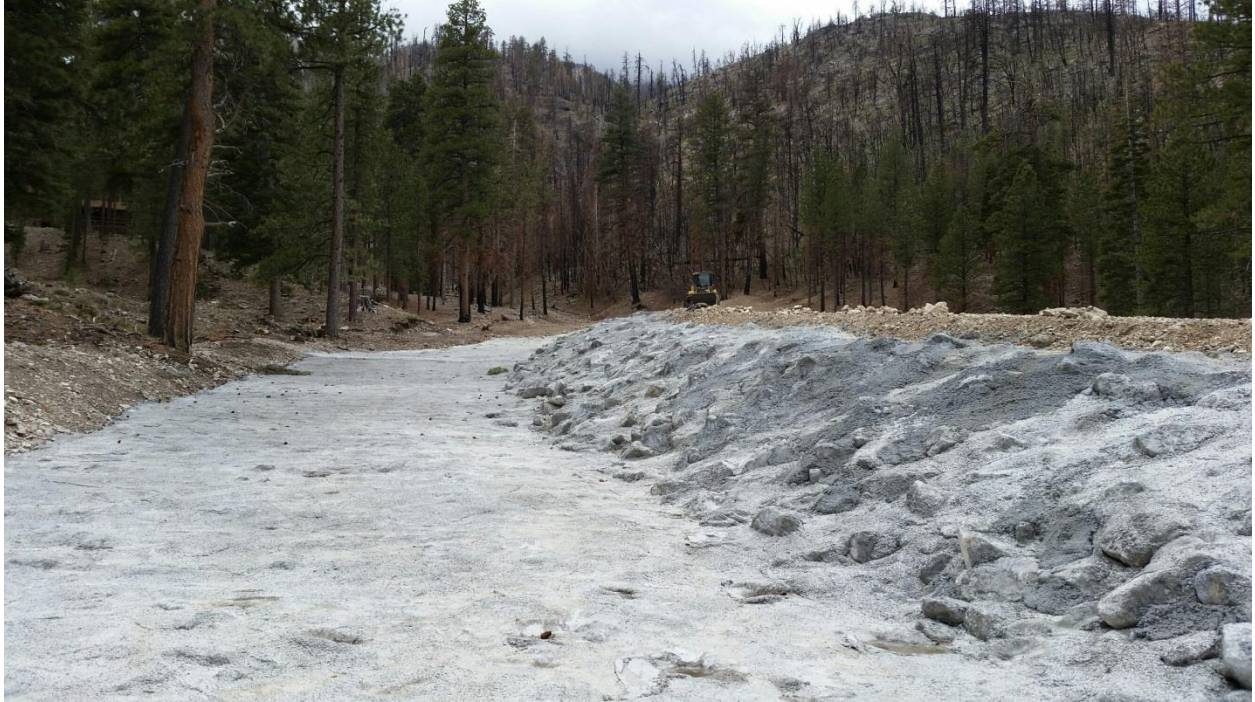
Figure 15. NWS Las Vegas picture showing the berm and diversion channel built by the United States Army Corps of Engineers to protect the Rainbow Canyon portion of Mount Charleston from additional flash flooding and debris flows. The Subdivision is off the picture on the right-hand side. The burn scar area remains visible across the higher terrain toward the top of the picture.

In early August the United States Army Corps of Engineers (USACE) were tasked with designing and constructing a diversion channel and berm to temporarily protect the Rainbow Canyon subdivision from future flash flooding and debris flows. The USACE utilized NOAA Atlas 14 (Bonnin et al. 2011) data as well as NWS Las Vegas local knowledge of the typical rainfall amounts and patterns for the Mount Charleston area. By the beginning of September, the USACE had prepared their design document for the diversion channel and berm, with construction scheduled to begin shortly thereafter. The project was scheduled for completion before spring 2015. Pictures taken by NWS Las Vegas in April 2015 show the completed diversion channel and berm ([Figs. 15](#) and [16](#)).

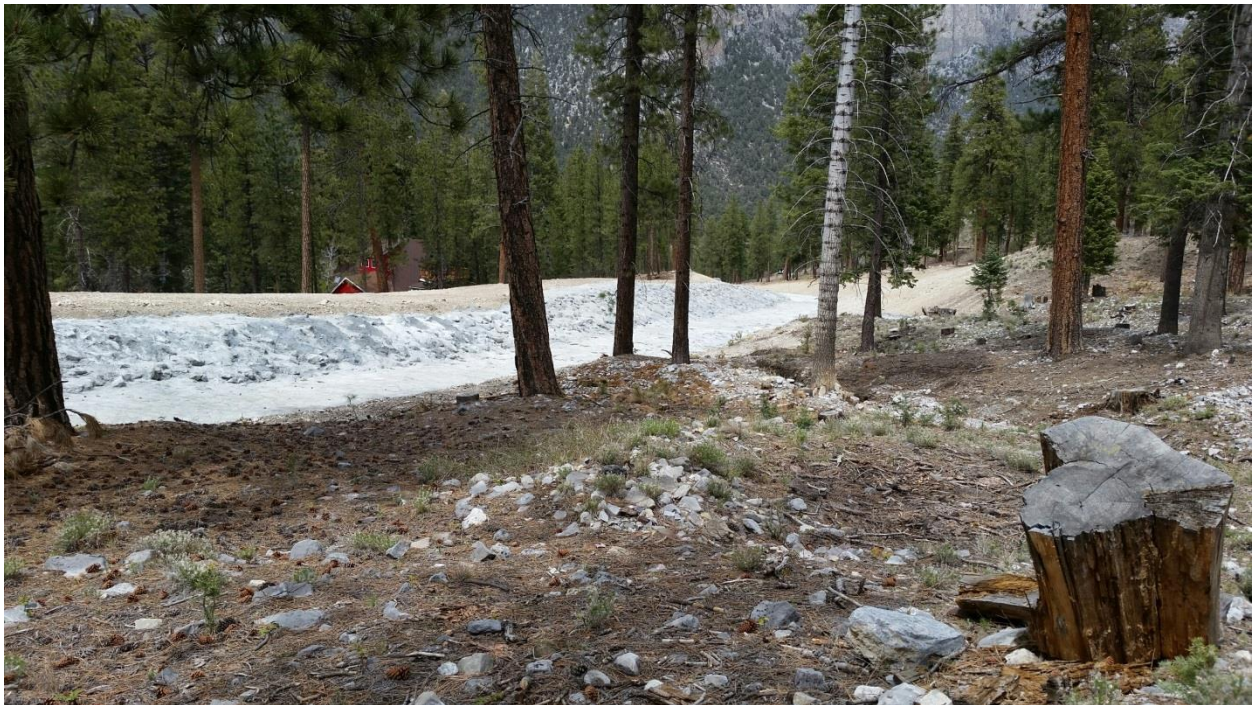
Figure 16. Same as [Figure 15](#), except facing downhill toward the Rainbow Canyon Subdivision.

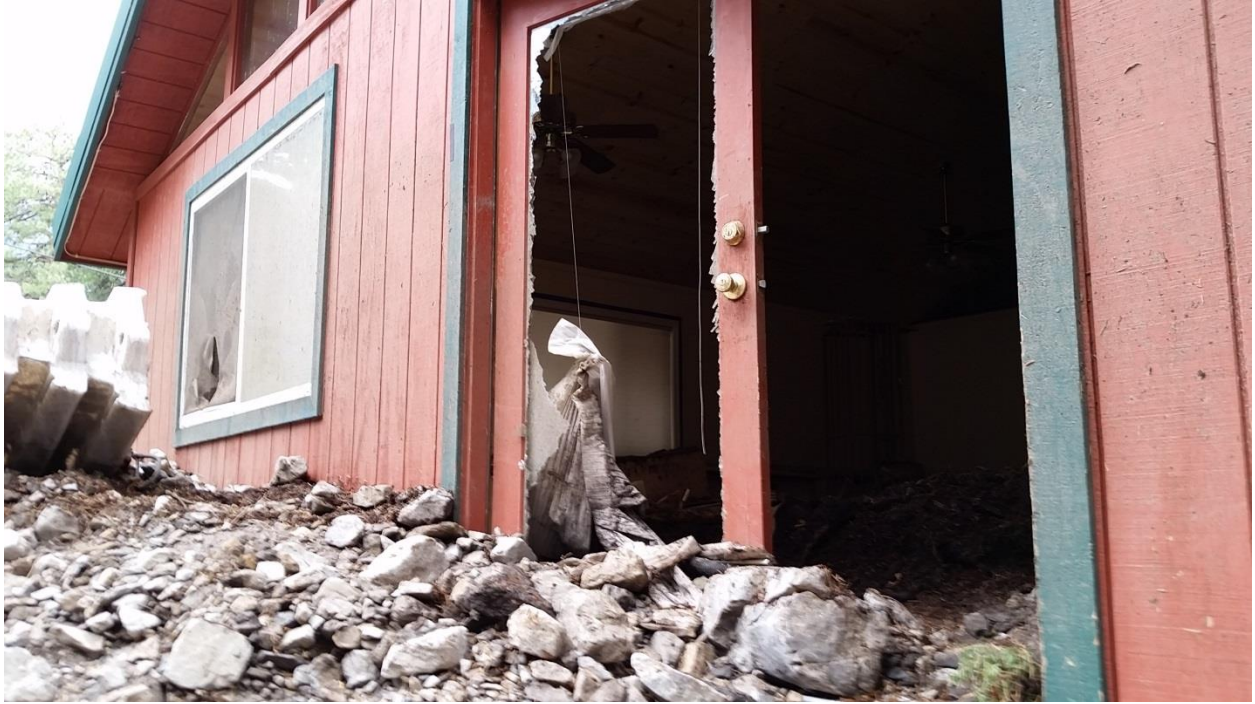
- Landline telephone service was lost during the event, restored the following day.
- Numerous propane tanks and connections were inspected and fixed where necessary.
- Approximately 12 homes were damaged, with two containing severe damage and were not inhabitable ([Figs. 18](#) and [19](#)).
- Shelters were established by the American Red Cross at a nearby hotel and school for impacted residents.
- Within 48 hours, Clark County cleared tons of debris and water, power, and fuel services were restored.

Figure 18. NWS Las Vegas damage survey picture showing substantial damage to one house, where debris broke through the front glass doors and rushed into the house. The debris piled to a height of three feet in several rooms of the house.

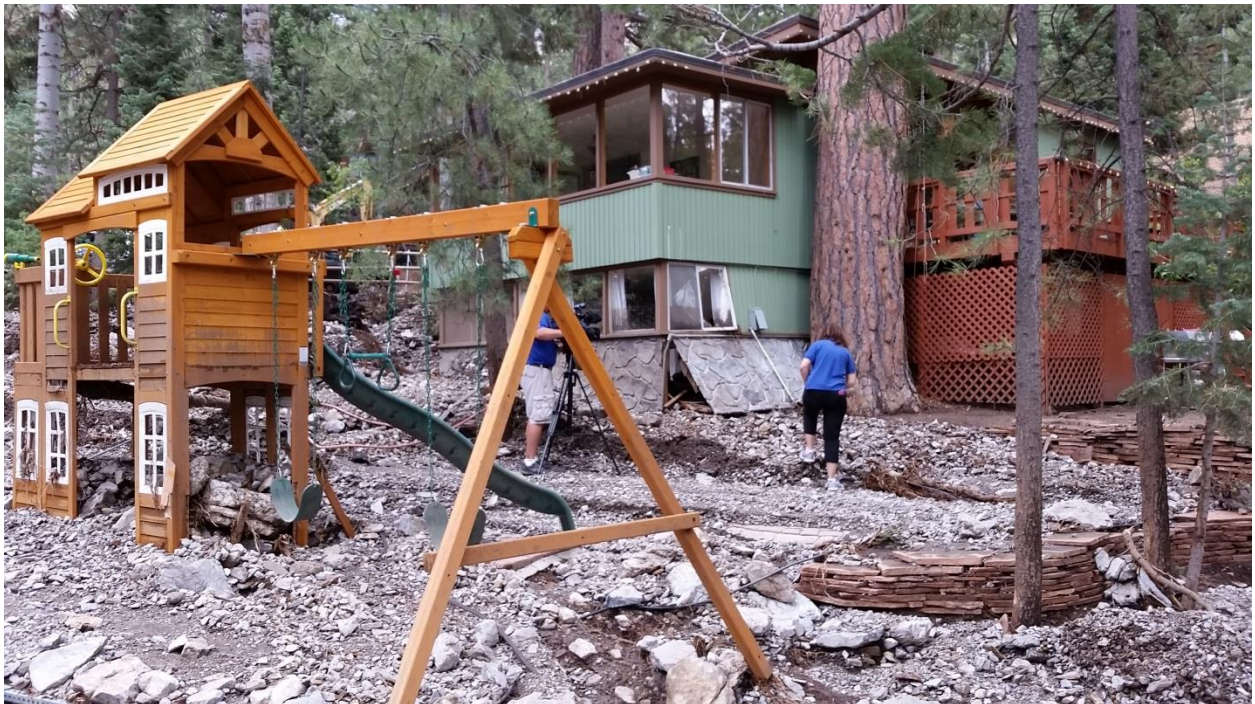
Figure 19. NWS Las Vegas damage survey picture showing damage to the lower level of another house. The debris, mud, and water height during the event is noticeable on the house, but more so on the children's play house and swing set.
