THE EVENT

A non tropical-cyclone, rainfall event 17th to 19th October 2018 led to a National flood disaster up until the 25th October 2018 in Trinidad and Tobago. Main precipitation and enhancement features were the ITCZ, low level troughs, upper level divergence, warm SSTs and a propagating Kelvin wave which were all tied to a deep moisture profile. The intense rainfall led to widespread flooding which impacted almost 80% of the country. An estimated 100,000 to 150,000 people across the country were directly affected with Greenvale community being hardest hit. There was widespread property damage in addition to crop annihilation, mass evacuation and/or displacement and active emergency shelter operations.

TRINIDAD & TOBAGO

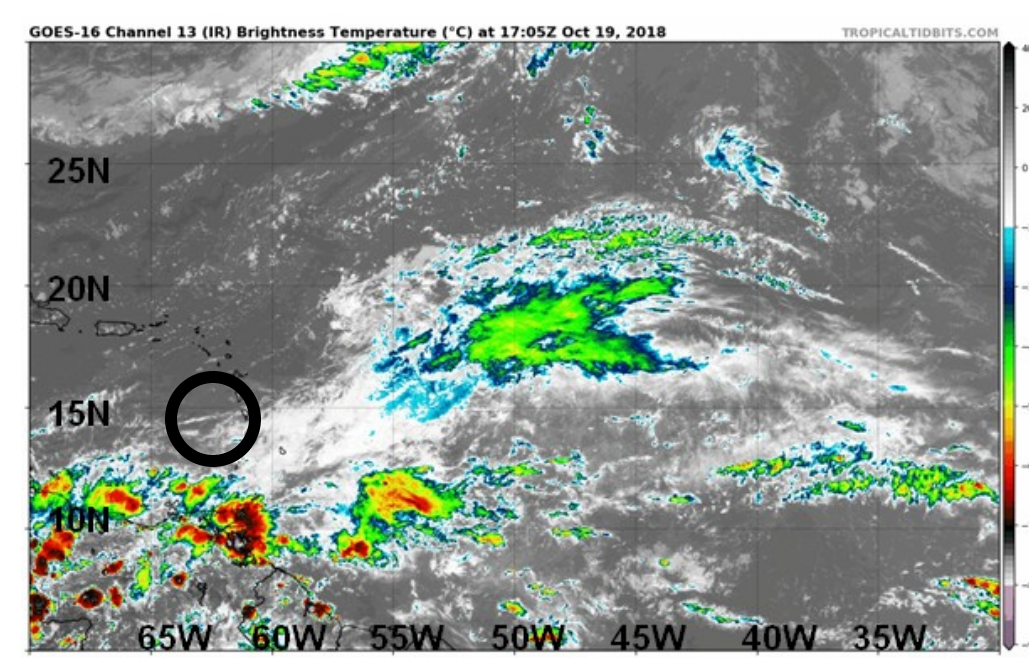
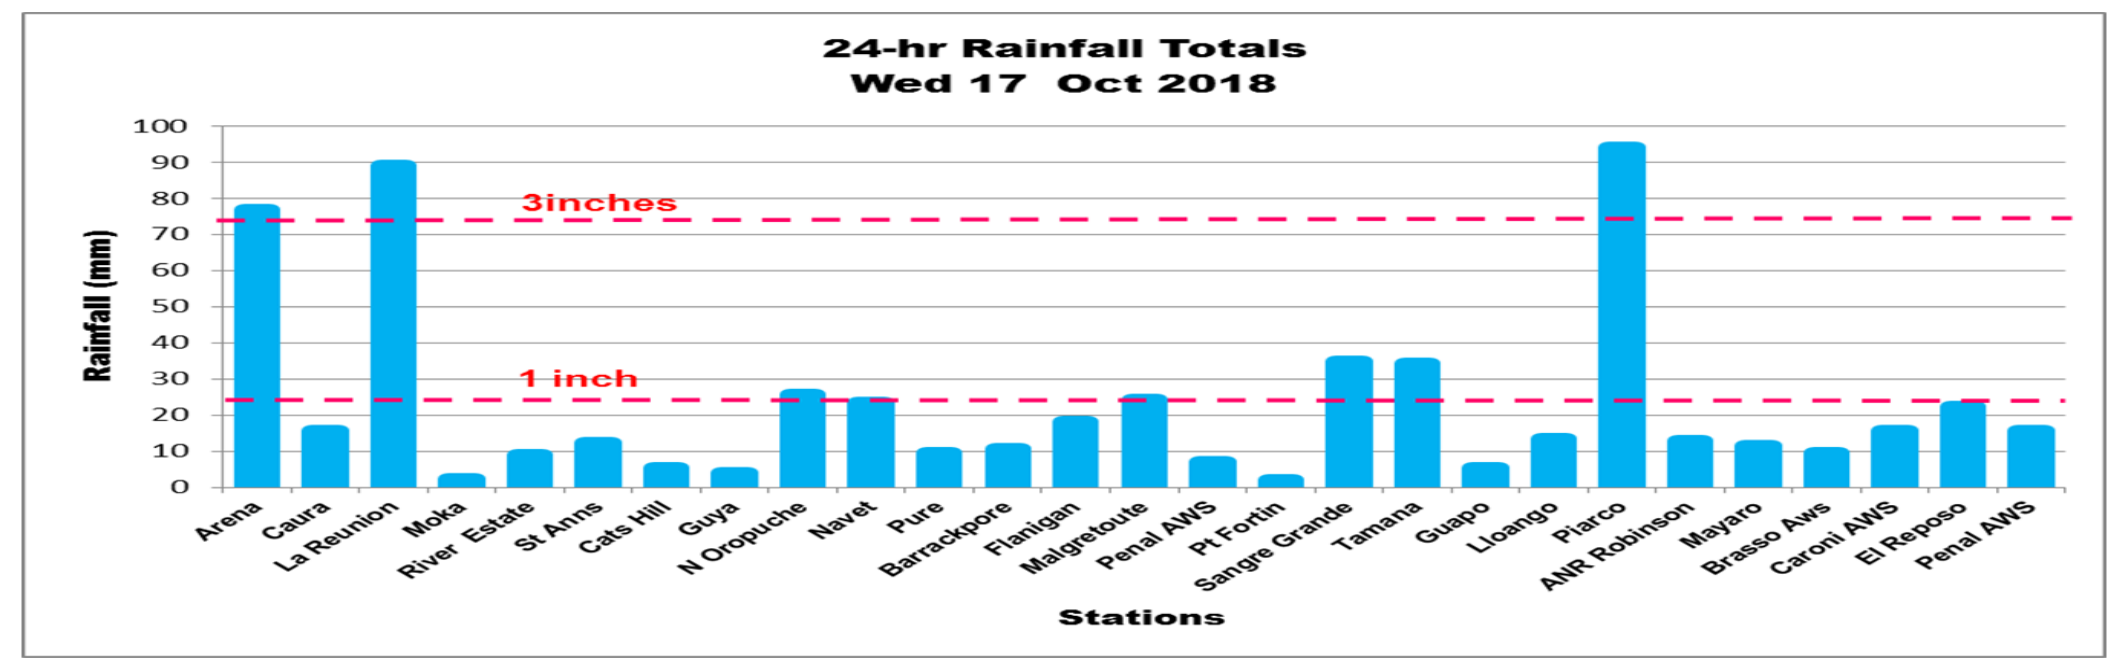
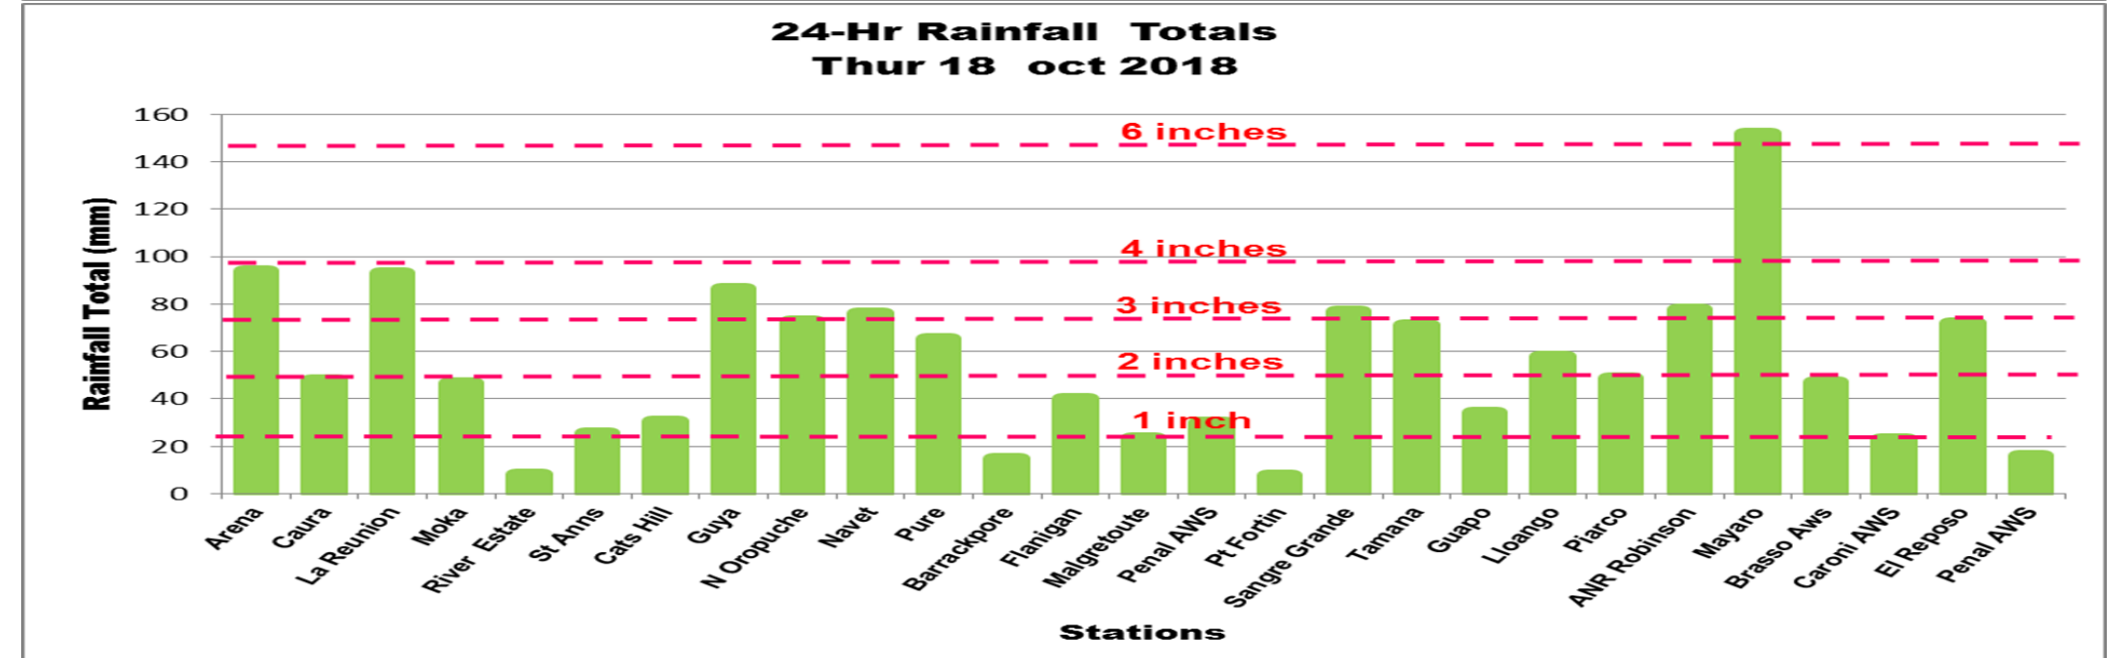
TORRENTIAL PRECIPITATION EVENT 17th –19th

A well established ITCZ ideally located mainly over north Trinidad pulsed at times by low level troughs. Deep convection and significant groundwater accumulation led to widespread and riverine flooding which lasted in some areas until the 25th October, with lingering ponding in some areas. Accumulated rainfall over the event was 9.86 inches (250.2 mm). The average (1981-2010) rainfall average for October is 8.15 inches (206.9 mm). This event was forecast by the TTMS since the 14th October 2018.

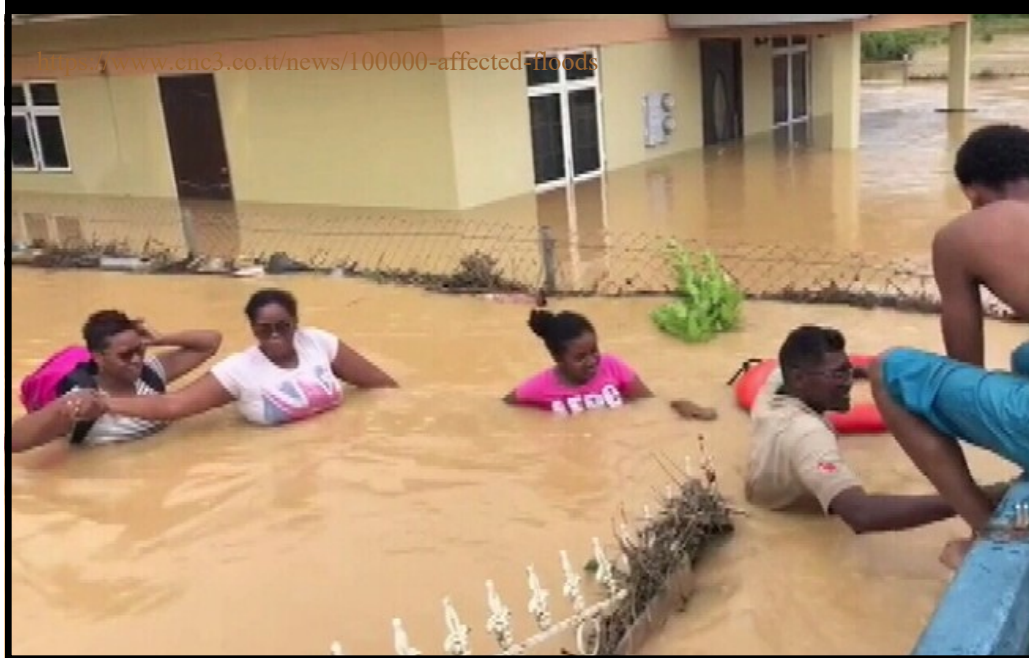
Evacuation by boat

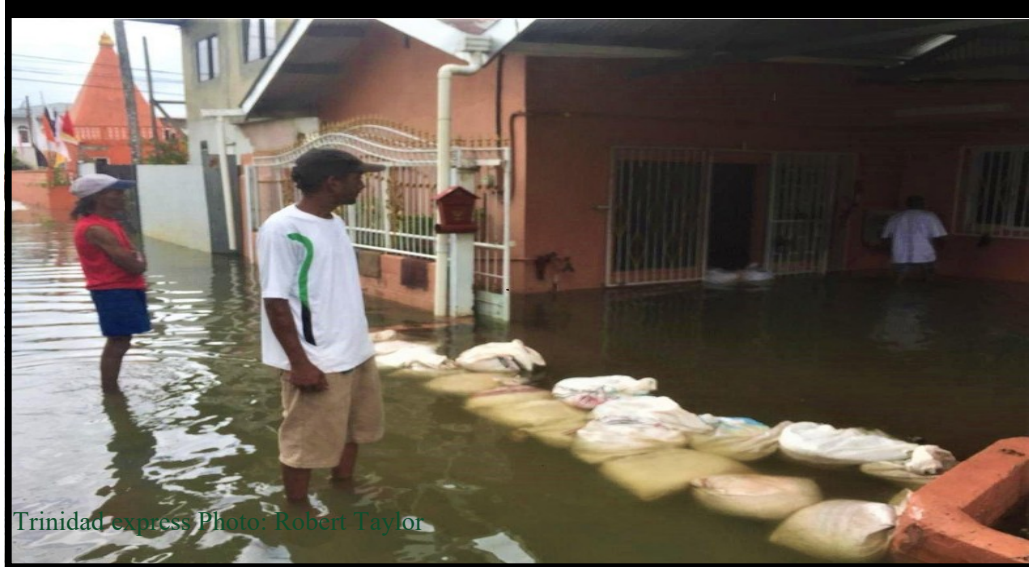
Sandbags ineffective

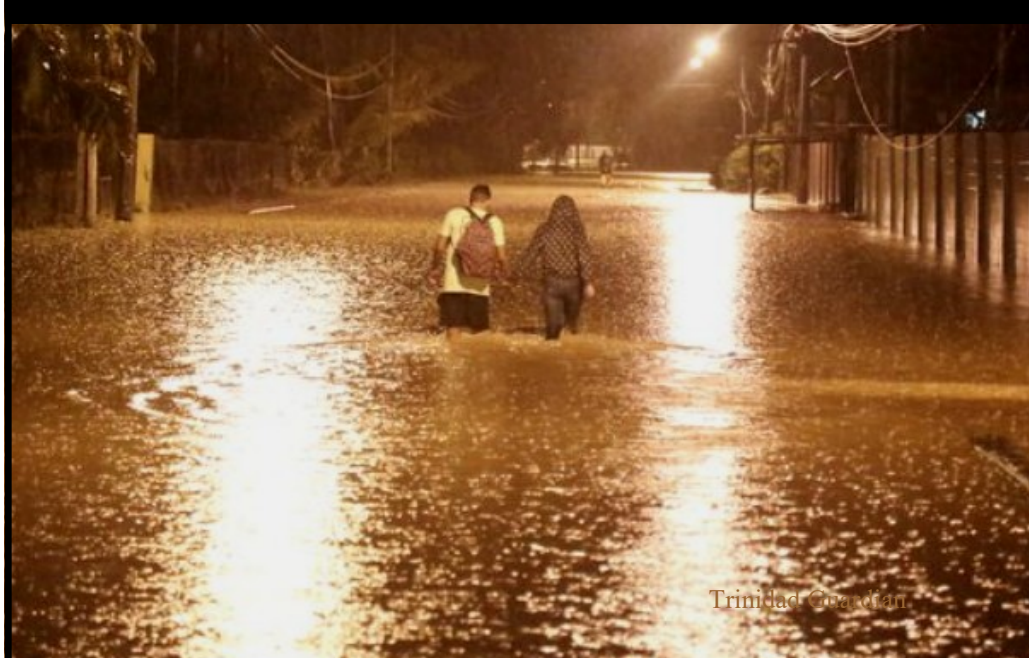
...and roads were rivers

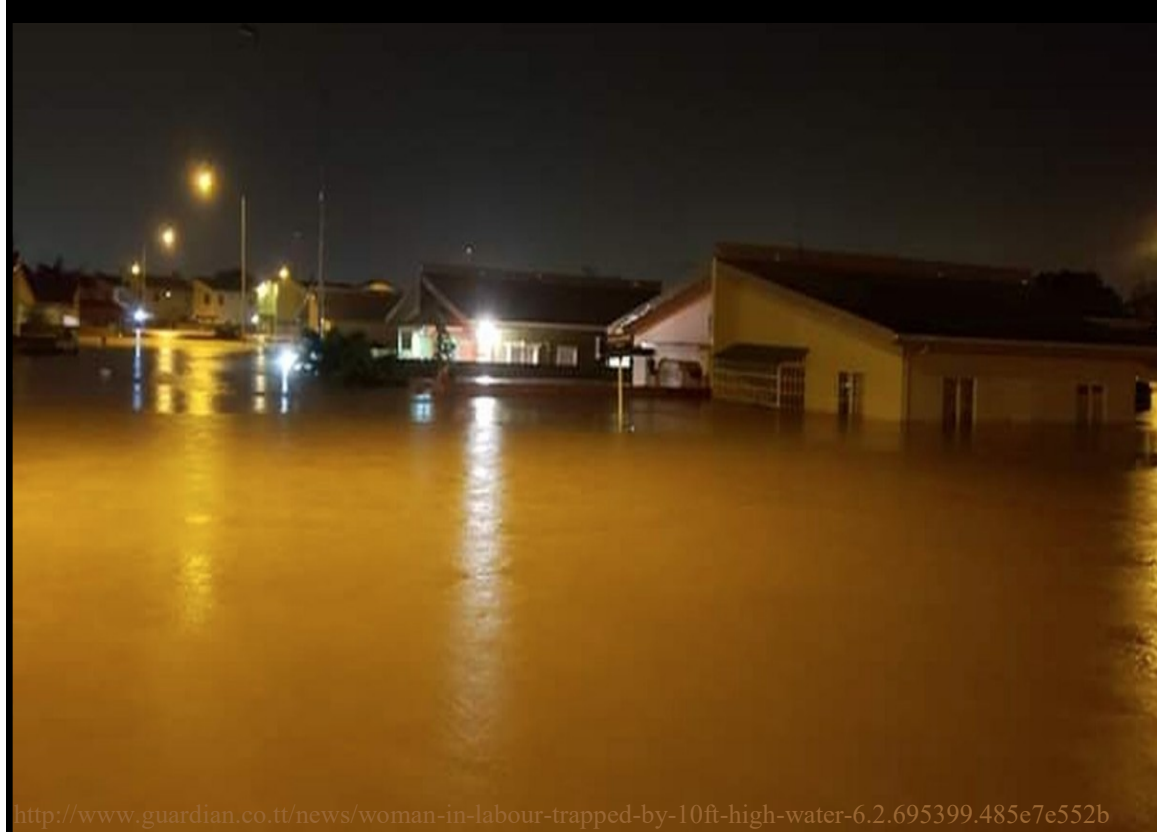
Greenvale Park inundated

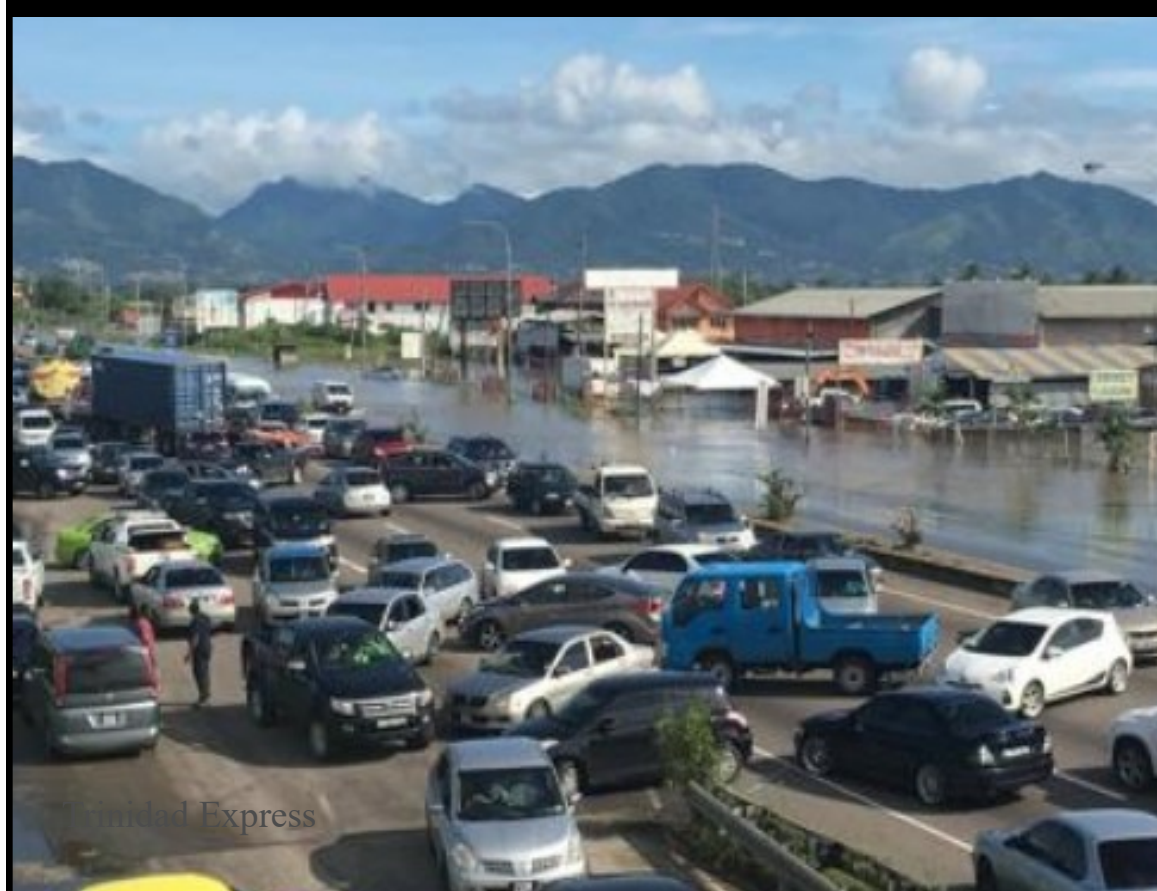
Restricted highway access
