### 3.5 FLOOD SAFETY: WHAT HAVE HISTORIC FLASH FLOODS TAUGHT US?

Matthew Kelsch\*  
UCAR/COMET<sup>®</sup>, Boulder Colorado

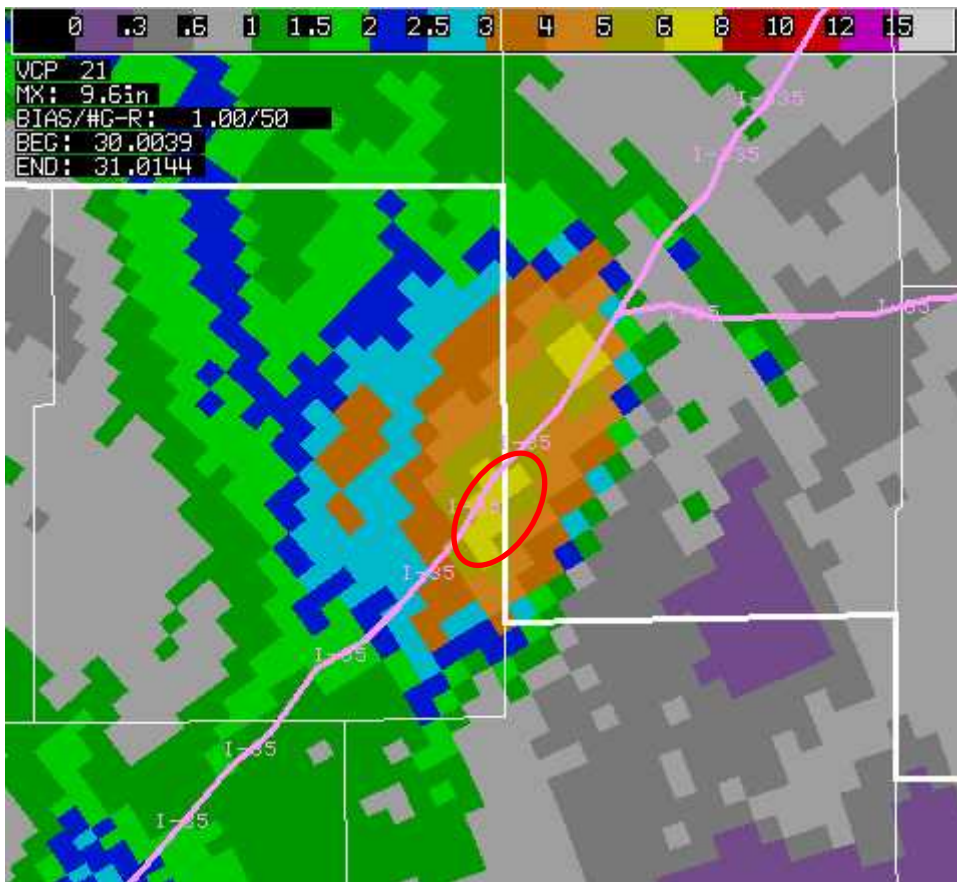
Figure 1: Radar-derived precipitation accumulation (inches) as of 0130 UTC 30 August 2003. The pink line is U.S. Interstate Highway 35, the Kansas Turnpike. White lines are county boundaries in east-central Kansas. The storm of interest is circled in red.

During the early evening of 30 August 2003, persistent torrential rain produced 150-200 mm (6-8 in) of precipitation along and immediately east of the Kansas Turnpike in east-central Kansas (Fig. 1). The heaviest rains fell at the headwaters of Jacob Creek which drains only 5-8 km<sup>2</sup> (2-3 mi<sup>2</sup>) upstream of the turnpike. This is the bright yellow area on Fig. 1 to the right of the highway. With the

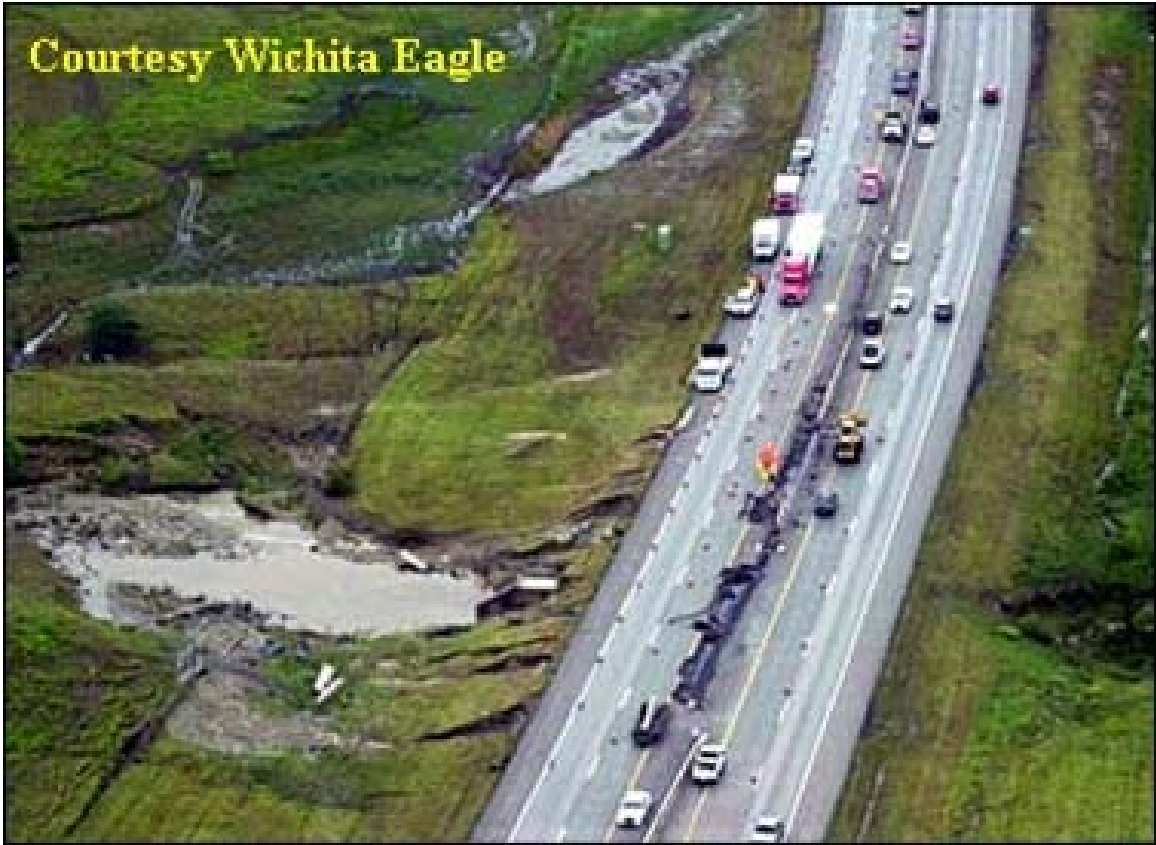
Figure 2: Aerial view of the flash flood area along the Kansas Turnpike taken just after the 30 August 2003 flash flood. To the left of the roadway is "downstream" where erosion scars are evident.

At roughly 9:30 PM local time, 12 of the concrete barriers down the median of the turnpike broke loose from the weight of the floodwater and surged downstream along with 7 vehicles. Sadly, six people lost their lives. Fig. 2 shows the section of the turnpike that experienced the severe flooding. Erosion downstream (left) of the interstate can be seen in the photo.

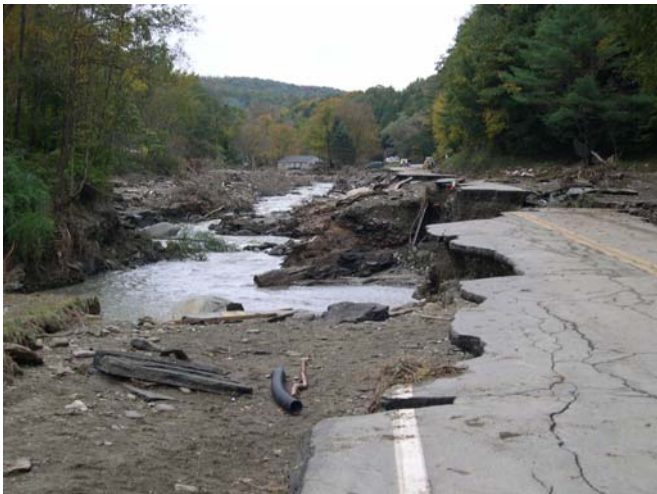
Figure 4: Damage to a roadway from the 9 October 2005 Cheshire County, NH flash flood.

The worst flooding episode occurred in the predawn hours and was associated with water that became impounded by road embankments. Structural failure at some of these embankments resulted in sudden releases of floodwater. The most dramatic example of this occurred on Warren Brook just upstream of the small town of Alstead. Water had backed up behind a road embankment and formed a lake about 7.6 m (25 ft) deep and covering an area of about 5 hectares (12 acres). The road embankment failed just before sunrise and tore a path of devastation for 10 km (6 mi) along Warren Brook and the Cold River. There were several fatalities. Fig. 4 shows an example of the destruction left behind after the flood surge passed.

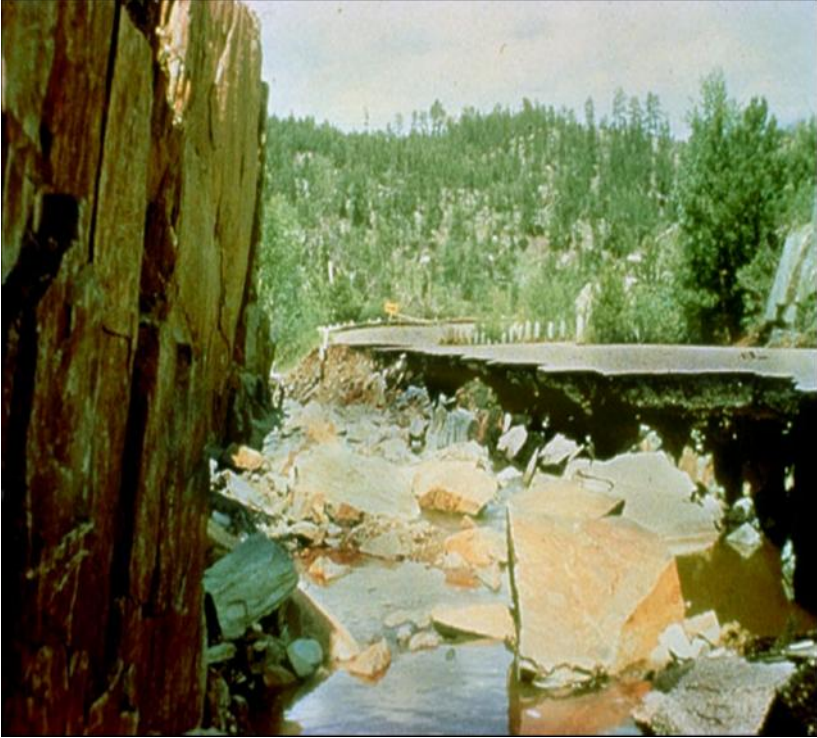
Figure 5: Damage to U.S. Highway 34 in the Big Thompson Canyon, Colorado from the 31 July 1976 flash flood.

During a four hour period that evening a thunderstorm deluged the upper parts of the canyon and its tributaries with up to 305 mm (12 in) of rain. The intense rain ran off the rocky surfaces and quickly down the steep terrain into the Big Thompson River. This rapidly swelled the river to a magnitude that was many times more volume than had ever been recorded. Many sections of U.S. Highway 34 through the canyon were obliterated along with many vehicles (Fig. 5). The flood claimed 145 lives, more than 70% of

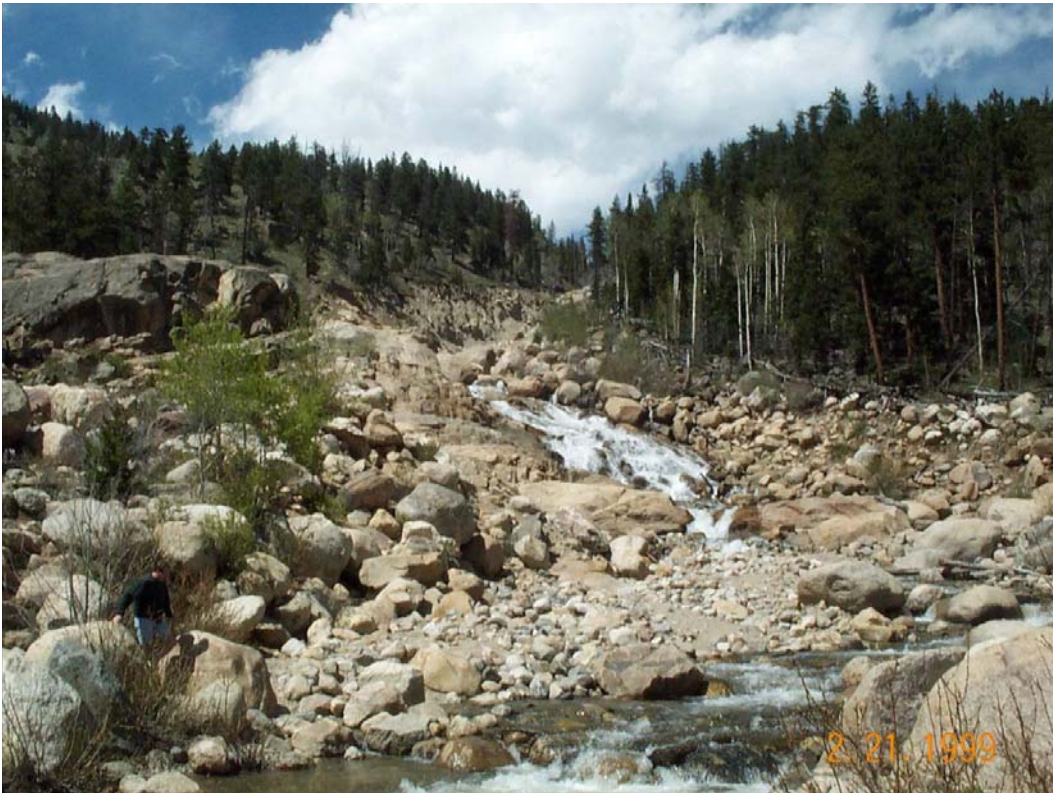
Figure 6: Alluvial fan, or flood deposits, remaining in Rocky Mountain National Park, Colorado, due to the 15 July 1982 Lawn Lake dam failure.

The alluvial fan, which is the massive debris deposit laid down by the flood, is one of the park's most beautiful and educational locations today (Fig. 6). Broken trees and multi-ton boulders that were hurled down the mountain are still a vivid reminder today about the incredible force of floodwater. It's an especially important reminder given that hundreds of earthen dams in less-than-ideal shape still exist across the United States and around the world.
