The Greensburg, KS Tornado

Daniel McCarthy
NOAA Storm Prediction Center
Norman, OK

Larry Ruthi and Jeff Hutton
NWS Weather Forecast Office
Dodge City, KS

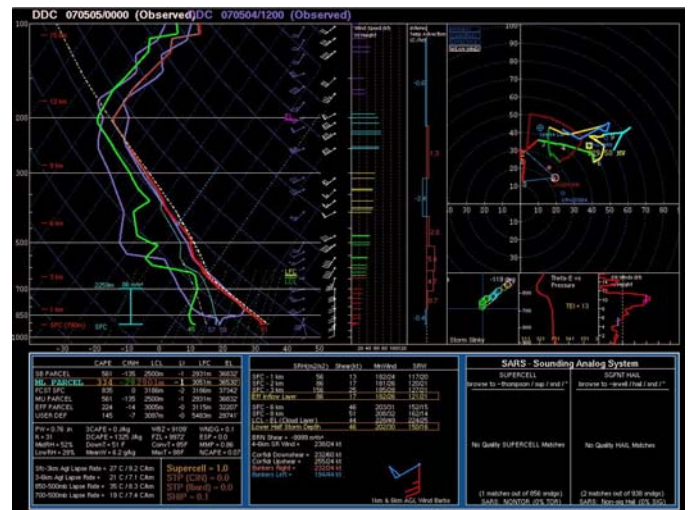
With the middle- and upper-level low over the Great Basin, low level flow was being drawn northward from the Rio Grande River Valley into western Oklahoma and central Kansas into south central Nebraska along and east of a strong dry line boundary. By 2000 UTC, surface dew points (not shown) ranged from the low to middle 60s across central Kansas to around 70 degrees across central Oklahoma. Figure 2 shows the DDC thermodynamic plot showing the passage of the dryline by 00 UTC.

Figure 2: Thermodynamic plot at DDC 5 May 07 at 00 UTC. Lighter purple plot is the data from 4 May 07 at 12 UTC.

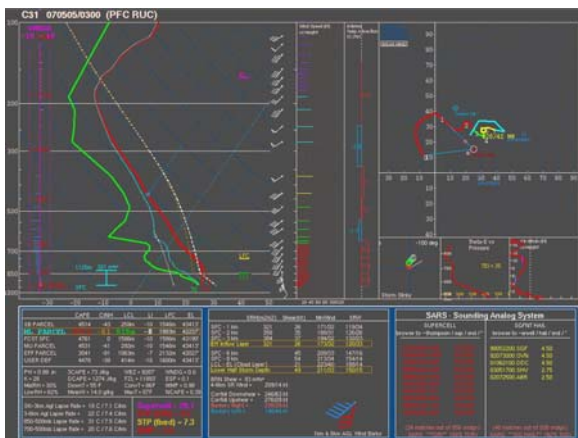
Figure 4: Point Forecast Sounding valid 03 UTC from the 00 UTC run of the Rapid Update Cycle model.

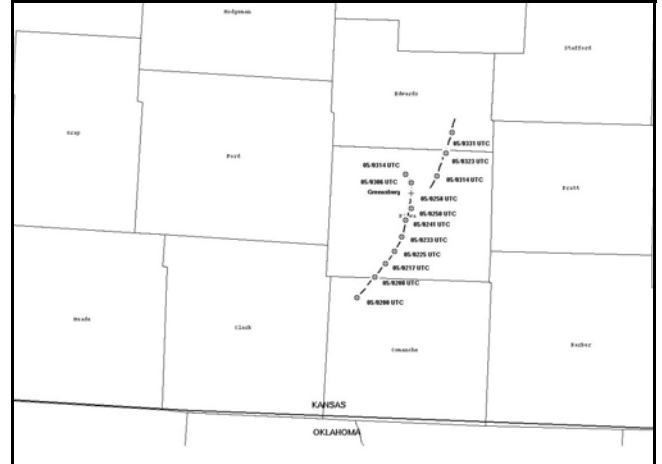
TVS signature with maximum shear to 80 kt! Figure 7 shows a plot

Figure 7: Plot of the mesocyclone centroid associated with the supercell that produced the Greensburg, KS tornado.

of the mesocyclone signature associated with the Greensburg, KS tornado and the development of the second tornado that developed coincident with the end of the Greensburg tornado just northeast of town.

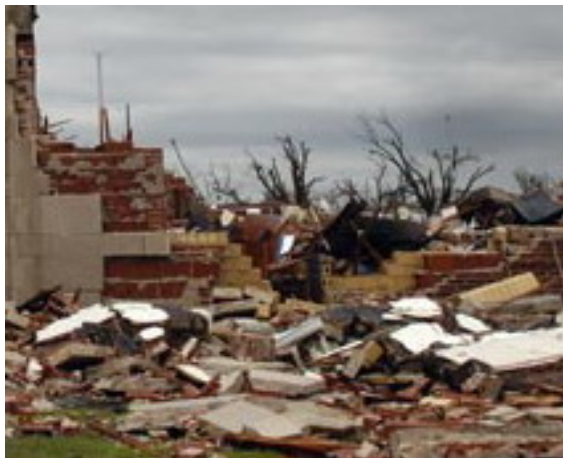
The rating of EF-5 was merited along this area of Main St. that included Greensburg High School built in 1939. The walls to the high school were built with two layers of brick and mortar for the outside wall and a layer of concrete block and mortar for inside wall support. In addition, a $\frac{3}{4}$ -inch layer of plaster made up the inside layer of the wall (Fig.8). Many of these walls crumbled in the tornado damage. The elementary school located just southeast of the high school also sustained significant damage with only part of the west wall remaining.

Figure 8: Damage to southwest wall to Greensburg High School. (Larry Ruthi, 2007)

Using the EF-Scale, the NWS Quick Response Team worked with the NWS DDC staff to determine the scale related to the damage from the tornado. Using the EF-Scale documentation and EF-Kit, a software program to use to evaluate storm damage, it was determined that the structure at the elementary and high schools was at least EF-4 damage.

However, given the structure of the high school and the hospital, it was thought that the descriptions in this particular case may have been insufficient. The Damage Indicator for an institutional building given that these buildings had masonry walls indicated that slightly stronger winds, or multiple vortices, enhanced the damage. Plus, the number of homes swept clean with little trace of debris led the team to the EF-5 rating with winds estimated between 200 mph and 210 mph.

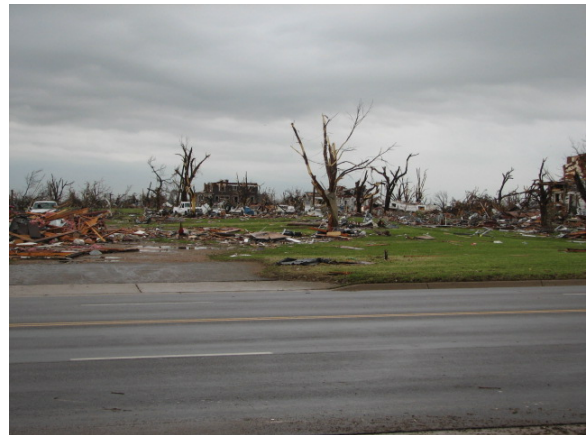
It is estimated that 85% of the structures in Greensburg sustained severe damage. It was difficult to research original locations of automobiles and other projectiles as the town was totally evacuated for safety reasons. Fig. 9 is a photograph

looking north from US 54 illustrating the heavy stripping of trees and homes through Greensburg.

Figure 9: Looking north through Greensburg, KS from the western end of U.S. 54.
