Timothy P. Marshall\*, Scott Morrison, and Jeffrey Green  
Haag Engineering Co.  
Dallas, TX

It is common for people to check their property for damage after a windstorm. Sometimes, they find cracks and separations in masonry walls and think this distress is due to the storm. In order to determine whether wall distress was caused or aggravated by wind, it is important to understand how wind affects masonry. This paper summarizes the types of distress wind can produce in brick and concrete masonry walls.

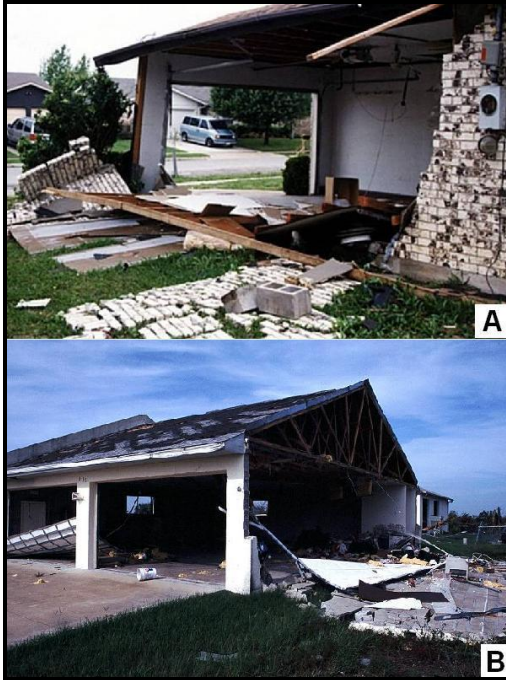
**Figure 2.** Failure of the garage doors led to internal pressures that helped topple the: A) brick wall and B) concrete masonry unit wall.

Masonry walls are susceptible to wind-caused damage especially when subjected to high internal pressures. Internal pressures result when doors or windows are breached on the windward side of the building (Fig. 2). The combination of positive pressures on the interior sides of perimeter walls and negative pressures on exterior sides can lead to wall failure. As shown by Marshall et al. (2008a and b), masonry walls that fail in the wind frequently rotate along horizontal hinge lines at the bases of the walls and separate along vertical joints at window and door openings. Window and door openings interrupt continuity and bridging action, thereby weakening walls.

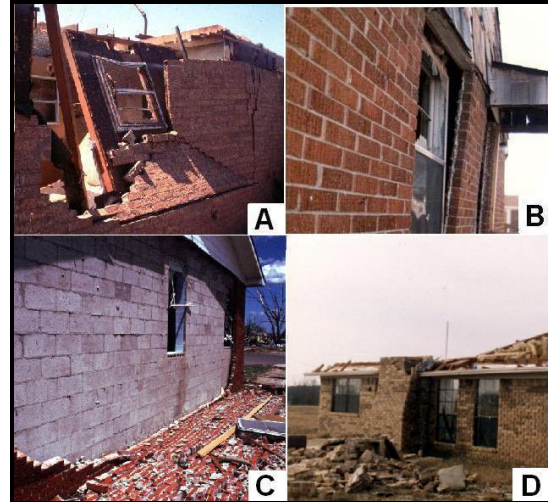
**Figure 3.** Failure of masonry in the wind: A) windward wall toppled inward around a window, B) leeward wall leaned outward around a window, C) toppled wall along a hinge line at the base of the wall, and D) a broken chimney at roof level.

Masonry chimneys are susceptible to toppling in the wind since they extend above the roof where wind speed is higher. Failures of chimneys usually occur along mortar joints as the joints have little tensile strength to resist lateral or uplift loads. Leaning masonry chimneys result from foundation movement due to uneven bearing on the underlying soil, and are not wind-caused.

Marshall and Robinson (2006) showed that gable ends of masonry walls were susceptible to toppling in strong winds. Lateral wind loads caused the masonry to fail along horizontal hinge lines at the bases of the gables. Sometimes when load bearing masonry walls fail, it can result in the partial collapse of the roof or total collapse of the structure. Such wall failures have been documented by Blaney (1994) after Hurricane Andrew in Florida and by Schultz et al. (2002) after tornadoes in Minnesota. Both load bearing and non-load bearing masonry walls should be designed in accordance with local building codes. In the United States, design wind loads vary from 40 to 67  $\text{ms}^{-1}$  as a three-second gust in open terrain.
