STORM SURGE ON LAKE BUTTE DES MORTS DURING THE 11 JUNE 2001 BOW ECHO EVENT

Timothy P. Marshall*
Haag Engineering Co.
Dallas, Texas

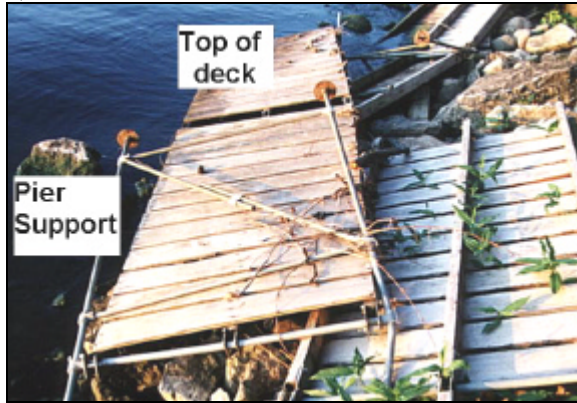
This lake is located just northwest of the city of Oshkosh. Numerous lake front homes had portable boat piers that extended into the lake. Many of these boat piers were destroyed during the storm (Figs. 5 and 6).

Figure 5. Boat pier debris on the shore of Lake Butte des Morts after the storm.

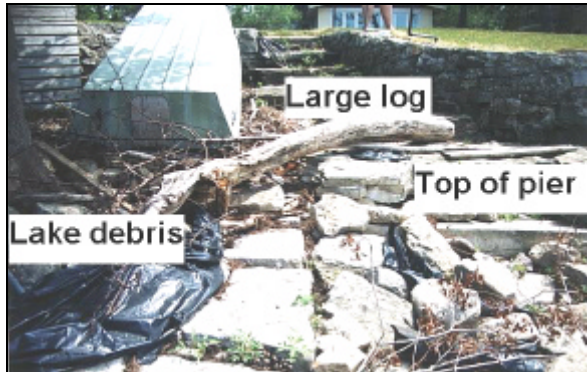
Figure 6. Pier area after storm. Large log (driftwood) deposited on step above the location of pier.
