Building Damage Issues in Hurricanes

Timothy P. Marshall, P.E.*
Haag Engineering Company

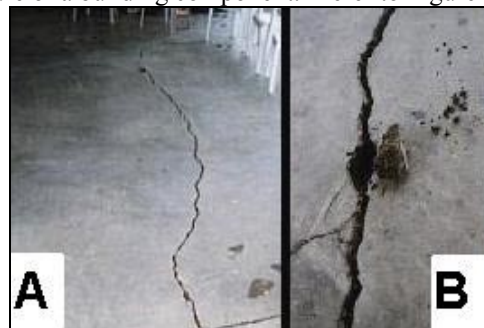
Figure 2. Old crack in middle of concrete slab (A) and close-up view (B) showing dirt in crack. This crack was not caused by the hurricane.

An examination of the crack interior will often determine whether the crack is new or old. Cracks become discolored with time as they accumulate dirt, paint or debris. Refer to Figure 2. Edges of the cracks become rounded with continued wear. Water entering the cracks can lead to rusting of reinforcing steel and the resulting expansion can lead to spalling the concrete. In contrast, cracks caused recently do not have these characteristics. Recent cracks appear fresh and unweathered with broken pieces of the concrete along the fractures. Concrete slab cracks associated with wind usually are found in the direct load path with failure of a building component. Refer to Figure 3.

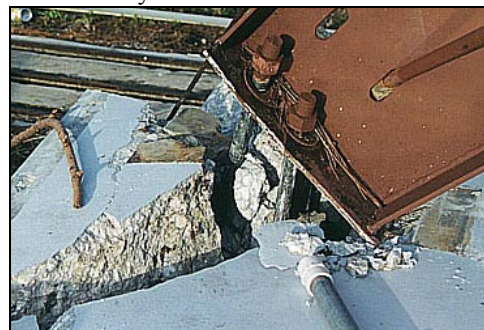
Figure 3. New crack in concrete slab caused by the rotation of the steel column that failed in the wind.

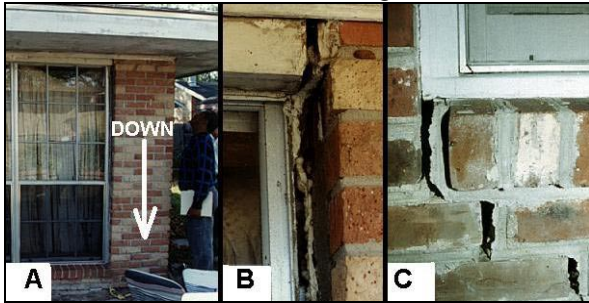
Figure 4. Foundation settlement at the corner of a house (A). Close-up view (B) shows V-shaped gap between window and brick, and (C) shows stair-step crack at base of window. Note prior attempts at caulk repair. The distress was not caused by the hurricane.

cement, sand, water, and lime. The lime is utilized to increase workability of the mix. Masonry walls are susceptible to distress from differential (up and down) foundation movement. Drainage conditions, locations of trees and downspouts all affect the soil moisture content. Window and door openings are naturally weak points in the wall where the distress concentrates. Cracks and separations that open with height (V-shape) indicate settlement on either side of the crack whereas cracks tapering closed with height indicate settlement at the base of the crack. Refer to Figure 4.
