P 9.1 THE DALLAS-FT. WORTH, TX HAILSTORM: 5 APRIL 2003

Timothy P. Marshall*, Richard F. Herzog, and Scott J. Morrison
Haag Engineering Co. Dallas, TX

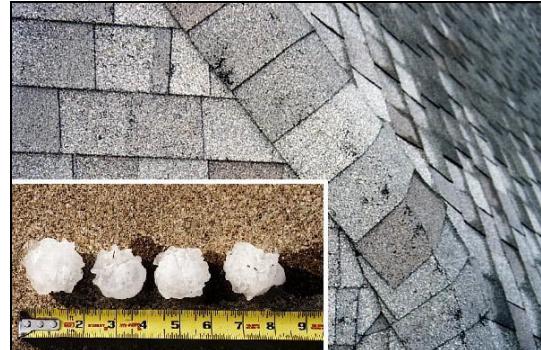
Figure 6. Hailstones to 2 in. (5.1 cm) in diameter and resulting roof damage in Flower Mound, Texas, in southern Denton County.

A hail damage survey team was dispatched to the metropolitan area after the storm and spent several days examining roofs and other items in an effort to map the hail sizes and direction of hailfall. A hail survey form was filled out for each of the locations visited. The form included the following information: the name and address of the building owner, roof covering type and age, the sizes and directions of hail spatter/scuff marks on metal and wood surfaces, and the sizes and direction of dents on metal and wood surfaces. In addition, some people kept hailstones in their freezers and the hailstones were measured, photographed, and compared to the extent of roof damage (Figure 6). Charlton and Kachman (1987) had conducted a similar hail damage survey in Edmonton, Alberta, Canada.

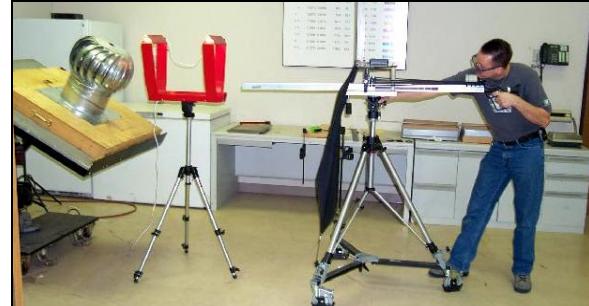
A mechanical device, was utilized to launch ice balls at the above metal items (Figure 11). The items were struck with solid ice balls of 1/2 in. (1.2 cm) to 2-1/4 in. (5.7 cm) using standard velocities similar to Greenfeld (1969). Impacts were done perpendicular to the metal surfaces as well as at 45 degrees. After striking the metal items, deformations in the metal were examined visually and the widths and depths of the dents were recorded.

In summary, Morrison found that the dents in lead soil stack flashing, galvanized steel turbine vent blades, and aluminum air conditioner fins were slightly smaller than the diameter of the ice ball, about 10 to 20 percent smaller. Thus, the assumption that hail size was equivalent to dent size in our damage survey was reasonable for these items. However, not all vents had such good correlations between dent sizes and hail sizes. Morrison found that dents in the aluminum box vents were about half the diameter of the ice ball. In contrast, dents were twice as large as the ice balls in the malleable aluminum flue vent caps. These vent caps tended to buckle when impacted. Experiments are currently under way to determine if impacting these objects with softer ice balls, which break apart more easily upon impact, would lead to better correlations.

Figure 11. Ice ball launcher (IBL-7) utilized to impact various metal items. A chronograph was positioned between the launcher and item to be impacted in order to obtain the velocities of the ice balls.
