Timothy P. Marshall^{*1}, William Davis², Steven Runnels²

¹Haag Engineering Company

1. INTRODUCTION

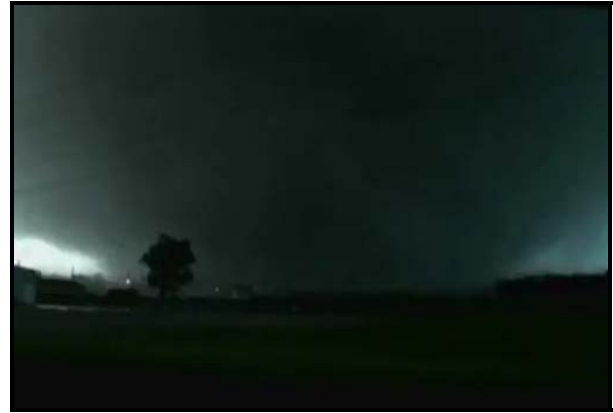
Figure 1. Large, rain-wrapped tornado in Joplin, MO. Photograph courtesy of Jeff Piotrowski.

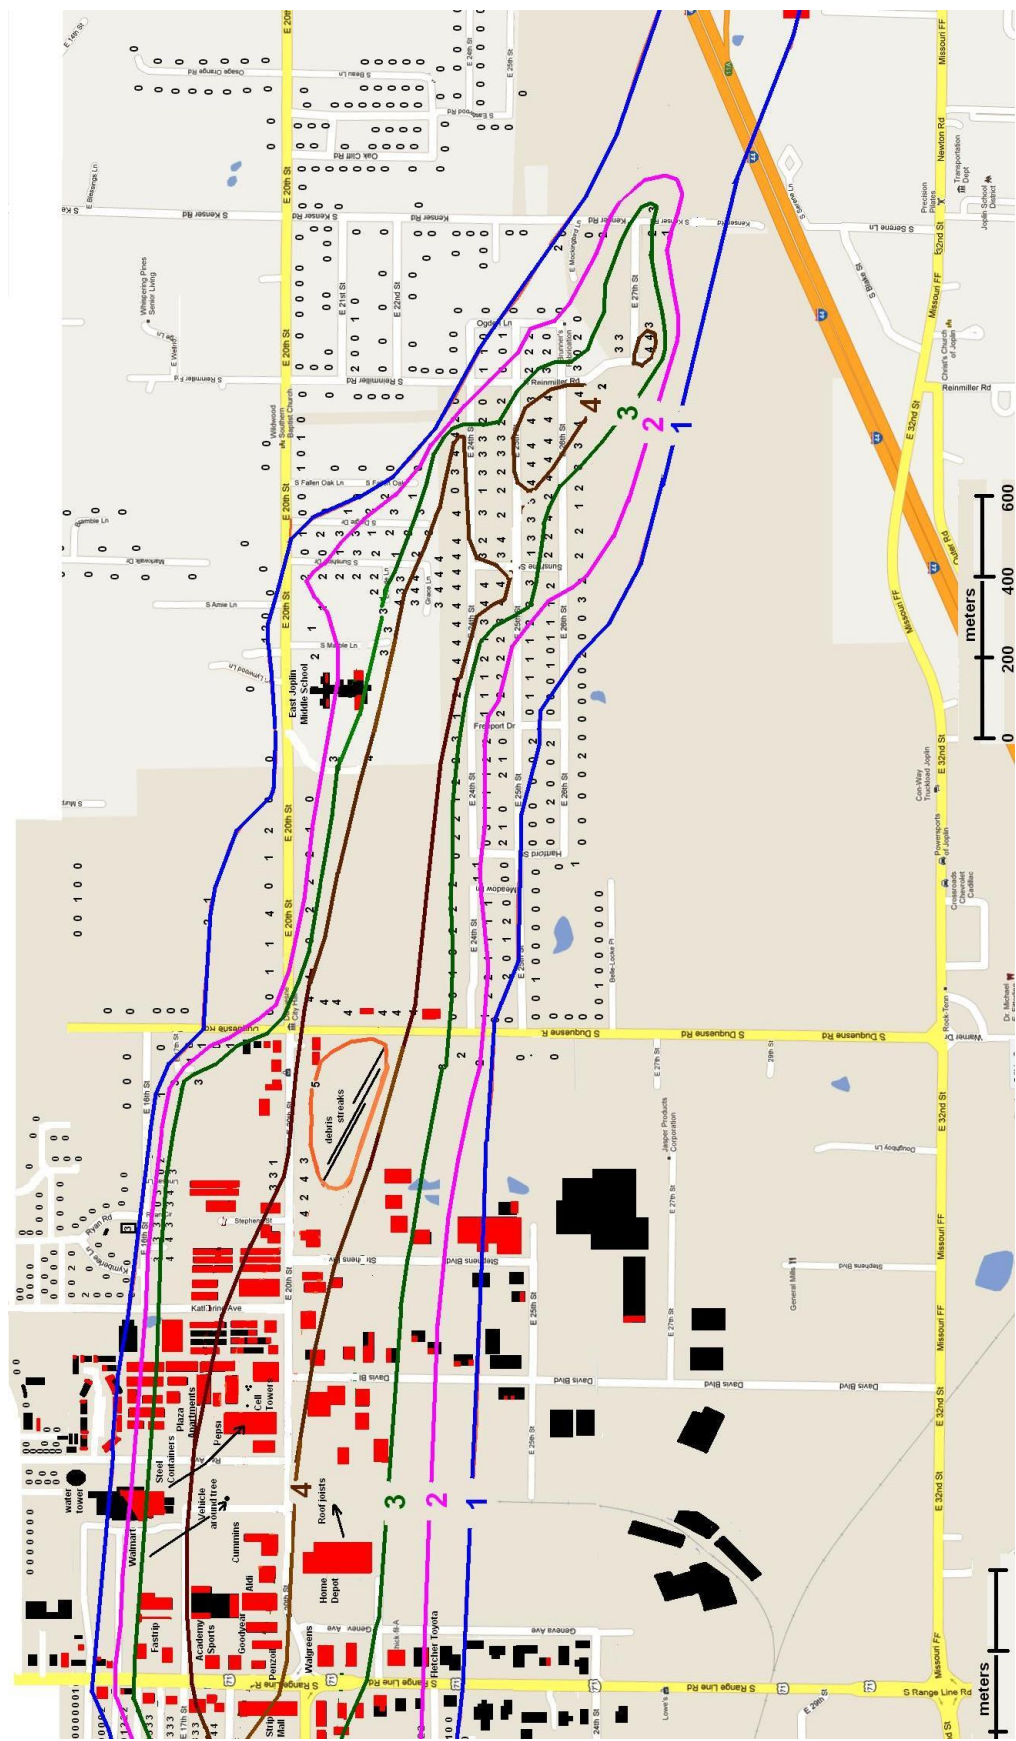
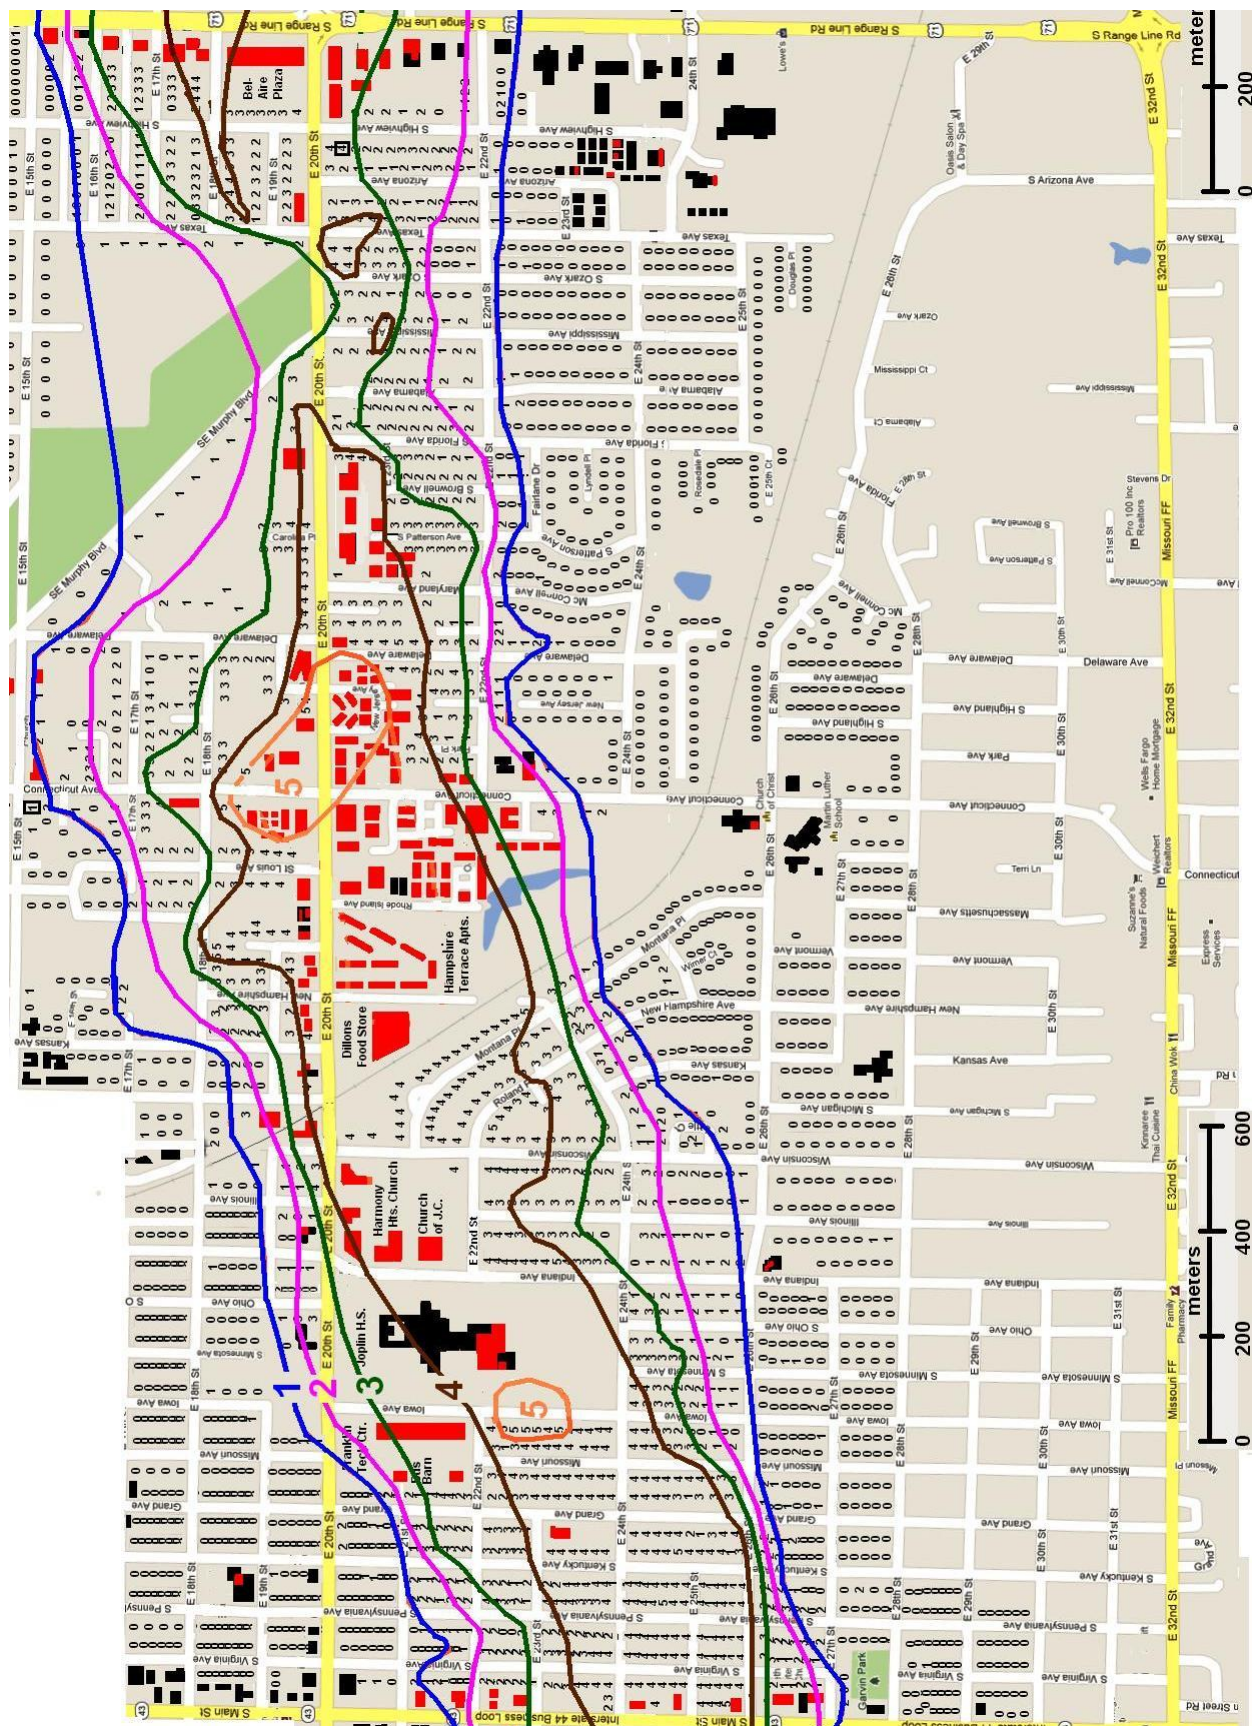
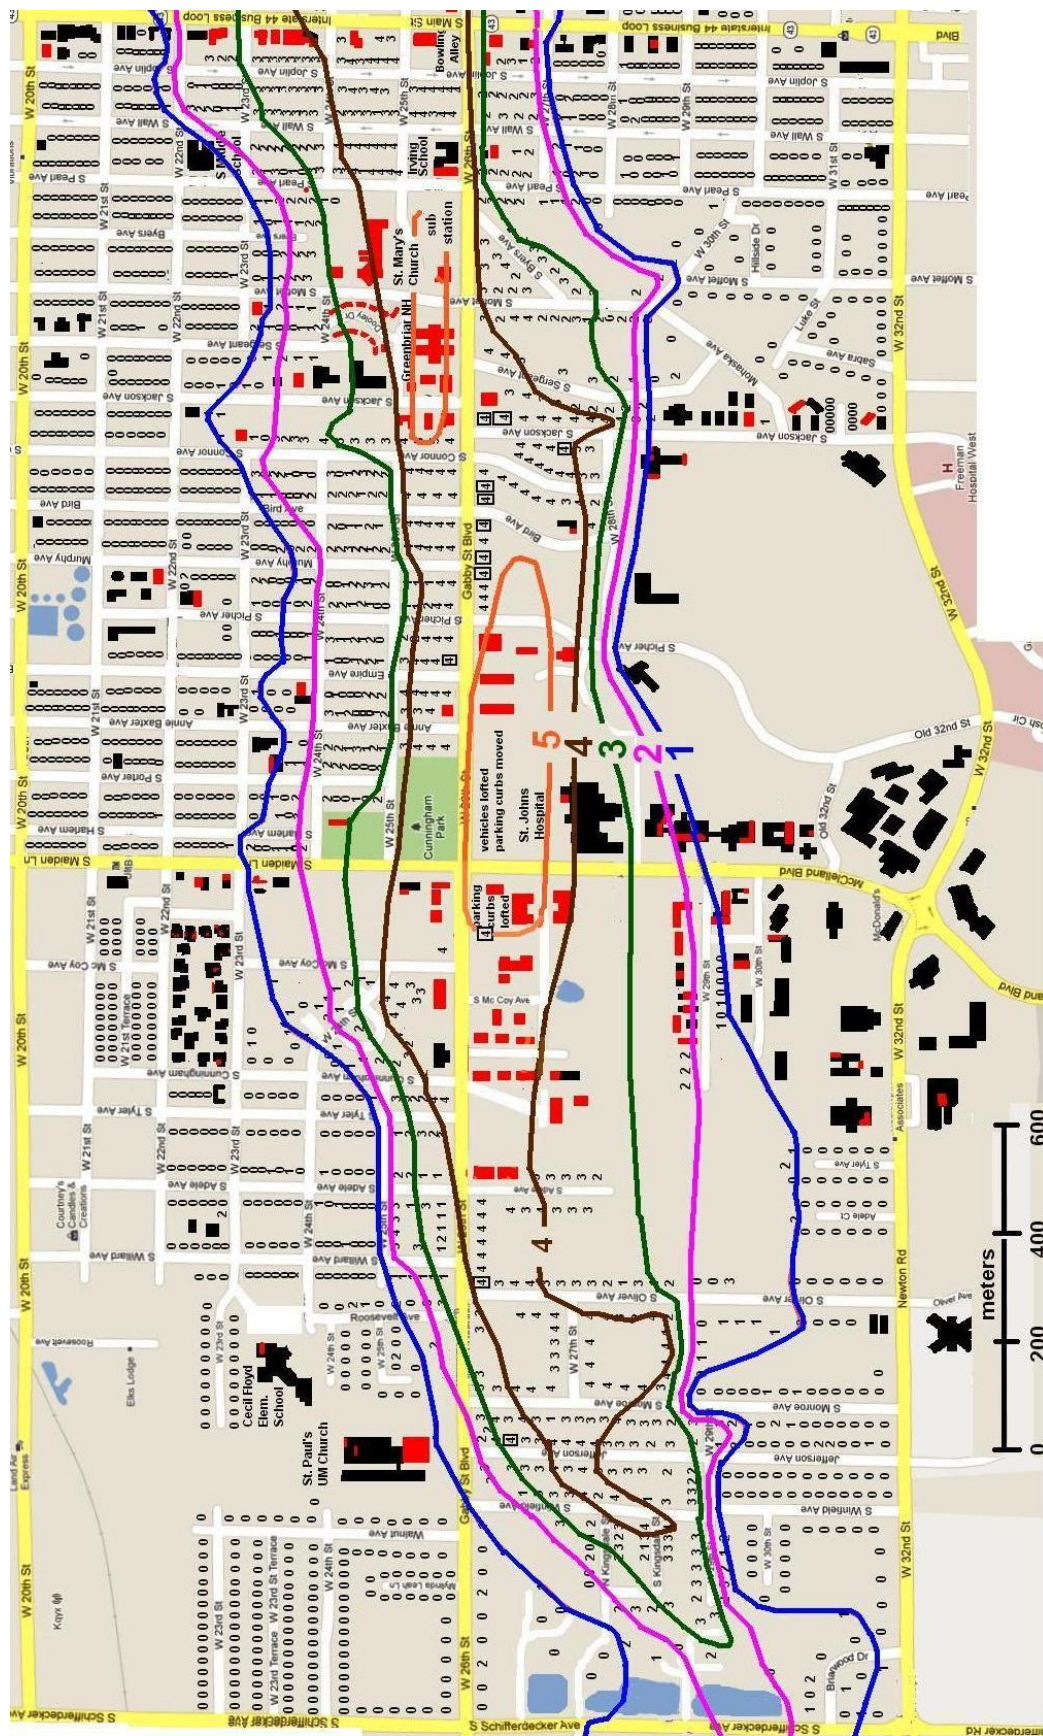
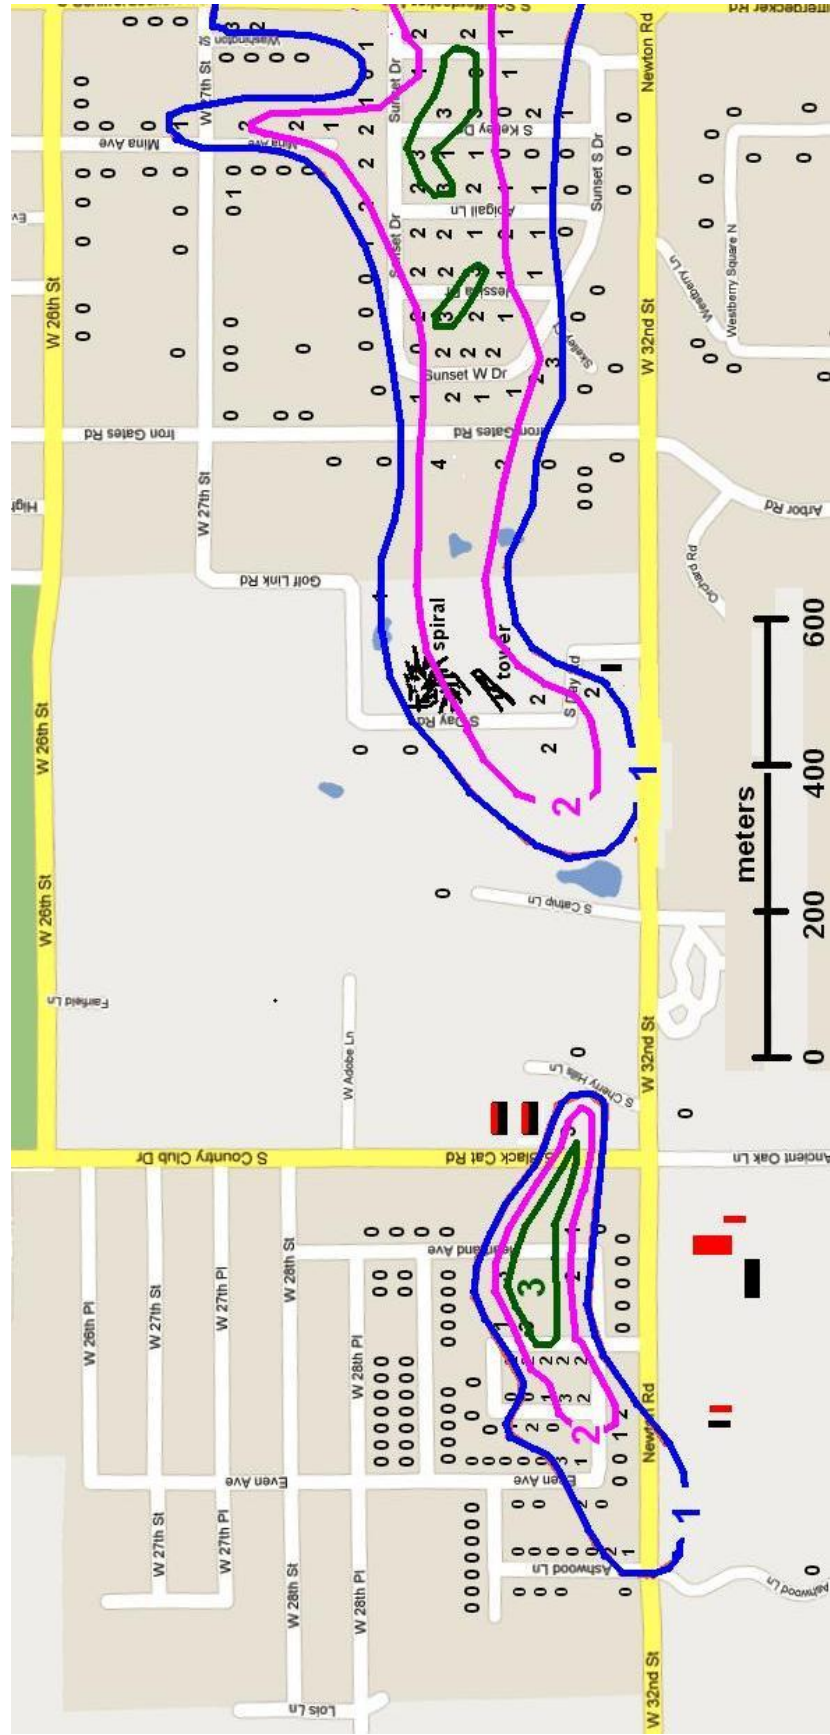
MAP ATTACHMENTS

We have attached damage maps developed from our analysis of the Joplin tornado. Only that portion of the track that went through the city is shown. Houses were rated EF-0 to EF-5 per the EF-scale. Boxes around the numbers indicated where homes slid off their foundations. The maps are contoured EF-1 through EF-5 in color. Lines shown in blue are EF-1, purple EF-2, green EF-3, brown EF-4, and orange EF-5.
