## 5.3 Damage Survey of the Tuscaloosa-Birmingham Tornado on 27 April 2011

Timothy P. Marshall, P.E.<sup>1</sup>, Jim Stefkovich<sup>2</sup>, John DeBlock<sup>3</sup>, James G. Ladue<sup>4</sup>, Chris Karstens<sup>5</sup>

<sup>1</sup> Haag Engineering Co.

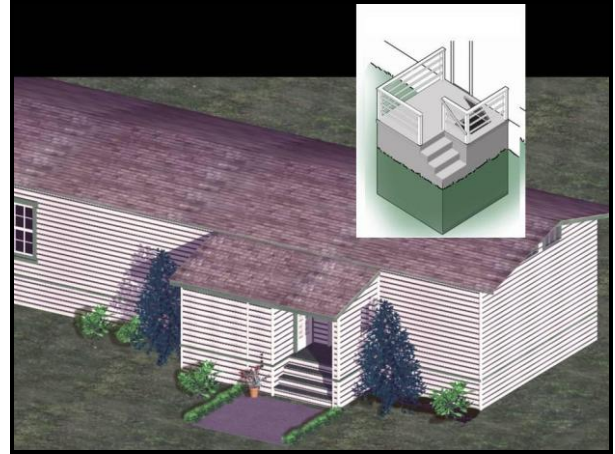
According to NOAA (2011), many people died in their homes, both conventionally constructed and manufactured homes. In cases where homes sustained complete destruction, we noticed many front porches remained intact. We believe that porch type shelters would have been effective in saving lives. These concrete or steel box shelters are placed partially below grade and can provide substantial occupant protection (Figs. 25 and 26). Unfortunately, few companies make porch shelters. A general internet search showed them to cost between \$3,000 to \$5,000. We did not observe any porch shelters during our survey.

**Figure 25.** The porch shelter.

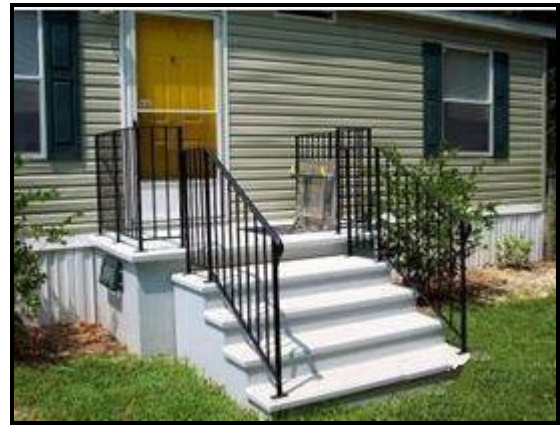
**Figure 26.** Example of an installed concrete porch shelter with steel entry door.

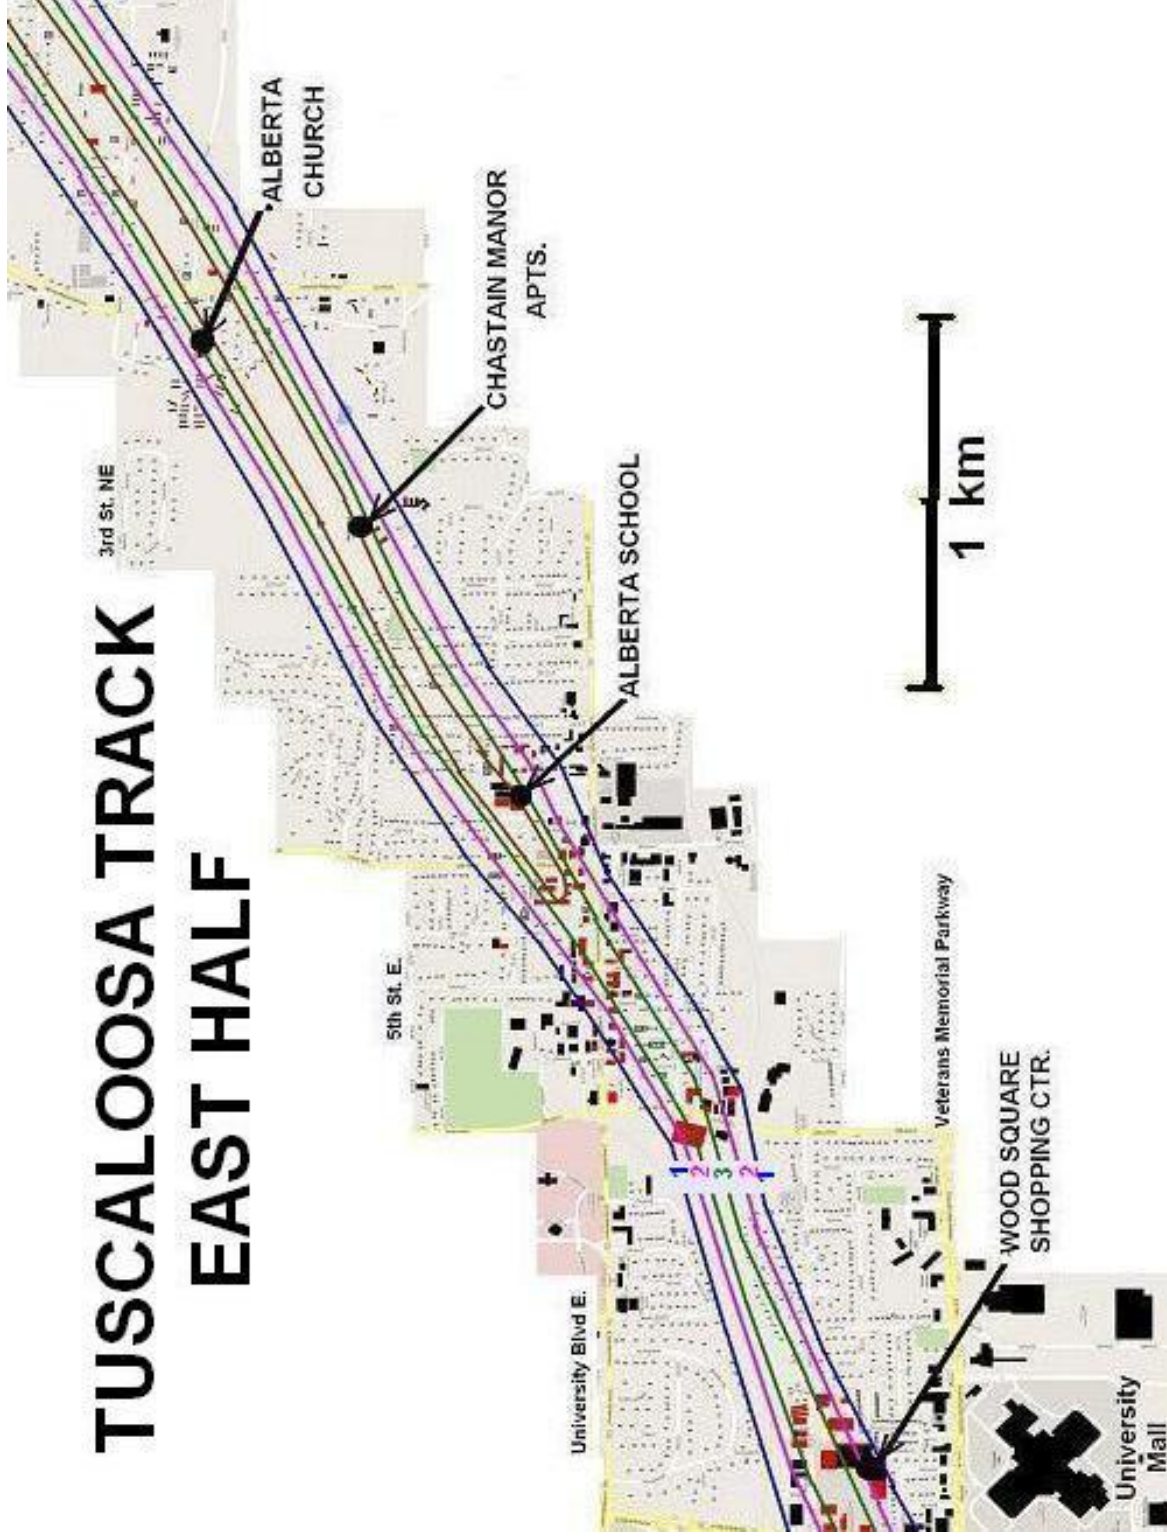
# TUSCALOOSA TRACK EAST HALF

We have attached damage maps developed from our analysis of the Tuscaloosa-Birmingham tornado. Only populated areas are shown. Rural areas were omitted. Houses were rated EF-0 to EF-4 per the EF-scale. Boxes around the numbers indicated where homes had slid off their foundations. The maps are contoured EF-1 through EF-4.
