## P7.101 Performance of residences and shelters in the Oklahoma tornadoes of 24 May 2011

Timothy P. Marshall<sup>1</sup>, James G. Ladue<sup>2</sup>, Kiel L. Ortega<sup>3</sup> and Gregory J. Stumpf<sup>4</sup>

<sup>1</sup> Haag Engineering Co., Irving, Texas  
<sup>2,3,4</sup> NOAA/NWS

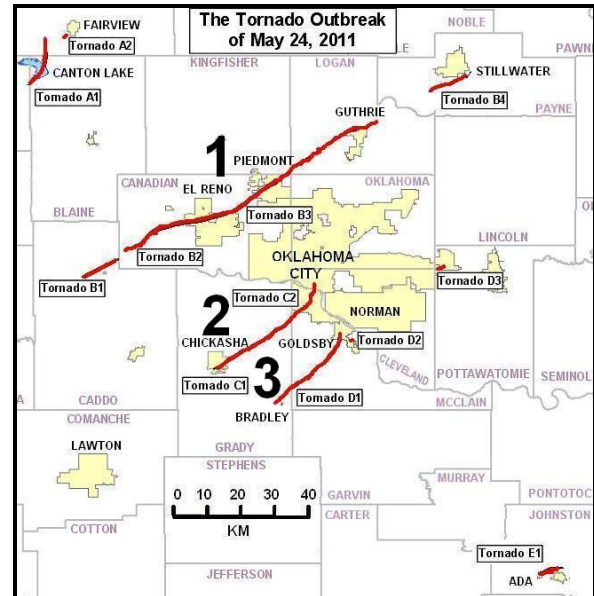
**Figure 1.** Tornado tracks on 24 May 2011 in central Oklahoma. Violent tornado tracks by town are: 1) Hinton-El Reno-Piedmont-Guthrie, 2) Chickasha-Newcastle, and 3) Bradley-Goldsby. Courtesy of the OUN NWSFO. More detailed maps are appended.

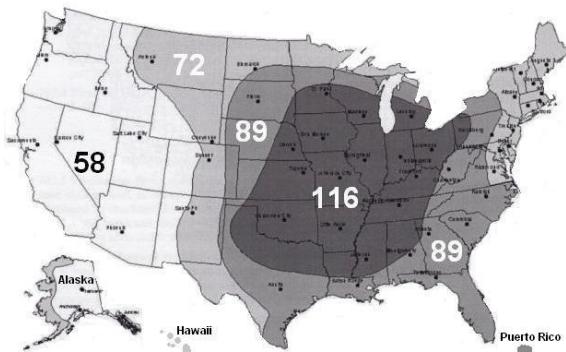
**Figure 23.** Storm shelter design wind speeds for tornadoes per the ICC-500 standard. Wind speeds shown are 3-second gusts in meters per second at 10m in open terrain.

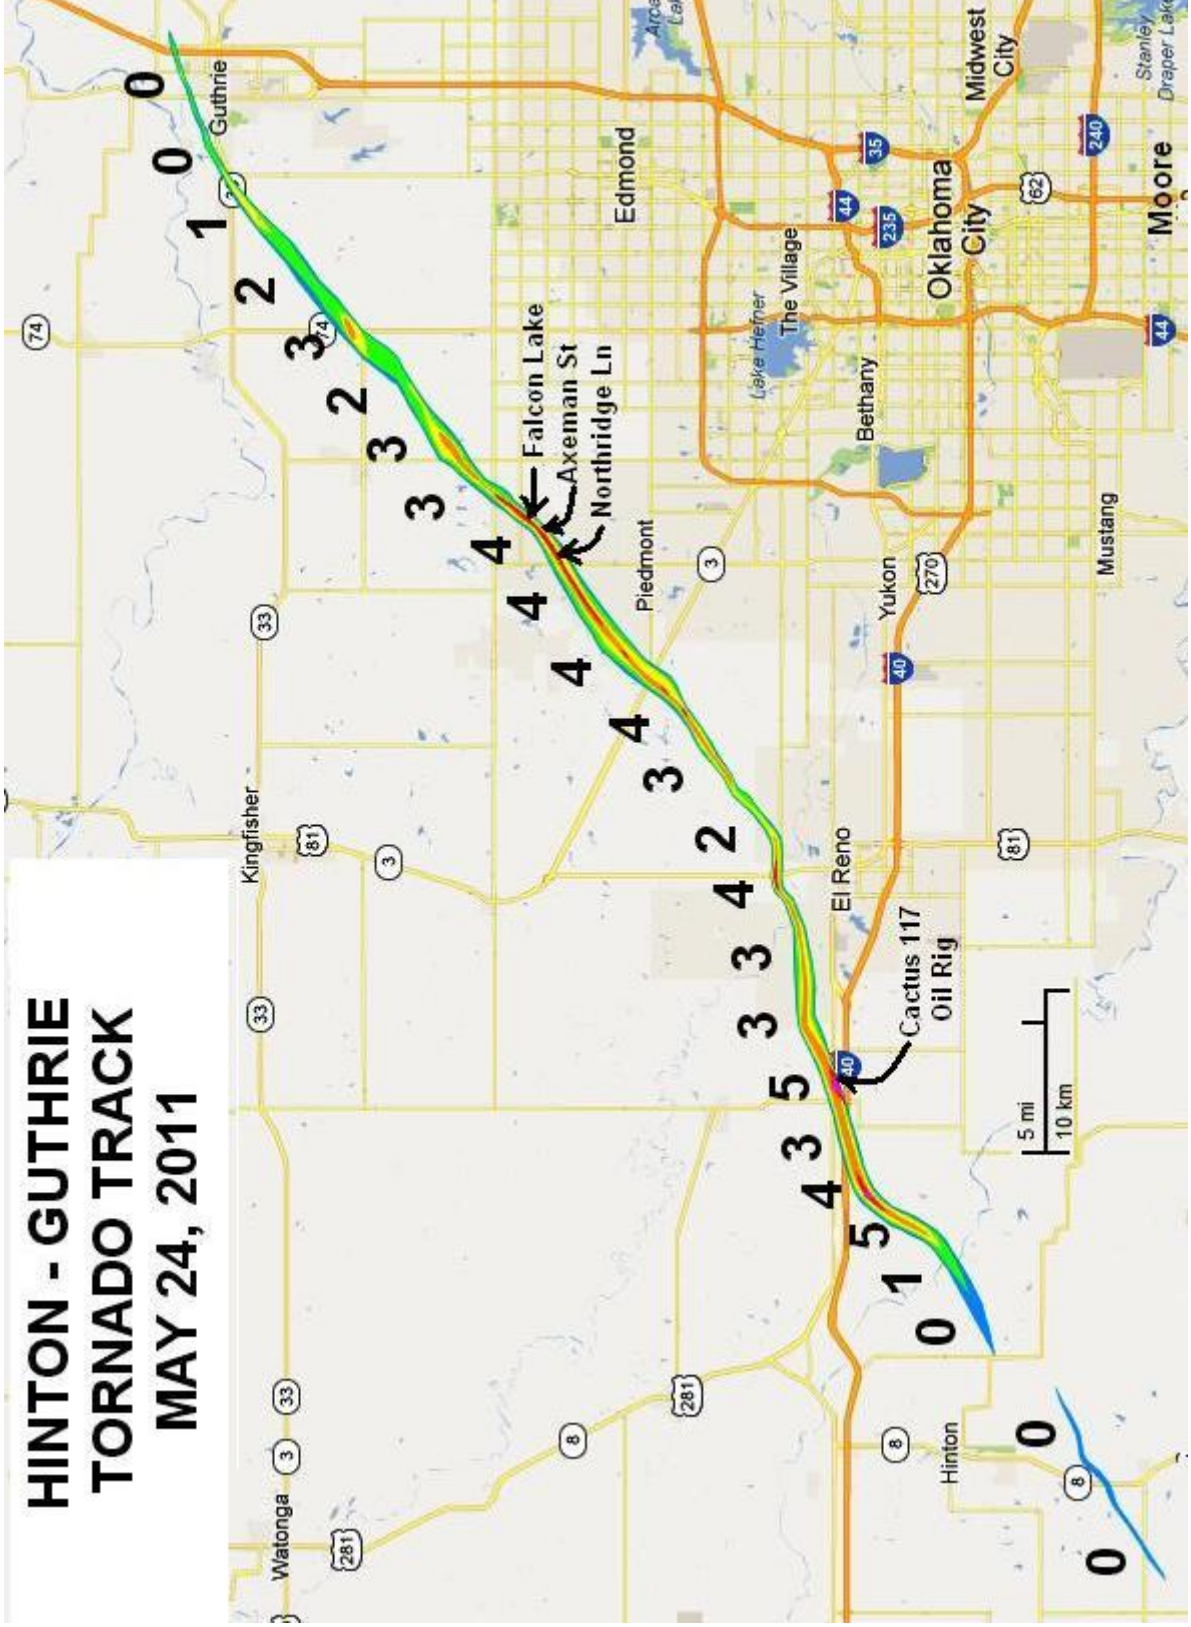
# HINTON - GUTHRIE TORNADO TRACK MAY 24, 2011

We have attached damage maps developed from our analysis of the Oklahoma tornadoes. Contours range from EF-0 to EF-4 or EF-5 depending on the tornado and are color coded: EF-0 is blue, EF-1 is green, EF-2 is yellow, EF-3 is orange, EF-4 is red, and EF-5 is pink. Interactive maps are available at:  
<http://goo.gl/maps/YrkdD>.
